# **Access Cover**

# **Question:**

I am working on an Ames 4 inch model C-200(a). The strange thing is that it doesn't seem to have any access covers. Do you guys have any experience with this assembly? If so, can you give me some tips regarding service procedures for this assembly?

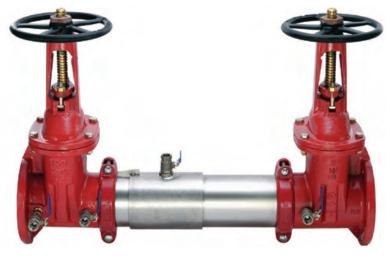
The Ames Model C-200(a) is a double check valve assembly. The Colt 200 is very unique in its appearance. The body of this assembly is made of stainless steel and uses grooved couplings to connect the shut off valves instead of traditional flanged ends. Many people say this assembly looks like a solid piece of pipe between two gate valves, but rest assured there is a way to get into this assembly. As manufacturers strive to build assemblies smaller, lighter and with better flow rates, we will start to see different looking assemblies in the field. They

will also have new innovations for access and repair of the check valves. This particular model utilizes a closure sleeve as an access cover.

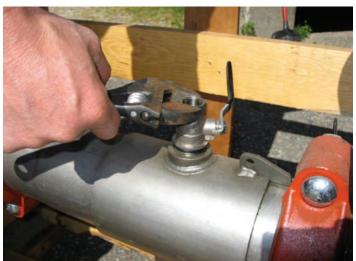
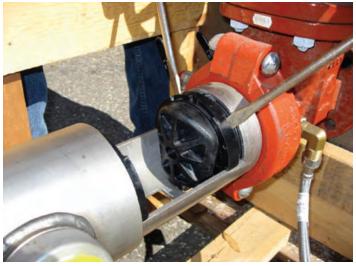
We'll go over a complete repair procedure so that we don't leave anything out. First, you want to close both shutoff valves. Then bleed the #2, #3, and #4 test-cocks to relieve any pressure in the device body. To gain access to the check valves, you need to completely remove the #3 test-cock by turning it counterclockwise. Removing this test-cock will unlock the closure sleeve. You will notice a tab that is welded to the sleeve. Place a screwdriver through the hole in the tab and use your screwdriver as a handle. To break the seal, move the sleeve from side to side and then slide the closure sleeve towards the outlet gate valve. With the closure sleeve opened and out of the way you should now be able to see the stainless steel check retainer.

The retainer will lift straight out and should not be difficult to remove. If you have trouble removing the retainer, make sure you have opened the #2, and #4 test-cocks to relieve all pressure in the device body. Once the retainer is out, you'll notice notches in each check valve. Place the tip of a slot-

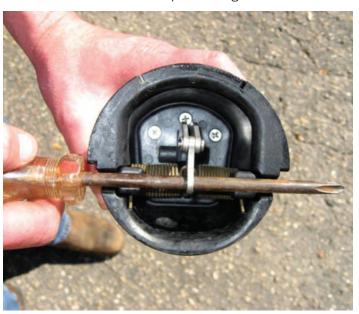
ted screwdriver in these notches and pry each check valve out, removing the #1 check first, followed by the #2 check. The check valves are o-ring sealed and simply slide out of the body. Now you are ready to start the repair on the checks. If you turn the check valve so that you're looking at the inlet side of the check, you'll notice two links, also known as a bi-link. One link is attached to the disc retainer and one is attached to the spring assembly. We want to hold the link in place so that it can be disconnected. To do this, slip a round shank screwdriver through the hole in the link and let it rest in the grooves of the plastic check body. You may have to push forward on the link so that the hole is lined up with the grooves.

With the screwdriver in place, the spring tension is now contained and we can inspect the seat and/or replace the check rubber. The two links are joined by a clevis pin that is held into place by an "E" Clip. Remove the "E" Clip with a small tip screwdriver being careful not to lose it. Once you remove the clevis pin, the disc retainer portion (clapper) will swing free. You can remove the (5) screws and replace the check disc if necessary. After cleaning or replacing the check valve rubber, reassemble links using the clevis pin and "E" Clip and remove screwdriver. Lube the seat o-rings and slide check assembly #2 in first, followed by the #1 check assembly. Now replace the retainer, slide the closure sleeve back into place, and then reinstall test-cock #3. \textstyle \te
