# 800 (M2,M3,M4) 1/2"-2"

# *Modification Overview*

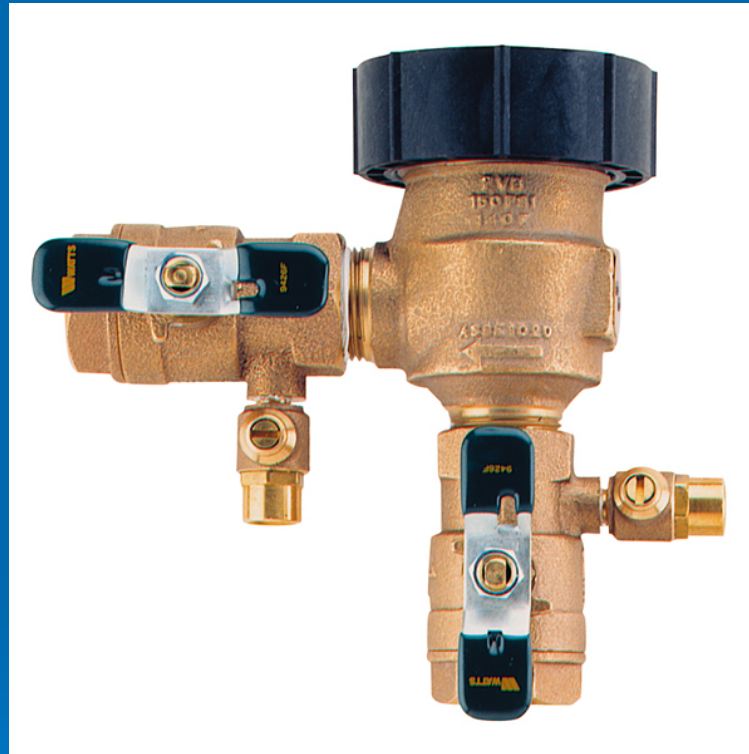
- The original model 800 was produced from 1982-1993.
- The 800M2 was produced from 1991-1994.
- The 800M3 (1/2", 3/4" sizes only) was produced from 1991-1994.
- The 800M4 production began in 1994 and is the current model.
- The 800M4FR was introduced in 1995 and is produced with a float assembly that contains a relief valve that protects the unit against freeze damage.
- A lead free (LF) version was introduced in 2010.

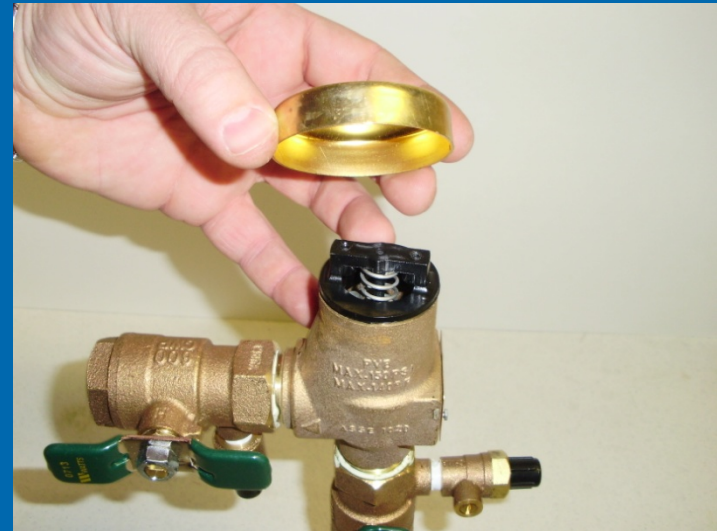
- The 1/2" - 3/4" hood is secured by two screws.

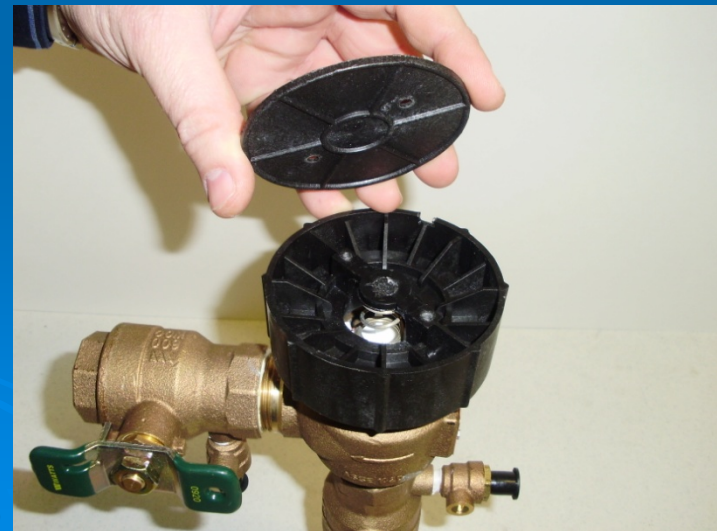
- The 1"-2" hood is secured by two screws.

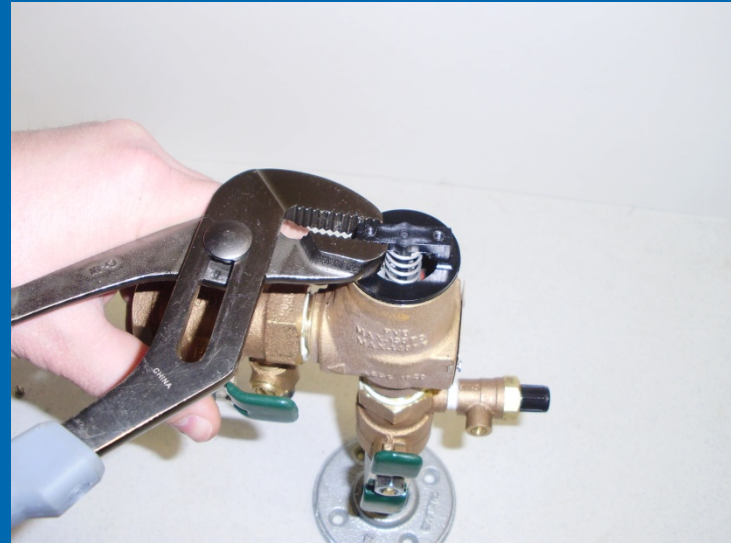
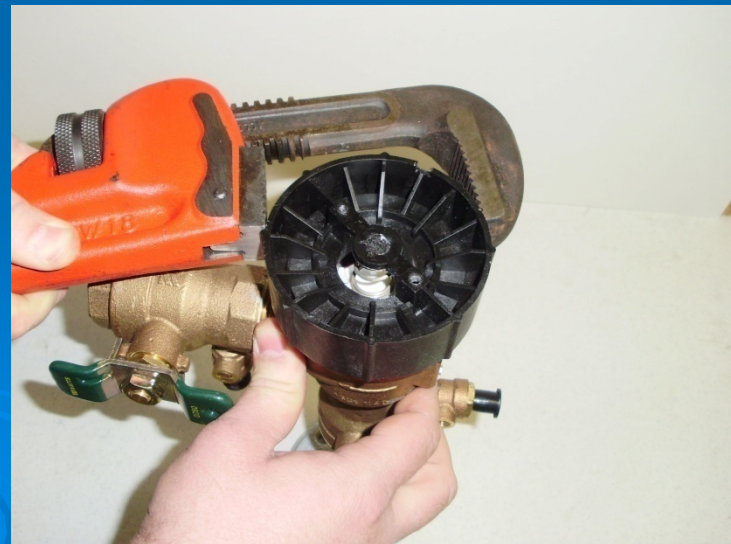
# Bonnet Removal

- The bonnet is threaded into the body and sealed by an o-ring.
- There is no spring load.

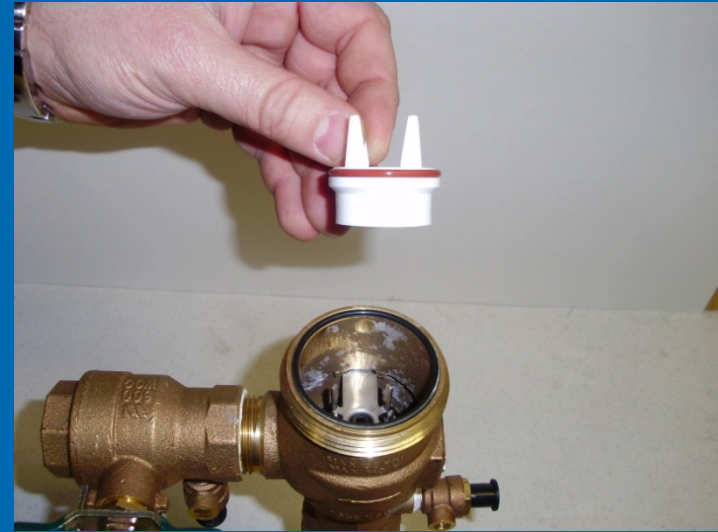
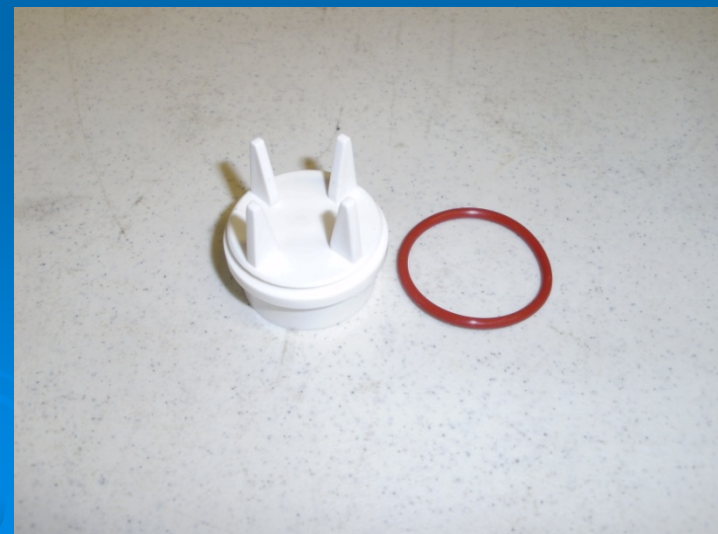
# Float Removal and Service

- The float is free once the bonnet has been removed.
- Replace the rubber seal by pulling it from the groove on the float.

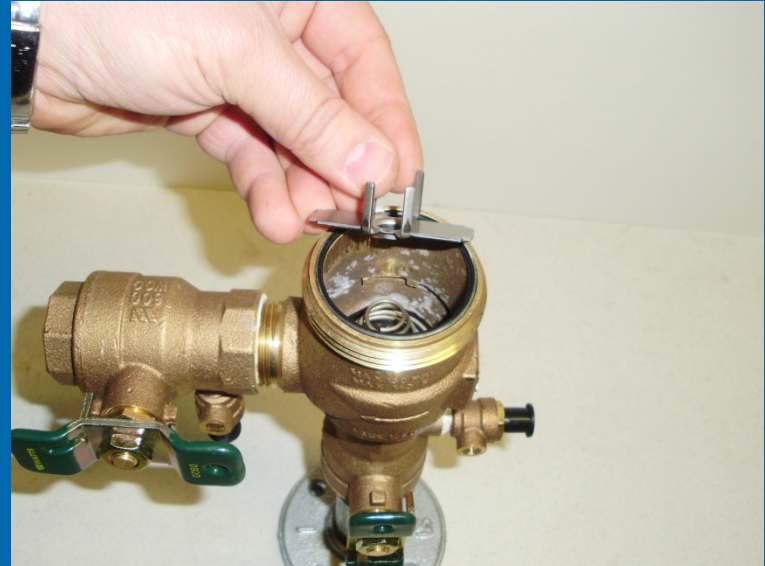
# Check Valve Removal

- Check valve is spring loaded.
- Remove spring retainer by pressing down and rotating to clear tabs on the body.
- Remove spring and poppet.

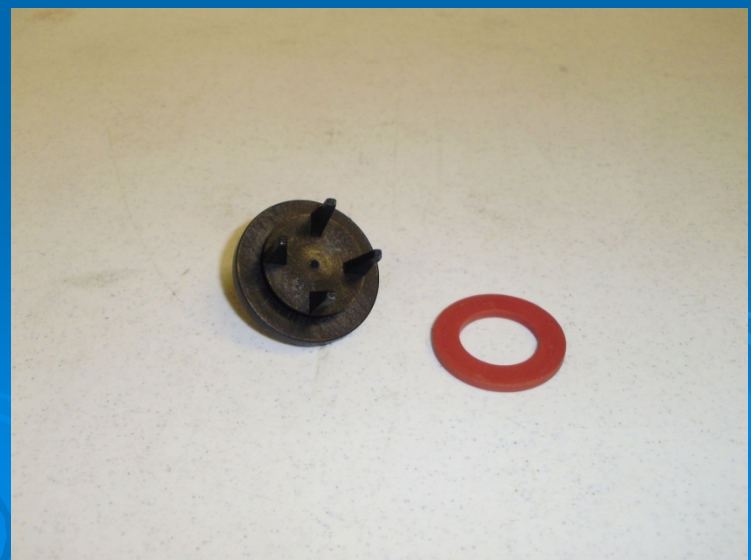
# Check Disc Replacement

- Replace the rubber disc by pulling it from the groove on the poppet.

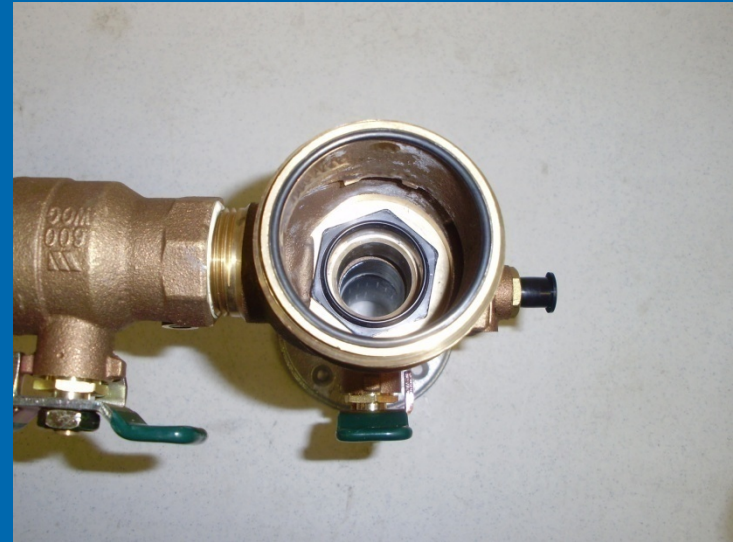
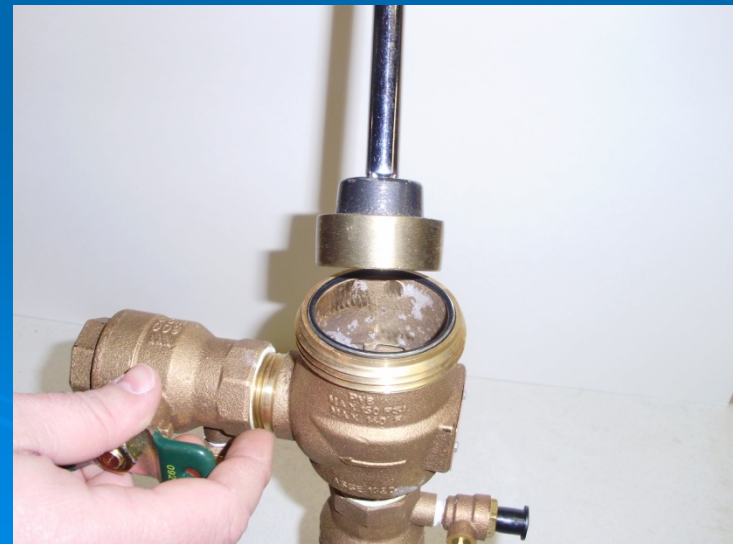
# Check Seat Replacement

- The check seat is threaded into the body and sealed by an o-ring.
- \*\* Note: A special tool is needed to remove the seat.

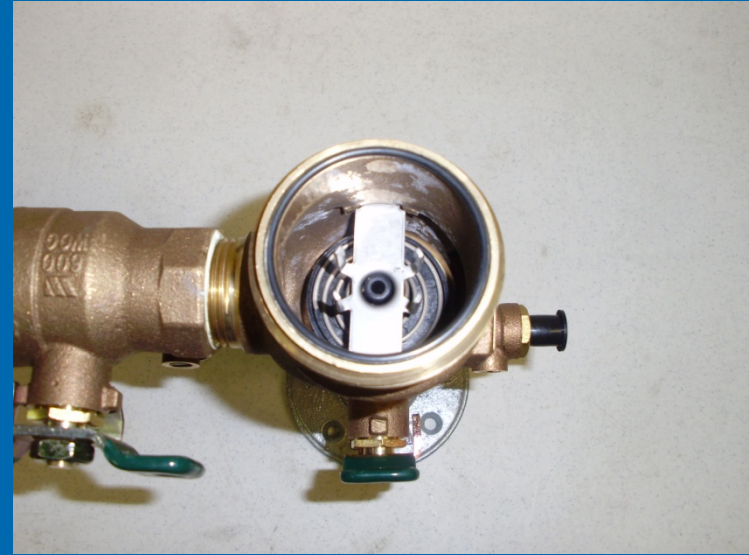
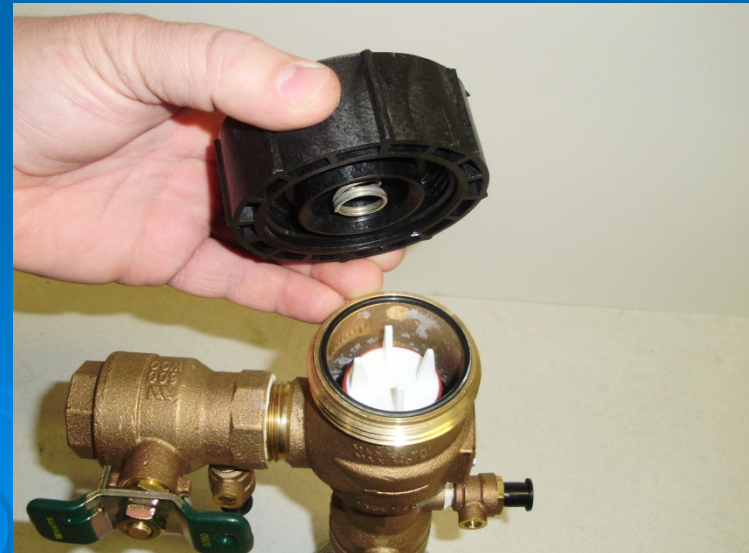
# Reassembly Notes

- Reassemble in reverse order.
- Place large end of spring down in body.
- The guides on the retainer face up.
- The guides on the float face up.
- Make sure the float spring is centered on the float.
