876, 876V 2½"-10"

FEBCO®

Modification Overview

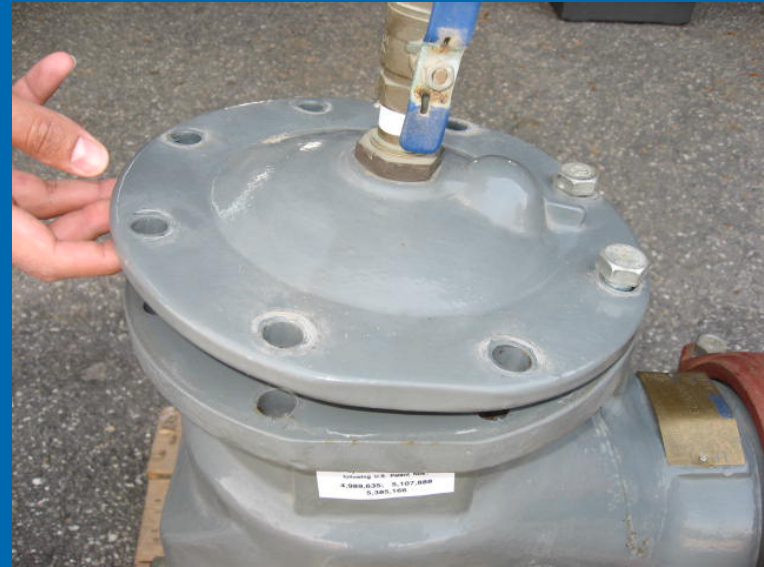
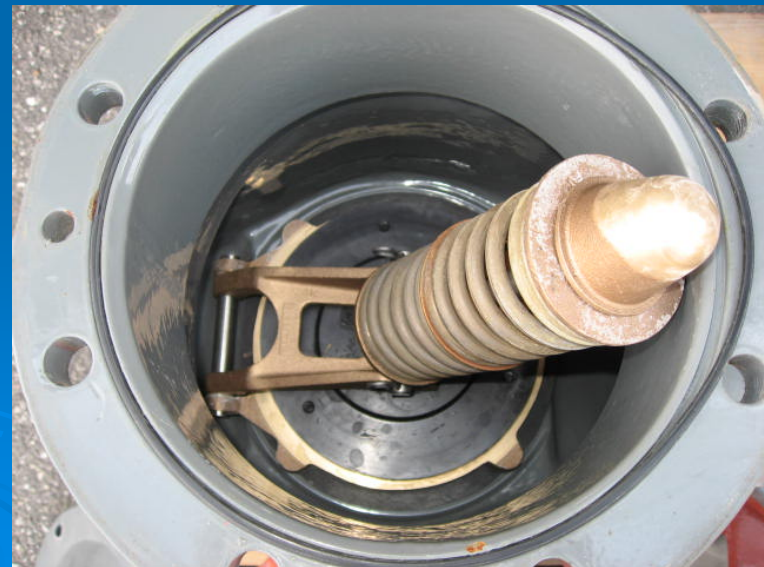
Check Cover Removal

- Cover is bolted and o-ring sealed.
- There is a slight spring load on cover.

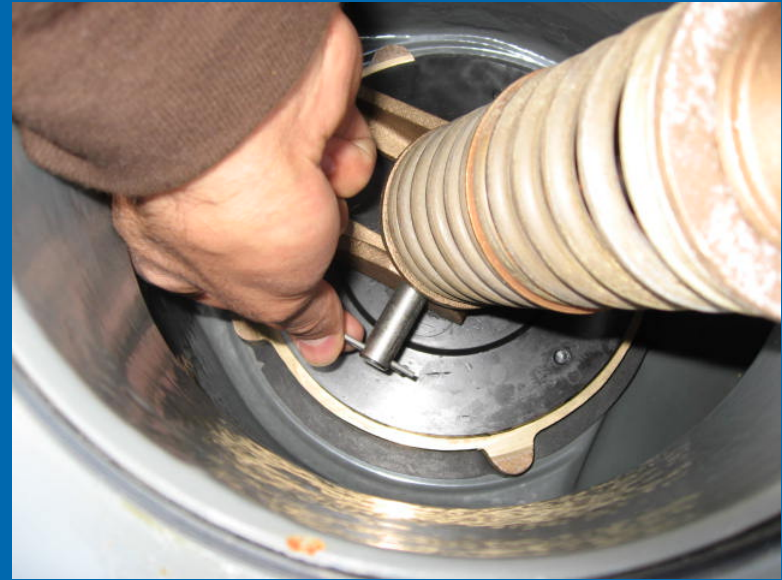
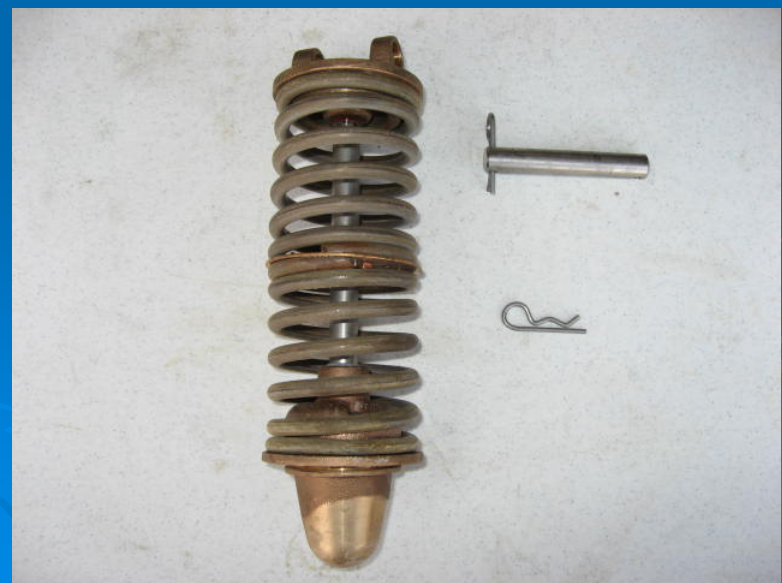
Disassemble Spring Module

- The spring module is held in position by the cover.
- Spring module is captured.
- Remove the retaining clip and hinge pin from the arm assembly.

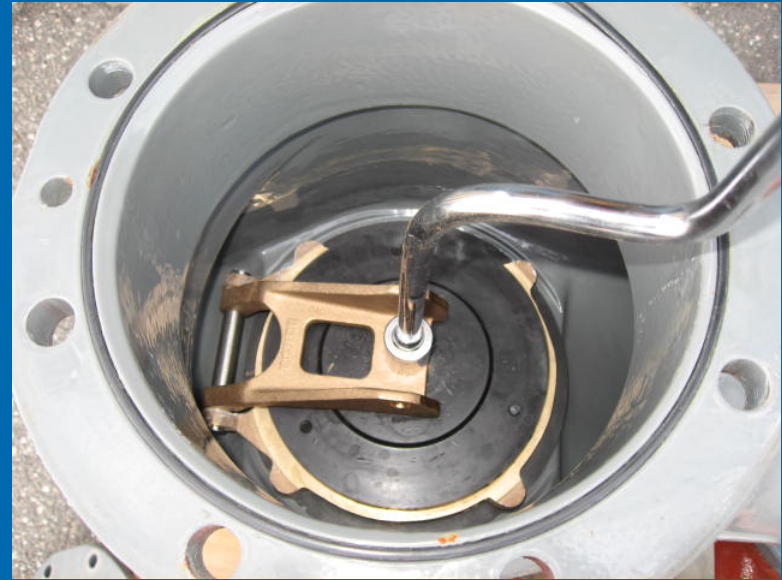
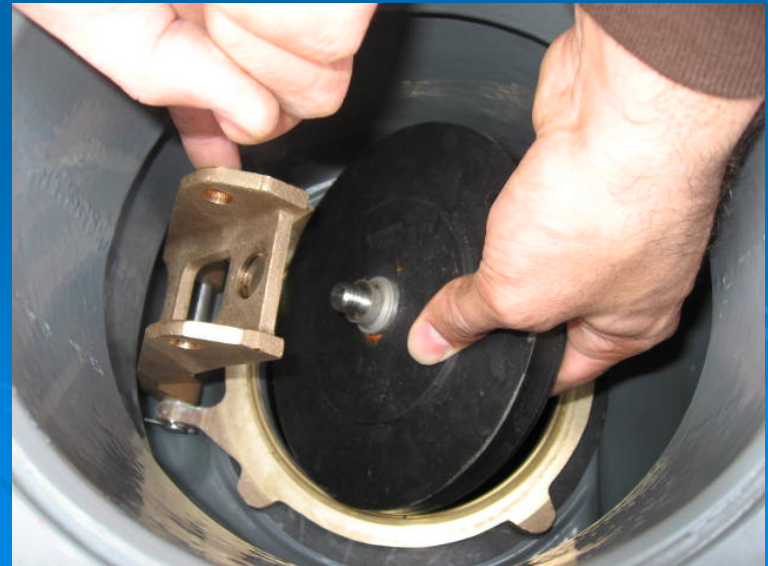
Check Disc Replacement

- The check disc is a vulcanized clapper plate.
- Remove jam nut and washer from the back of the disc plate.

** When jam nut is tight, check disc is designed to “wobble”.

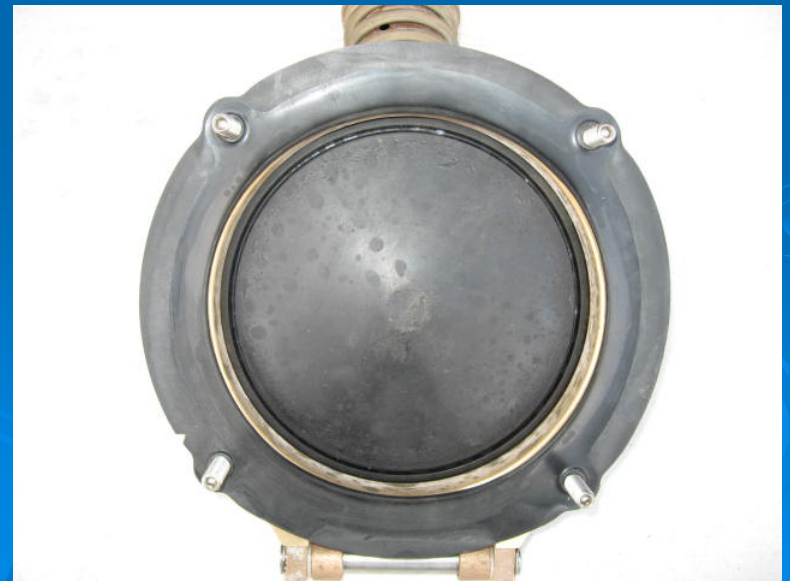
Check Seat Removal

- The seat and arm must be removed as one piece.
- The seat and arm assembly is bolted “**through**” the body and sealed by a gasket.

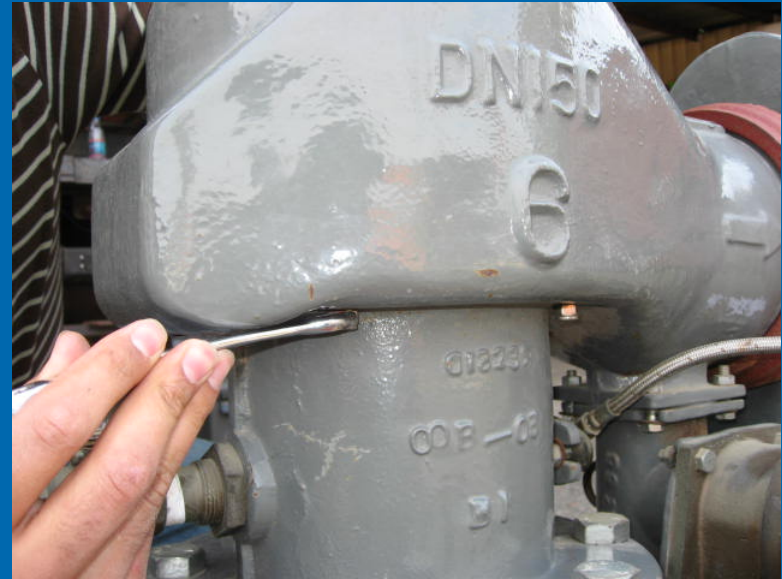
Check Seat Removal

- Locate and remove the four lock nuts on the “**outside**” of the body.
- Pull the seat and arm assembly straight out of the body.

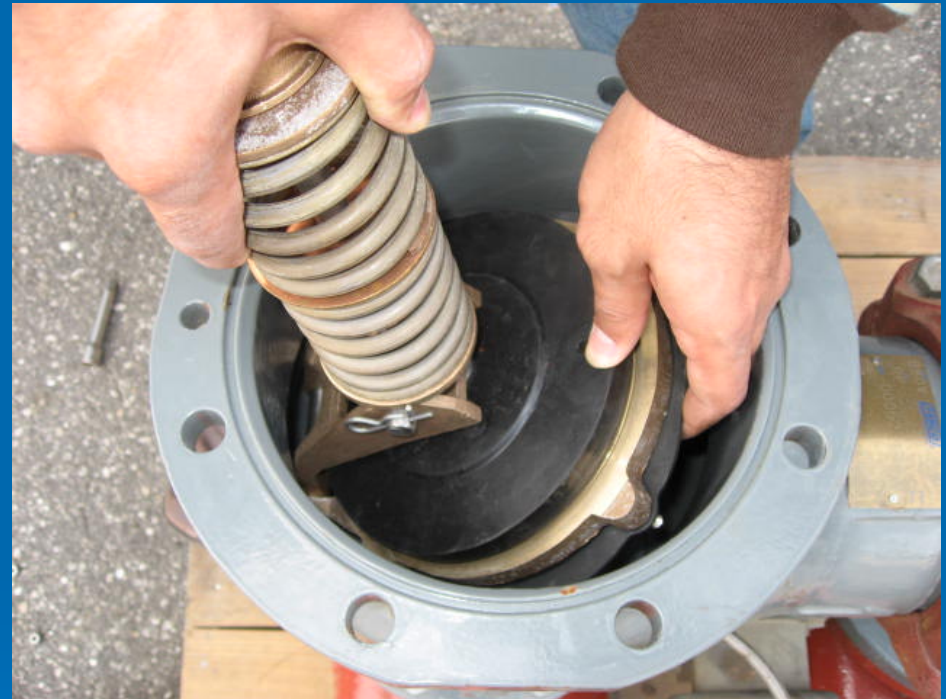
Check Valve Reassembly Notes

- Reassemble in reverse order.
- The seat assembly, disc plate, and spring module can be assembled together and placed into the body as one component.
- The seat ring will only fit into body one way, check the alignment of gasket and studs.

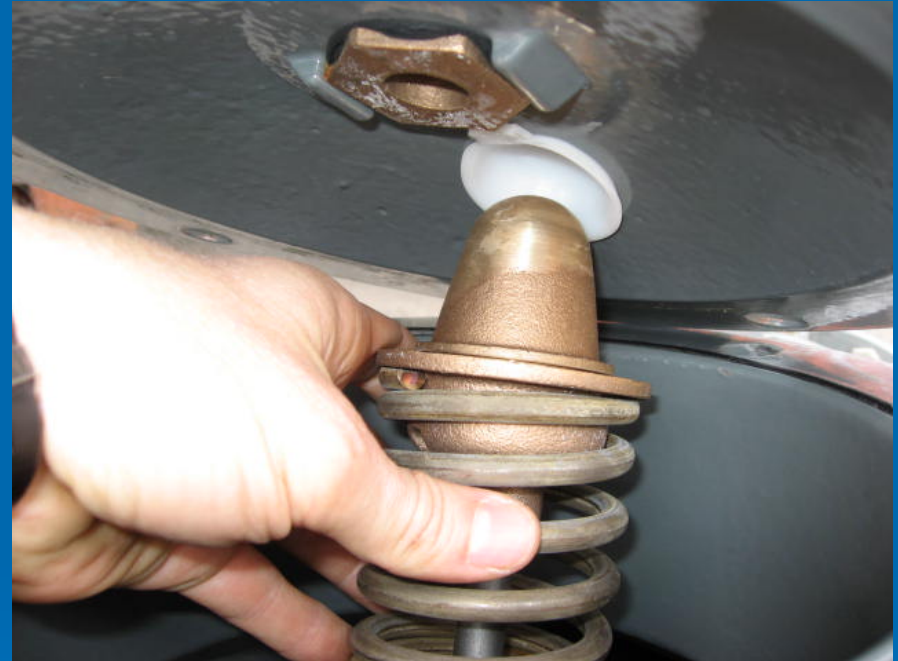
Check Valve Reassembly Notes

- The spring module is positioned by the cover.
- Make sure the pivot bearing is resting in the pivot socket on the cover.
