# the Repair Guys

I recently tested and failed the second check of an assembly that I am not familiar with. The assembly is an Ames 4-inch model C-400. The strange thing is that it doesn't seem to have any access covers. Do you guys have any experience with this assembly? If so, can you give me some tips regarding service procedures for this assembly?

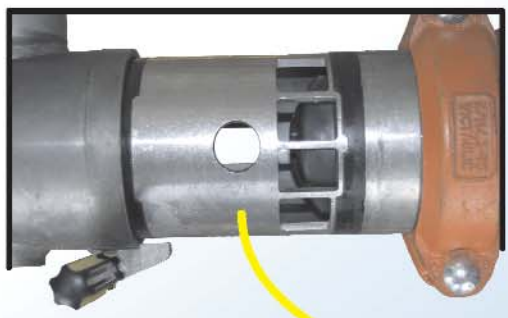
*The photos at the right and lower right have the outer sleeve rotated 90 degrees for the photograph. The relief valve is normally in a downward direction under the assembly.*

*The outer sleeve must be pulled back to the downstream coupling. Then the retainer, shown in place at the left, can be lifted out as shown in the photo below.*

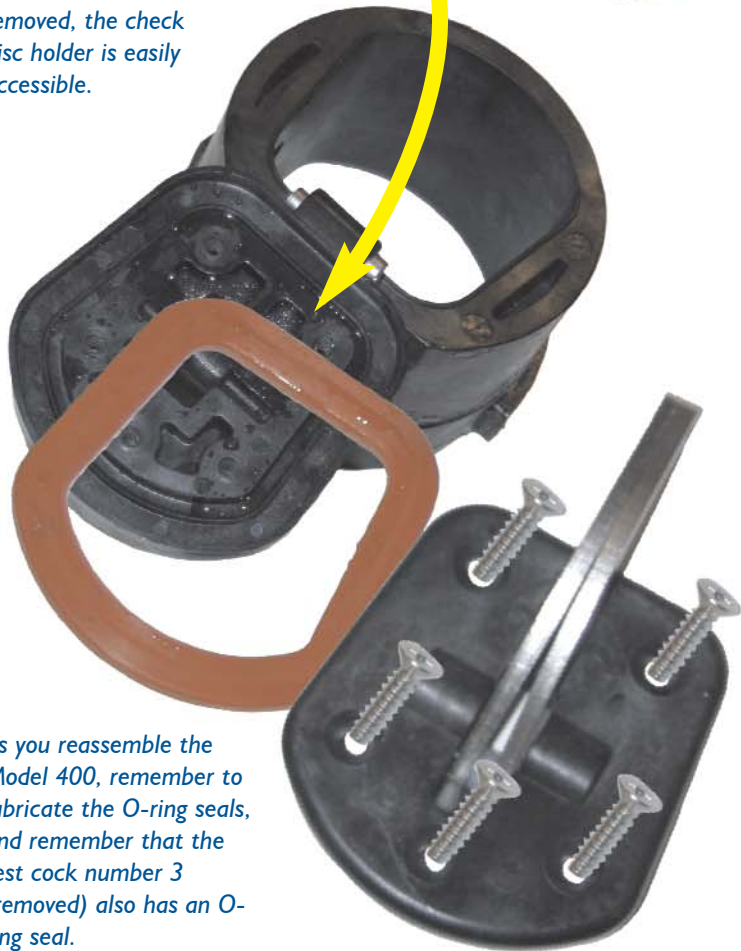
As you reassemble the Model 400, remember to lubricate the O-ring seals, and remember that the test cock number 3 (removed) also has an O-ring seal.

Now replace the retainer, slide the closure sleeve back into place, and then reinstall test-cock number 3.

*Note: After the retainer is initially removed, leave the closure sleeve in the open position. Do not slide the closure sleeve over the check valve compartment without the retainer being in place. Doing this could result in the sleeve O-ring either rolling off or getting cut, and to replace this o-ring is a chore.*
