Model 18-4

3" - 10"

American Backflow
Products Company

Product Overview

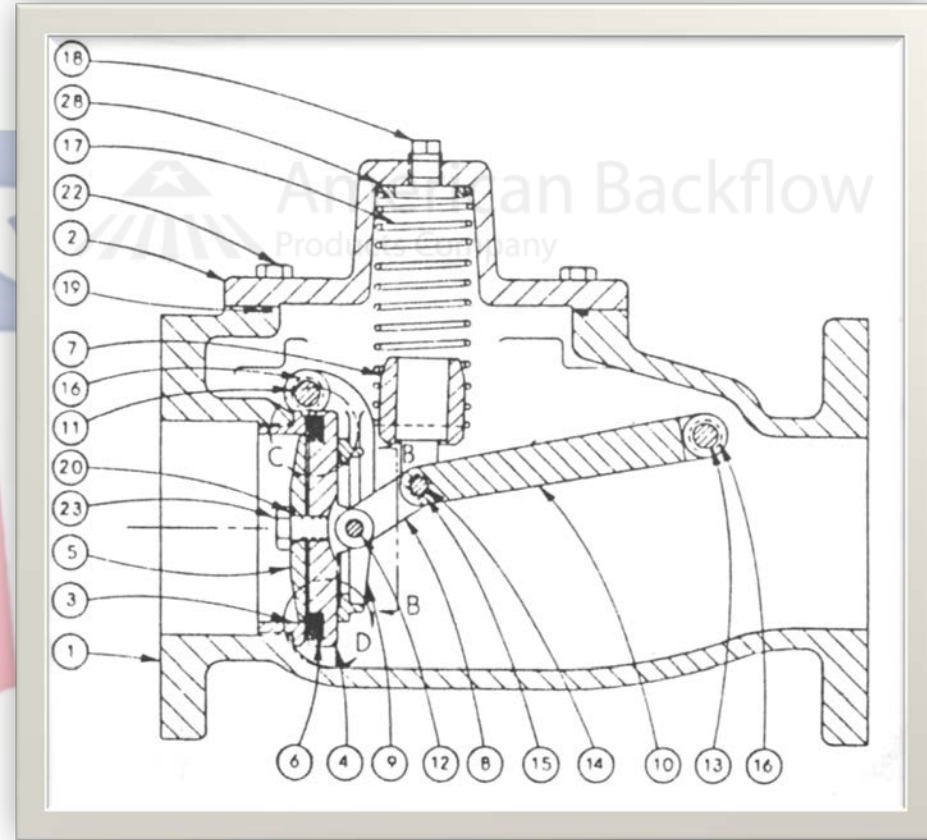
Check Valve Removal

Remove the two pipe plugs on each side of the valve body, to expose the lever arm pin (item 13) and the hinge pin (item 11).

Using a brass rod (smaller in diameter than the pins), gently tap out the rear lever arm (item 13) pin first.

CAUTION: Support the lever arm (item 10) while completely removing the lever arm pin. Let the lever arm rest gently in the bottom of the check valve.

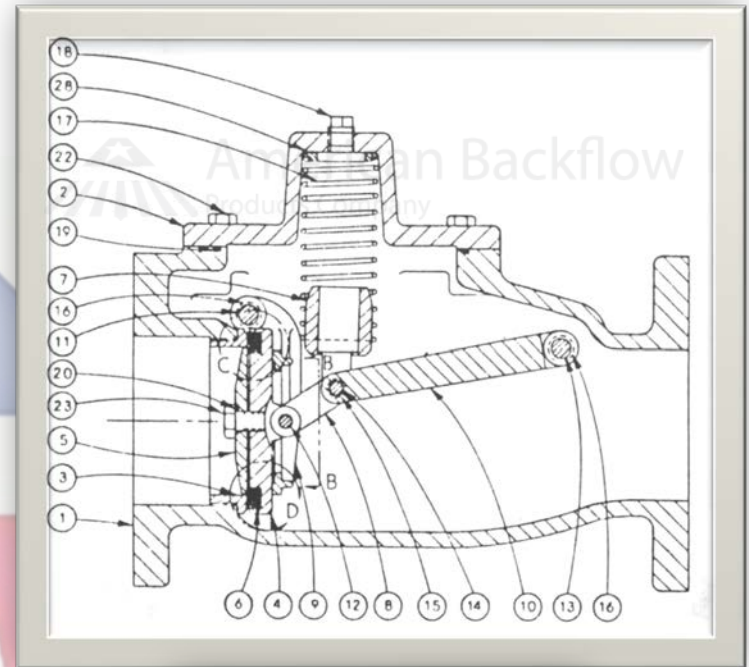
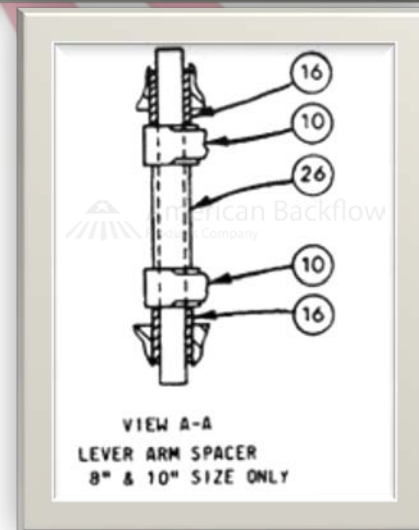
Check Valve Removal

Grasp the yoke (item 7) with one hand, while removing the front hinge pin (item 11). Lift out the toggle-lever clapper assembly, being careful that the brass seat is not dented.

NOTE: On 8" and 10" sizes, a lever arm spacer (item 26) is installed between the two lever arms to maintain proper distance between them, and prevent binding.

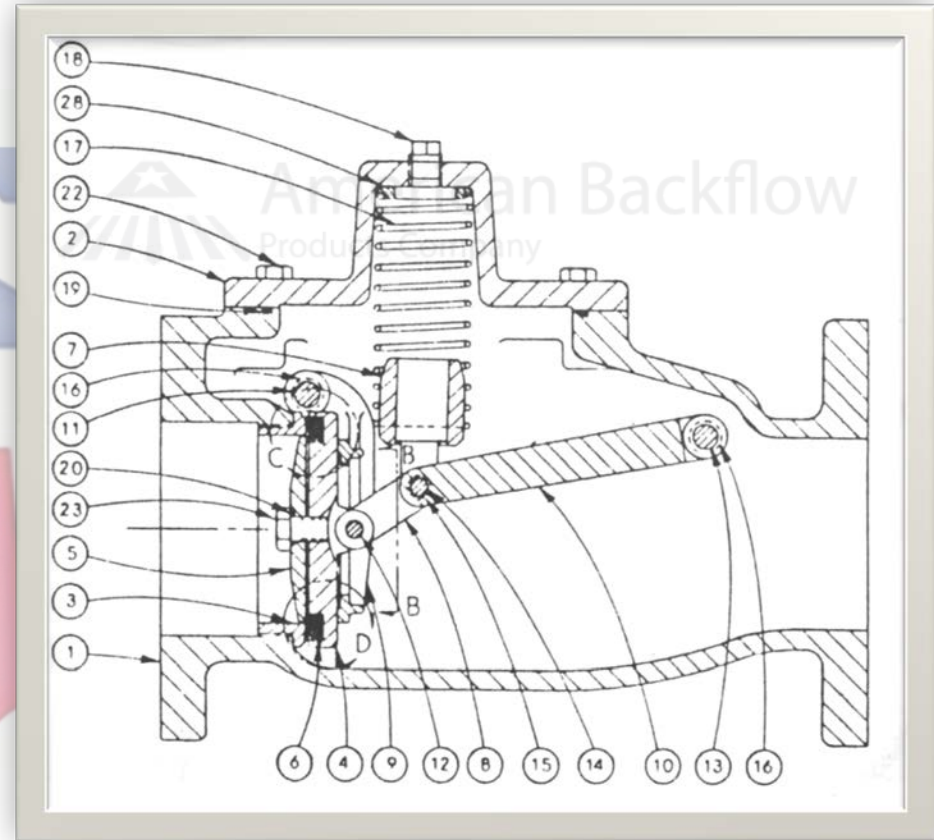
Check Valve Disassembly

2" through 8" sizes remove the retaining bolt (item 23) from the center of the disc guide.

10" sizes (only) remove sixteen retaining screws from the disc guide (item 5).

The check disc is free once the guide is separated from the disc retainer (item 4).

NOTE: An o-ring (item 20) is installed on the retaining bolts for sizes 2 1/2", 3", 4", 6", and 8".

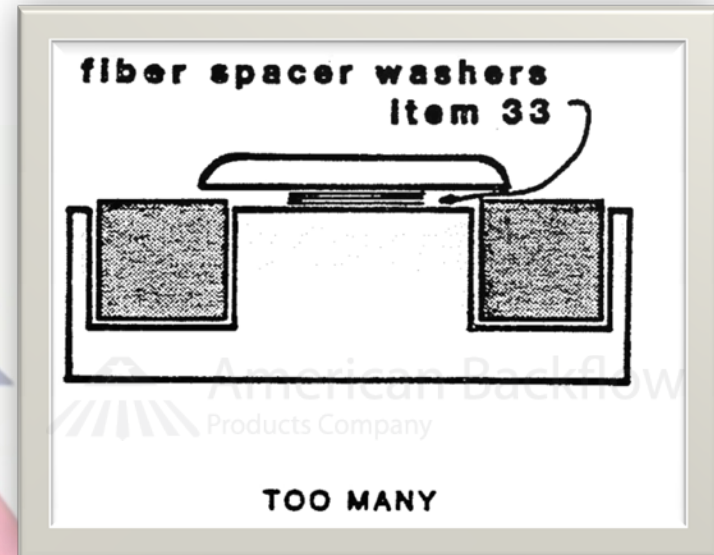
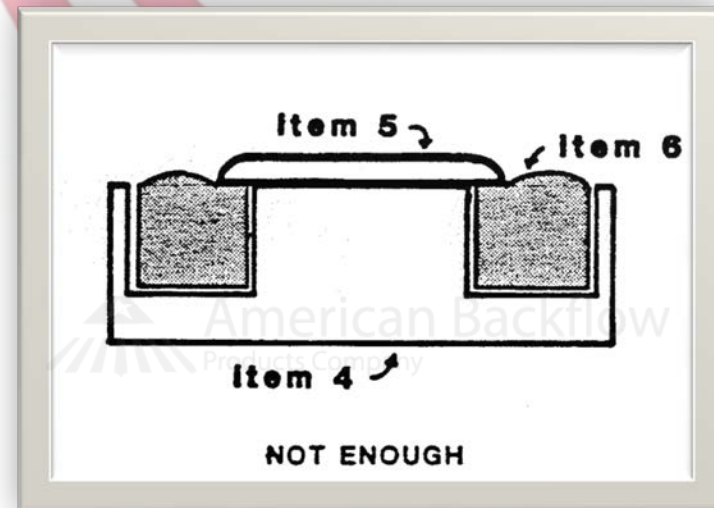
Check Disc Replacement

When installing a new check disc, fiber spacer washers between the retainer and guide MAY or MAY NOT be required.

Fiber spacer washers (item 33) are installed to ensure the proper “squeeze” on the disc (item 6).

Too many washers will not allow sufficient squeeze on the disc (not a water tight seal). This will cause the check valve to fail.

Too few washers between the guide and retainer can generate TOO MUCH squeeze on the disc, causing it to bulge around the guide. This will also cause the check to fail.

Proper squeeze on the disc is achieved when the disc cannot be rotated and no bulge appears.

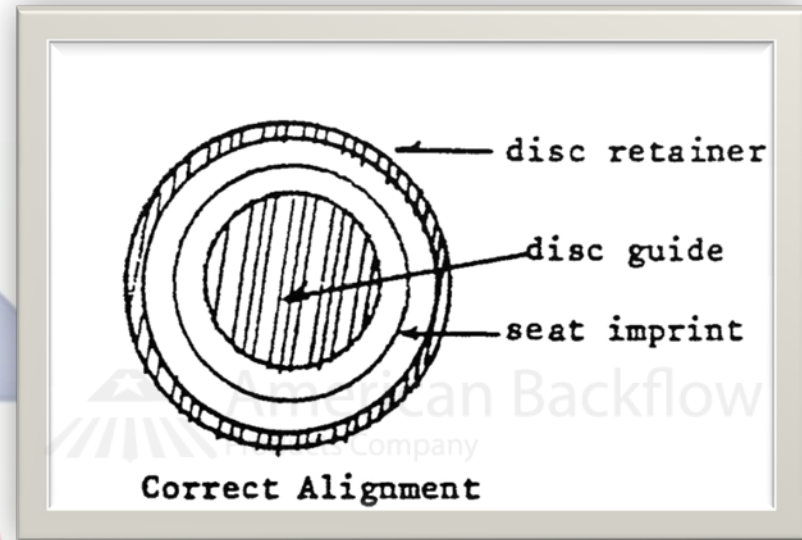
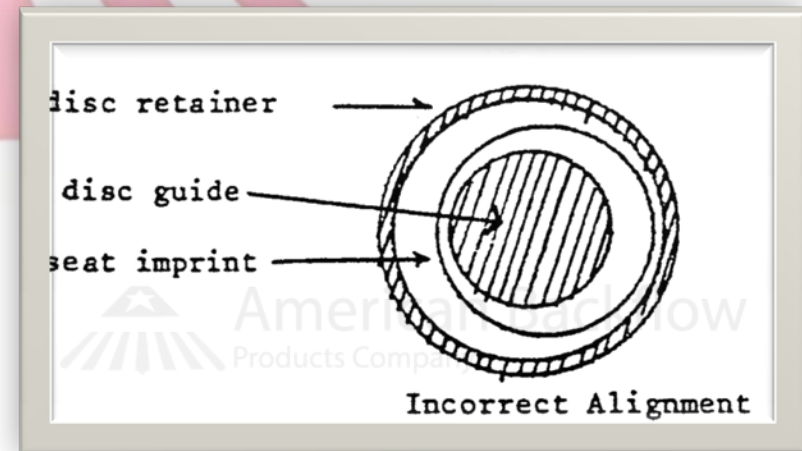
Check Valve Alignment

Re-install clapper assembly. Be careful not to damage check seat.

Support clapper assembly with one hand and install hinge pin.

With clapper assembly supported by hinge pin only, exert pressure to force disc against the seat, and leave an imprint of the seat in the disc.

Remove clapper assembly. Inspect disc to ascertain that alignment is correct.

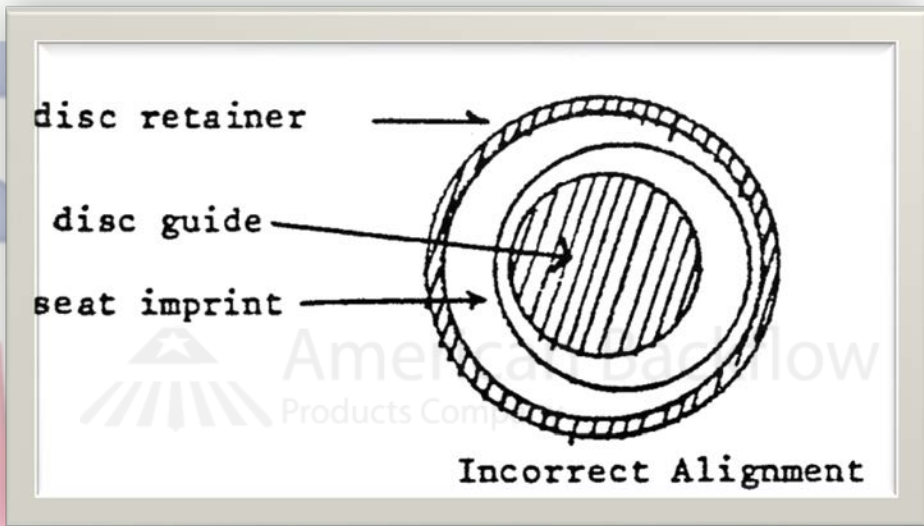
Check Valve Alignment

In the event the seat imprint indicates an incorrect alignment, adjust hinge pin bushing OUT, on the side that corresponds to the least distance between the seat imprint and disc guide.

In this figure, adjust hinge pin bushing on the RIGHT side outward.

Alignment is correct if the seat leaves an imprint on the disc equi-distant on all sides of the disc guide.

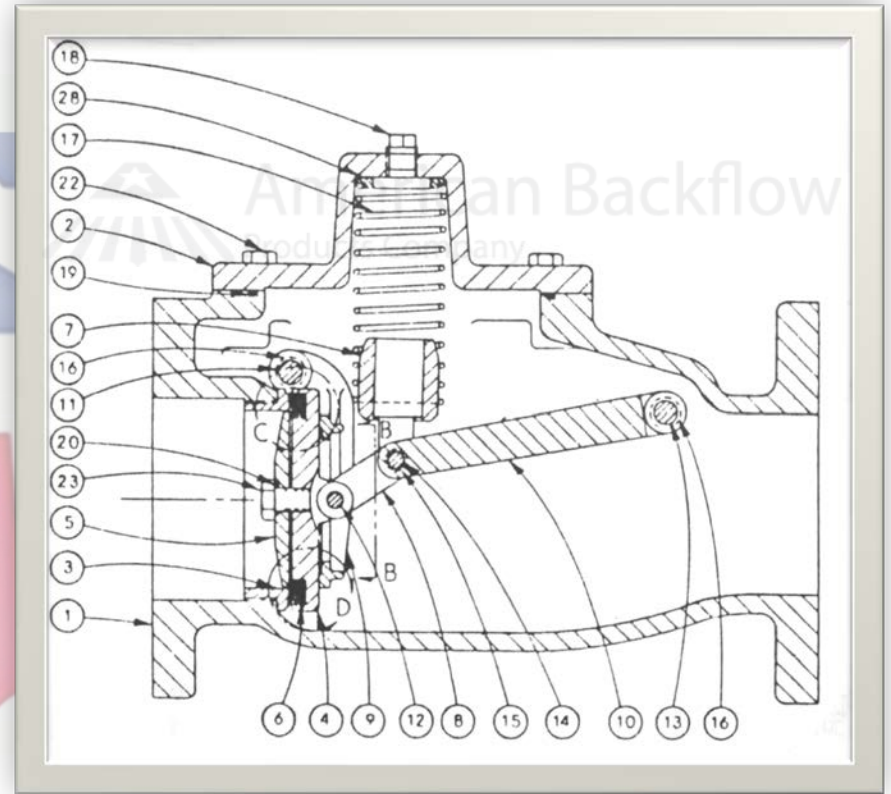
Check Reassembly Notes

When the two pins that hold the toggle-lever (clapper) assembly are installed, be sure to note that the yoke (item 7) and the lever arm pivots upward freely.

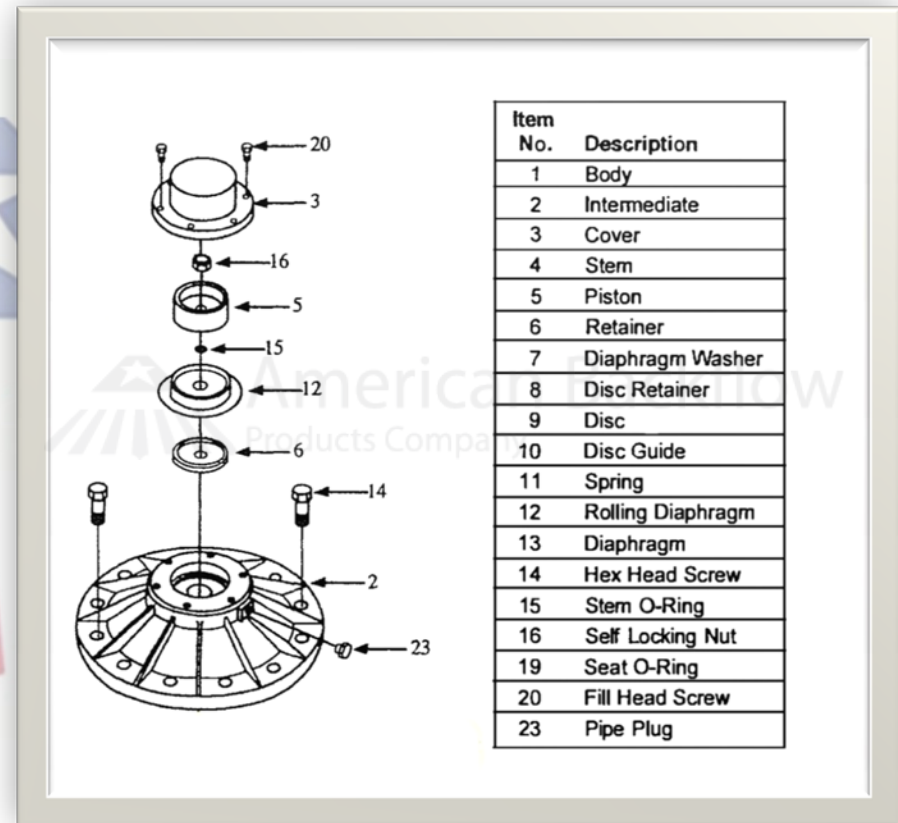
Relief Valve Cover Removal

The CDHS-20/ CDHS-24 RV has two covers. The belloram cover (item 3) and the intermediate body or “diaphragm cover” (item 2).

The belloram cover (item 3) is located on top of the RV assembly.

The belloram cover is secured by screws and sealed by the belloram.

There is no spring load on this cover.

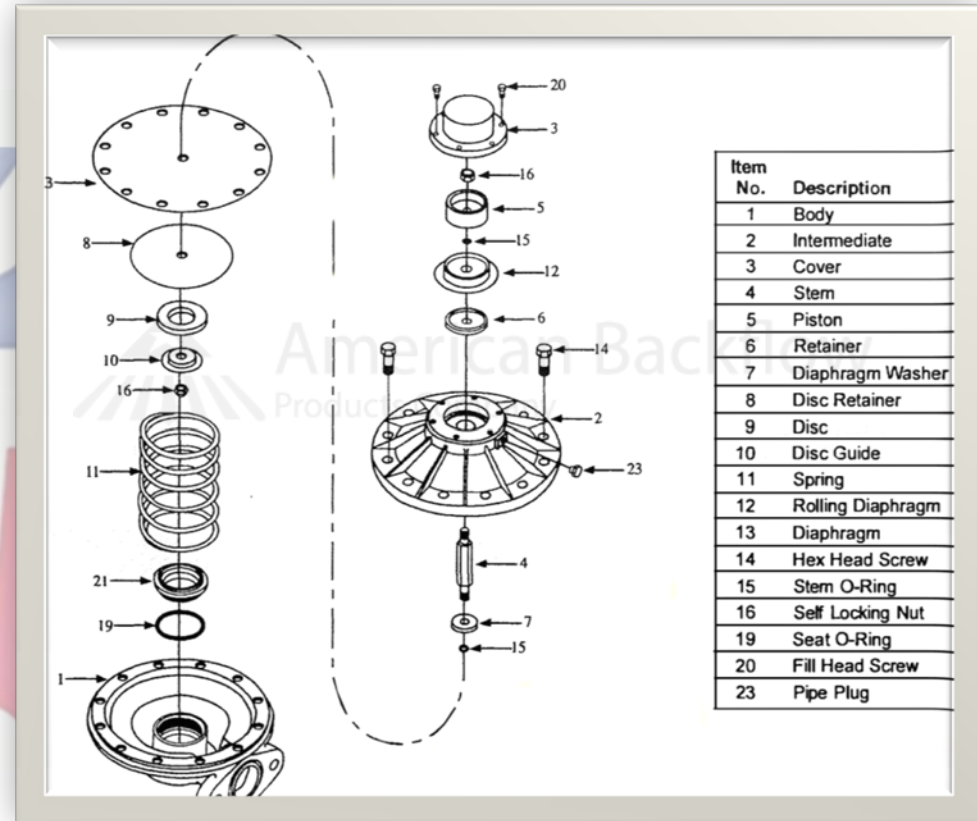
Relief Valve Cover Removal

The intermediate body (item 2) is secured by cap screws and sealed by the diaphragm.

There is a slight spring load on this cover, so exert pressure downward on the cover as the cap screws are removed.

The RV stem assembly is mounted through the intermediate body.

The RV spring is free once cover is removed.

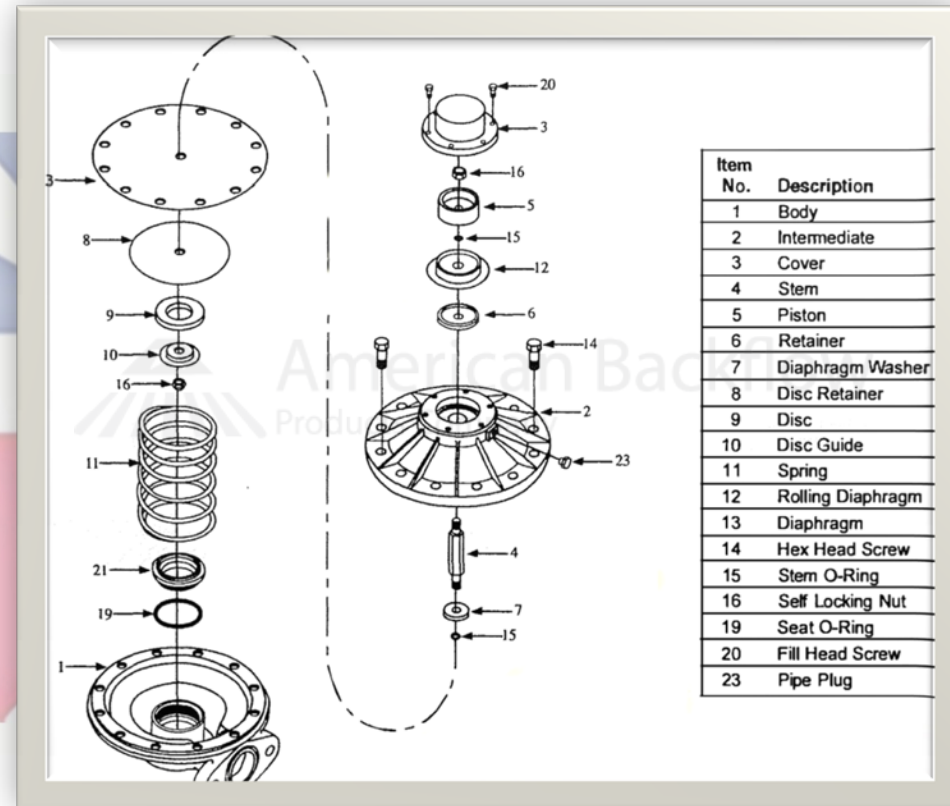
Disassemble RV Stem

The stem is secured by the upper and lower stem nuts (item 16).

Remove the upper stem nut first.

The bellofram, piston and retainer can now be removed from the upper stem.

Remove the stem along with the diaphragm and disc from the body.

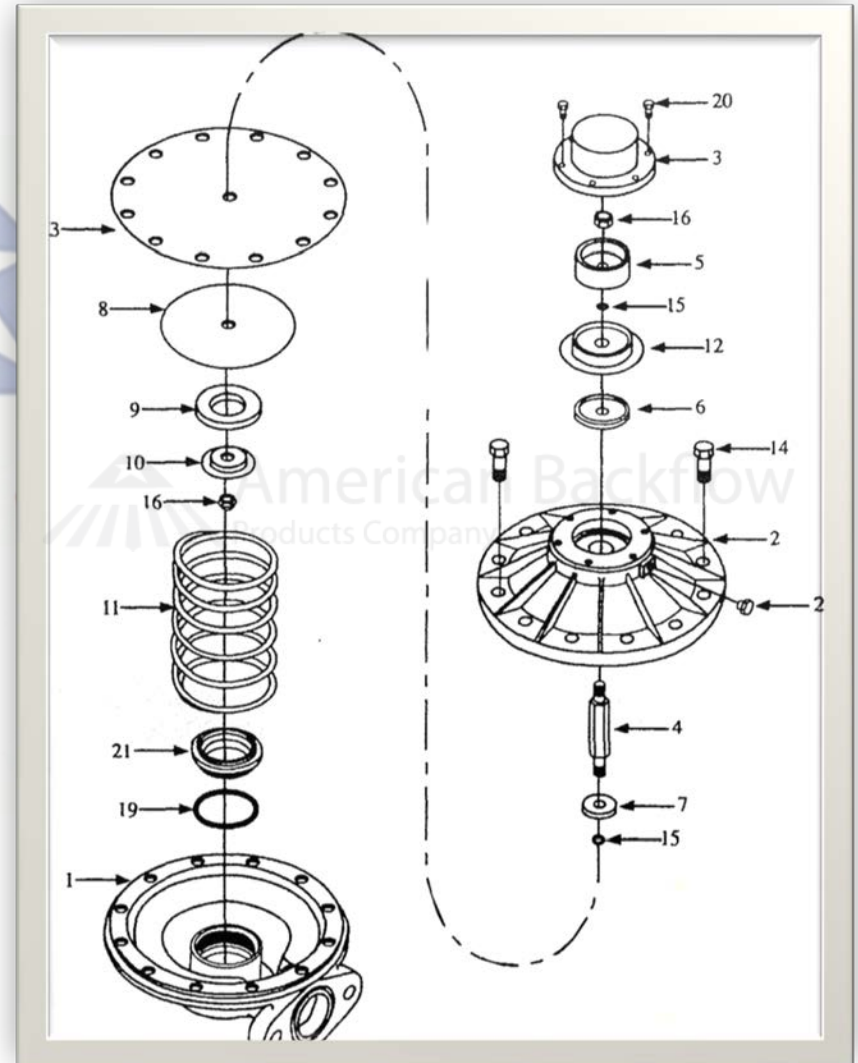
Disassemble RV Stem

Remove lower stem nut (item 16).

The RV disc (9), disc retainer (8), and guide (10) are removed as one assembly. (Simply pry disc from retainer)

Remove the diaphragm (item 13), the lower stem o-ring (item 15) and washer (item 7) from stem.

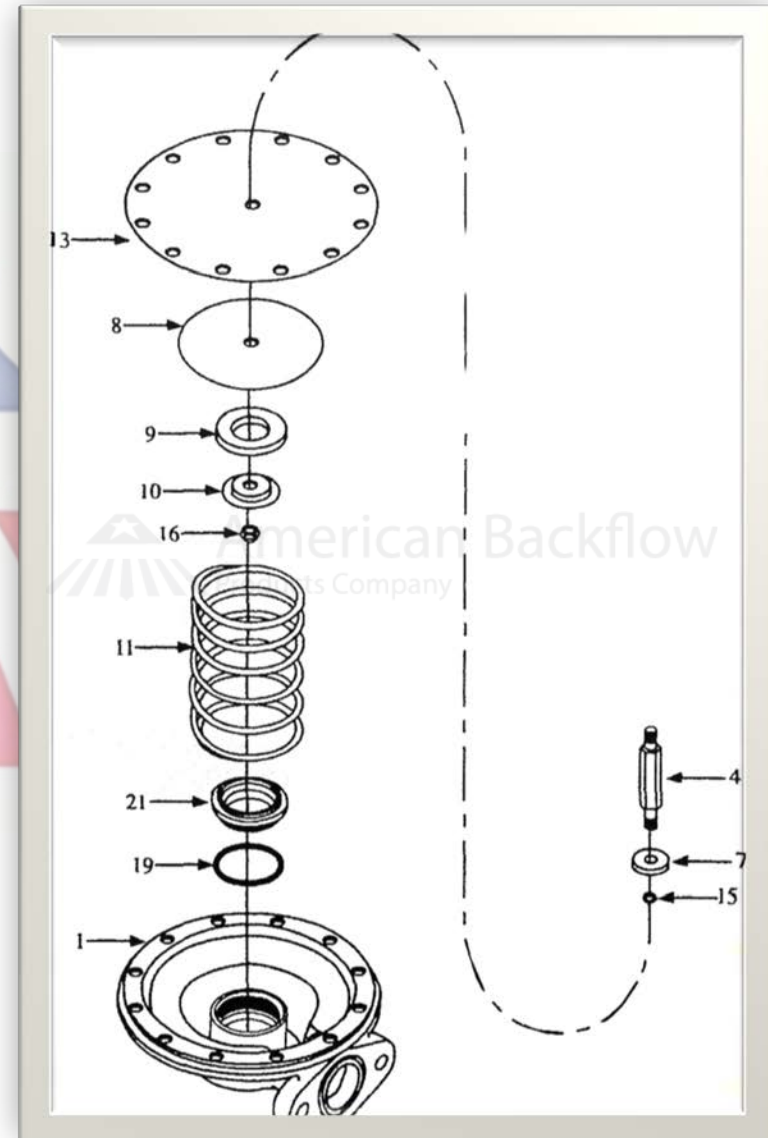
Diaphragm Reassembly

Reassemble the diaphragm (item 13), lower stem o-ring (item 15) and washer (item 7) on the lower stem (4).

Reassemble the RV disc, disc retainer, and guide as one assembly on the lower stem.

The serrated area of the disc retainer (8) is positioned against the diaphragm.

Insert the stem (4) with diaphragm and disc retainer intact, into the intermediate body.

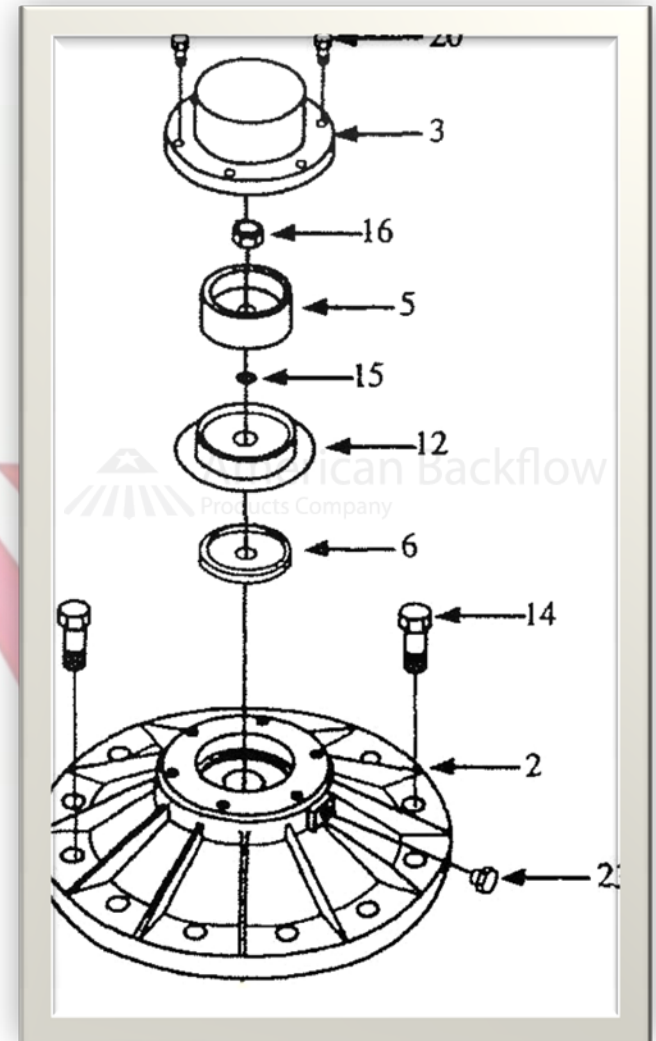
Upper Stem Reassembly

Reassemble the bellofram (12), piston (5), retainer (6) and stem o-ring (15) on the upper stem and replace stem nut.

Position the retainer (6) with its outer lip facing up.

Position the bellofram with the glossy side against the retainer(6). *The fabric side against the piston(5)*

Position the piston (5) with the recess around the stem hole facing down toward the o-ring (15).

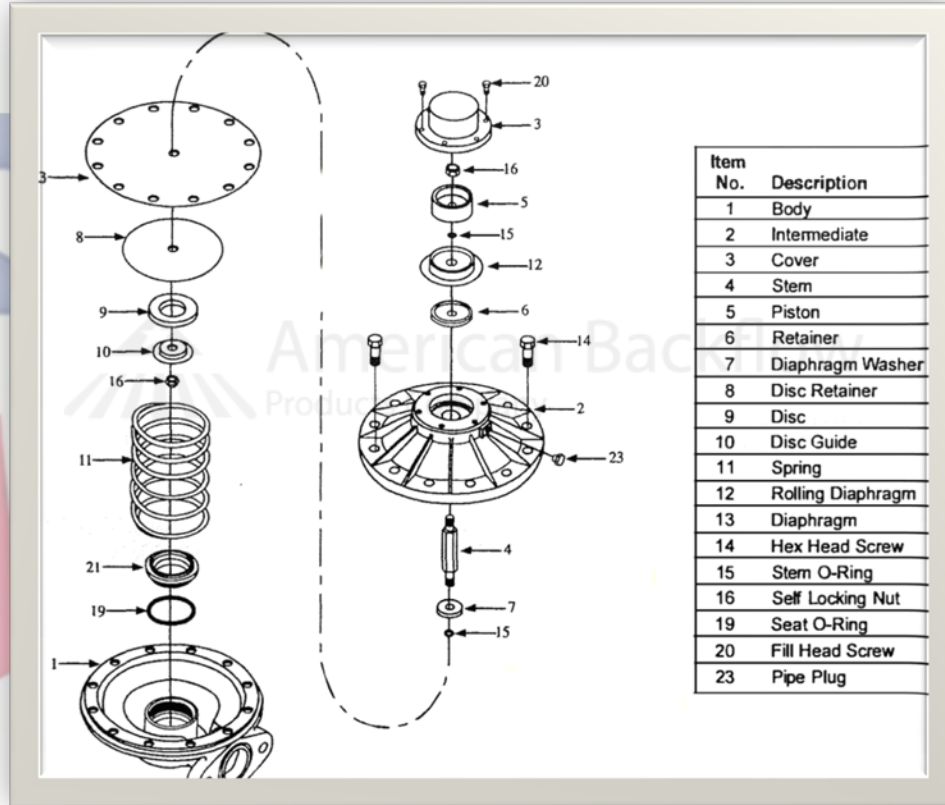
Intermediate Body Reassembly

Position the RV spring over the seat in the main body.

Insert cap screws through intermediate body and diaphragm.

Make sure the sensing passage is aligned properly.

Press the intermediate body down on the main body and start cap screws.

Be sure to evenly cross tighten cap screws.

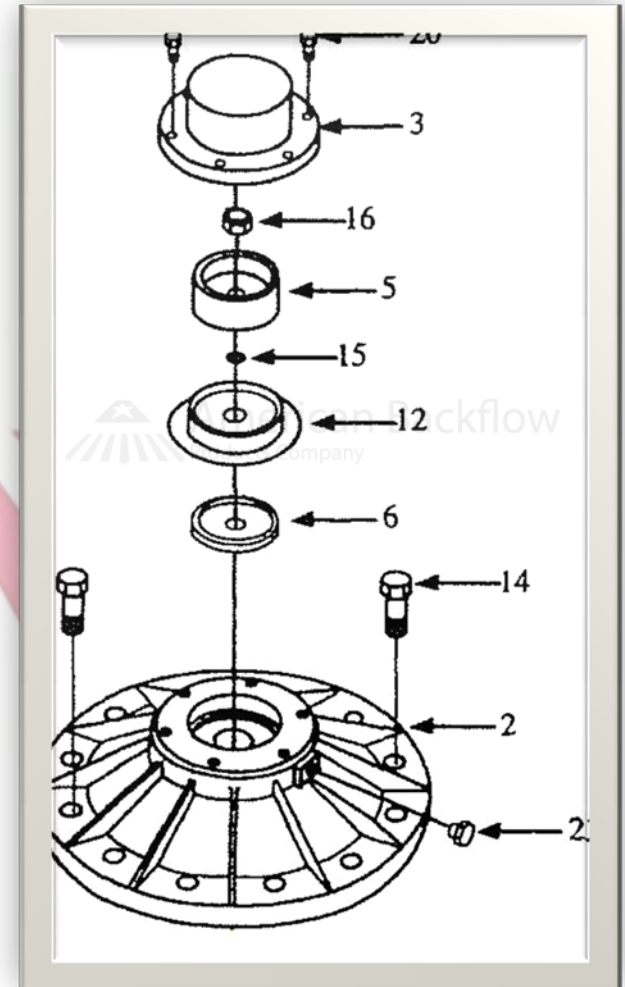
Bellofram Reassembly

Carefully push bellofram(12)
“brim” straight down over itself so
that the “brim” is flat and smooth
against the intermediate body.

Make sure the bellofram is not
twisted or wrinkled.

Install cover (3) so that weep
hole faces out away from
backflow.

Do not rotate cover after placing
over the “brim”, this can twist and
tear the bellofram.
