Model 18

3" - 10"

American Backflow
Products Company

Product Overview

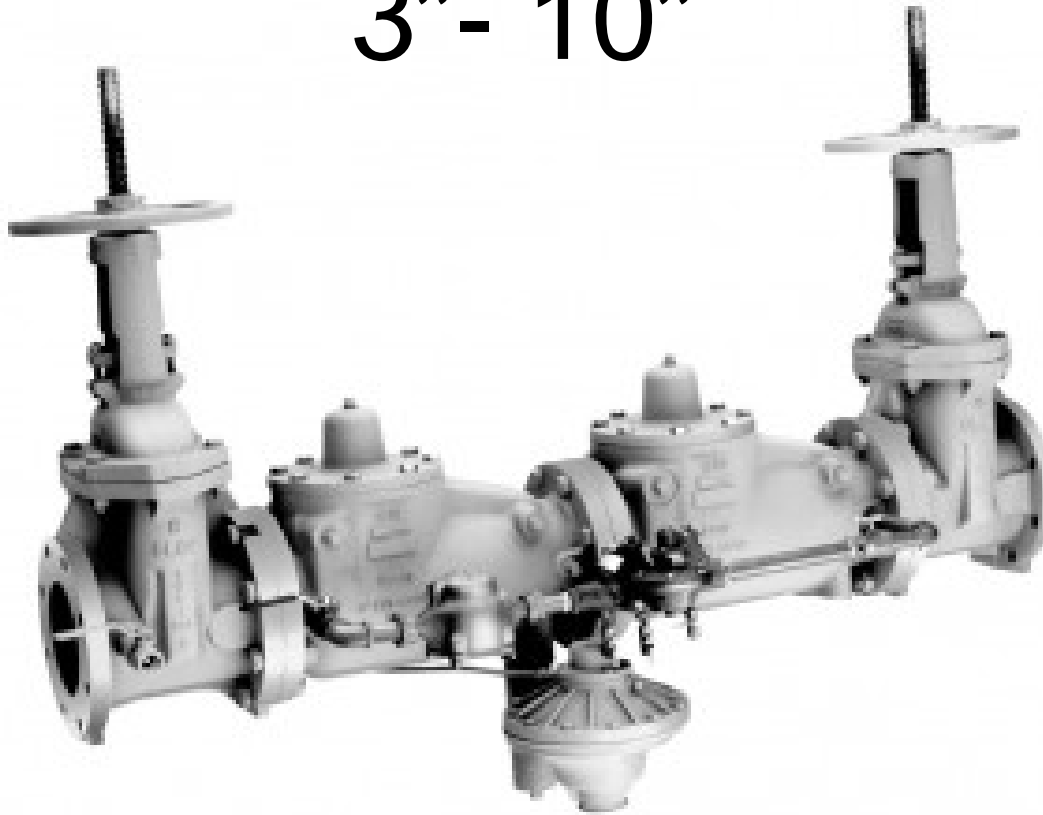
Model 18 RPDA (1989-1990) Utilized the 3081EX Toggle Lever Checks and CDHS-20 relief valve. Produced in 3"-10" sizes only.

Bypass was a $\frac{3}{4}$ " RP-2 or a Wilkins 975XL.

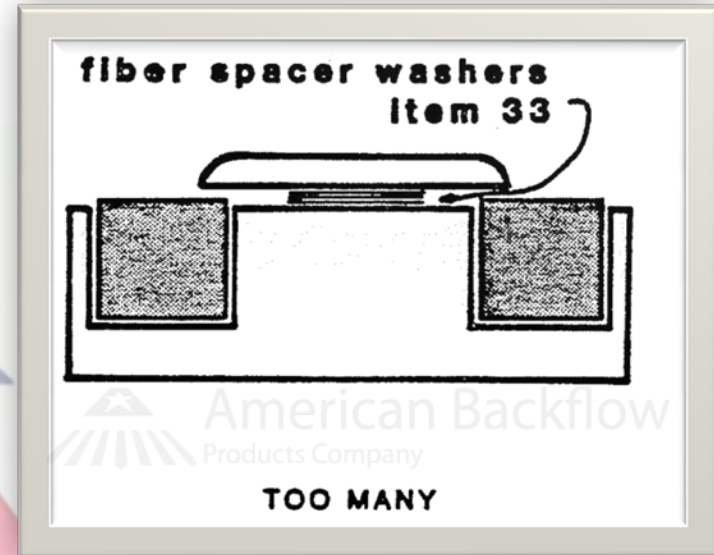
Check Disc Replacement

When installing a new check disc, fiber spacer washers between the retainer and guide MAY or MAY NOT be required.

Fiber spacer washers (item 33) are installed to ensure the proper “squeeze” on the disc (item 6).

Too many washers will not allow sufficient squeeze on the disc (not a water tight seal). This will cause the check valve to fail.

Too few washers between the guide and retainer can generate TOO MUCH squeeze on the disc, causing it to bulge around the guide. This will also cause the check to fail.

Proper squeeze on the disc is achieved when the disc cannot be rotated and no bulge appears.

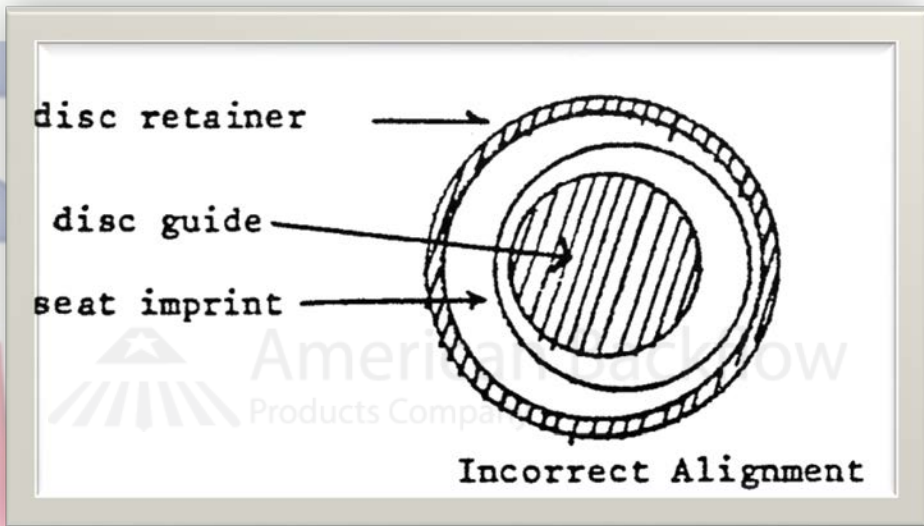
Check Valve Alignment

In the event the seat imprint indicates an incorrect alignment, adjust hinge pin bushing OUT, on the side that corresponds to the least distance between the seat imprint and disc guide.

In this figure, adjust hinge pin bushing on the RIGHT side outward.

Alignment is correct if the seat leaves an imprint on the disc equi-distant on all sides of the disc guide.

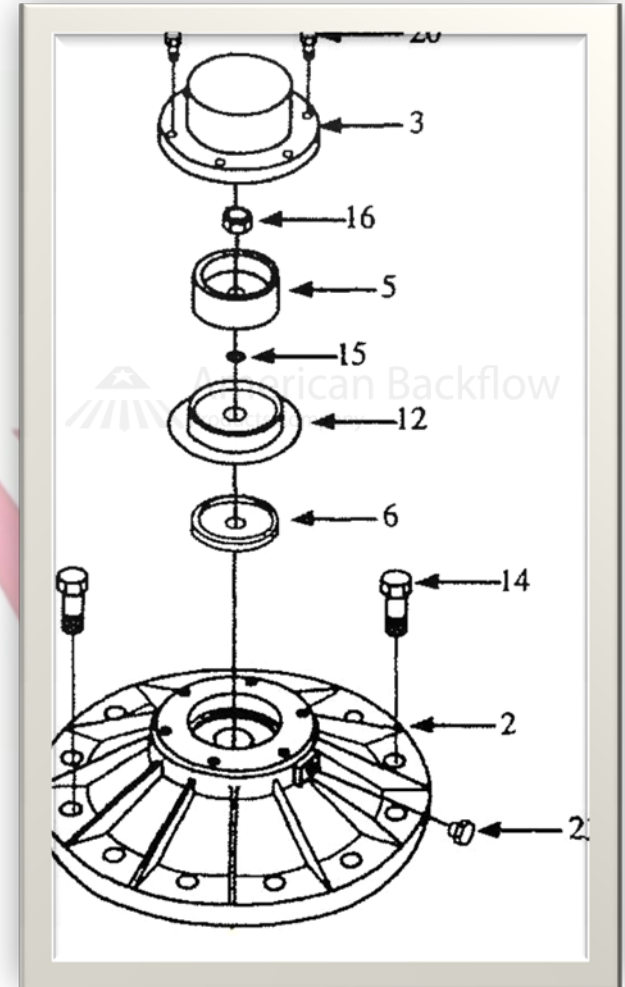
Bellofram Reassembly

Carefully push bellofram(12)
“brim” straight down over itself so
that the “brim” is flat and smooth
against the intermediate body.

Make sure the bellofram is not
twisted or wrinkled.

Install cover (3) so that weep
hole faces out away from
backflow.

Do not rotate cover after placing
over the “brim”, this can twist and
tear the bellofram.
