40-500

1/2" - 2"

American Backflow
Products Company

Modification Overview

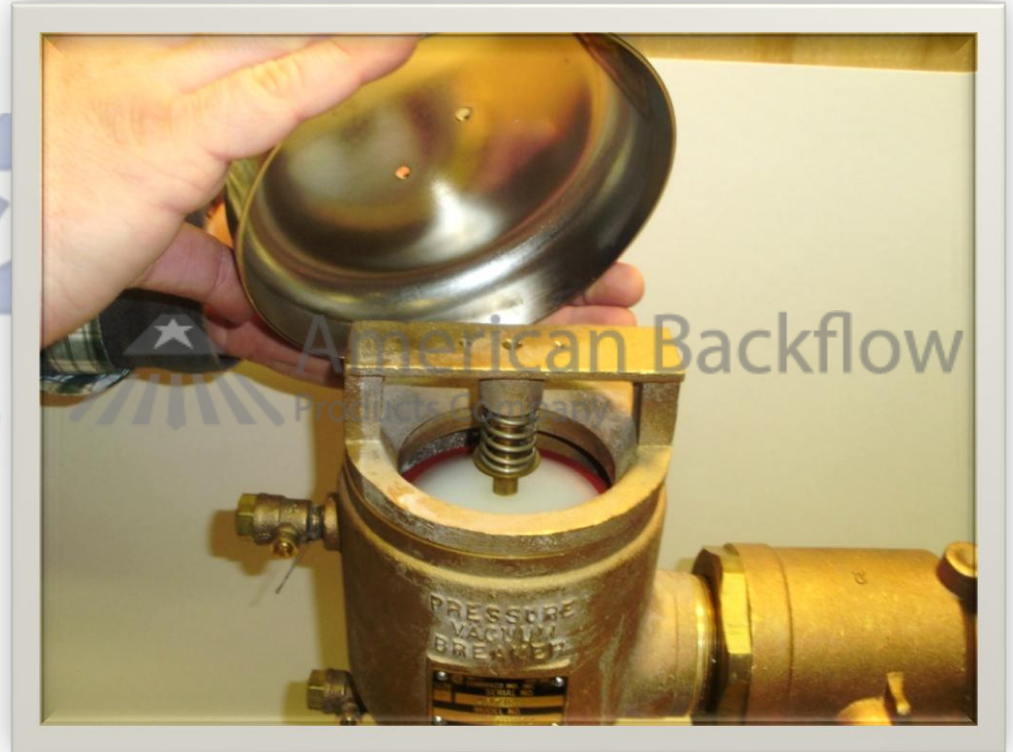
Bonnet Removal

The bonnet is threaded into the body and sealed by an o-ring.

Unscrew the bonnet counter clockwise.

There is no spring load.

If float spring is damaged, the bonnet must be replaced.

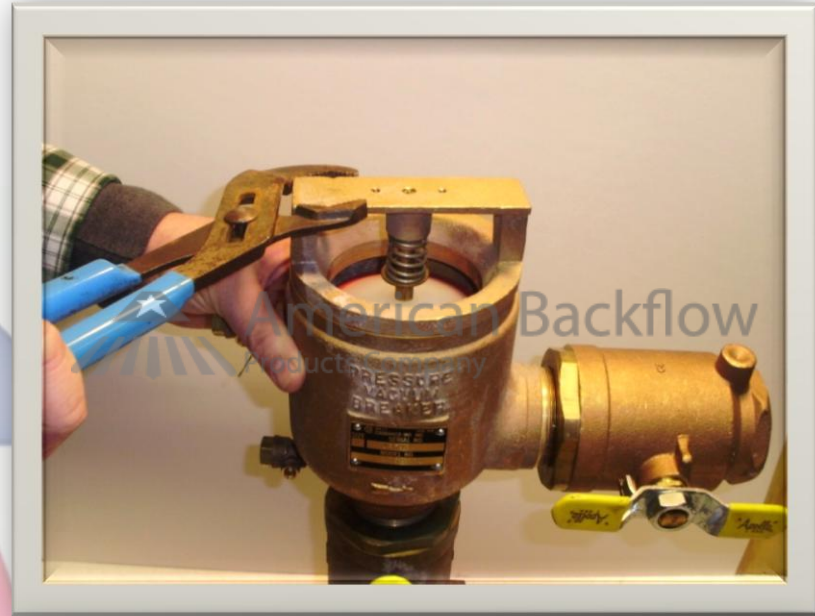
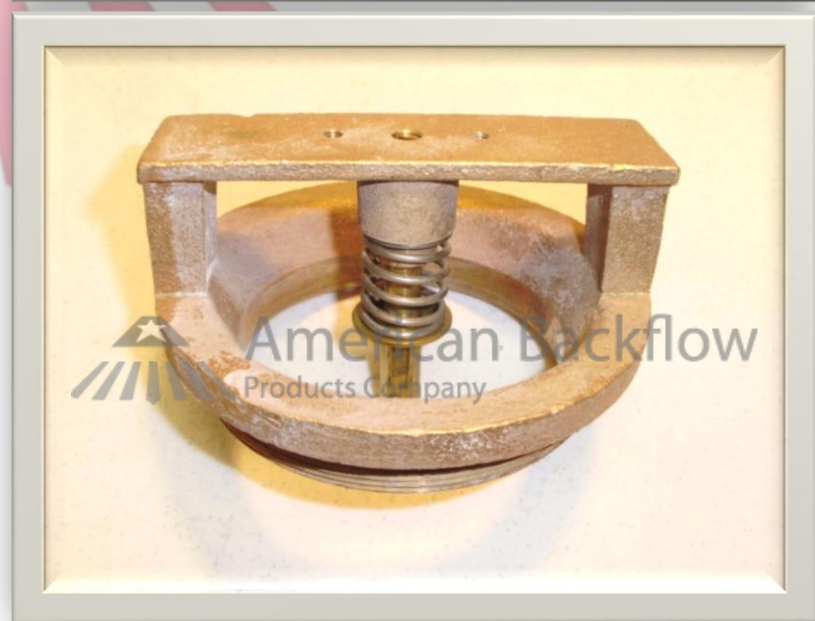
Float Removal and Service

The float is free once the bonnet has been removed.

Replace the rubber seal by pulling it from the groove on the float.

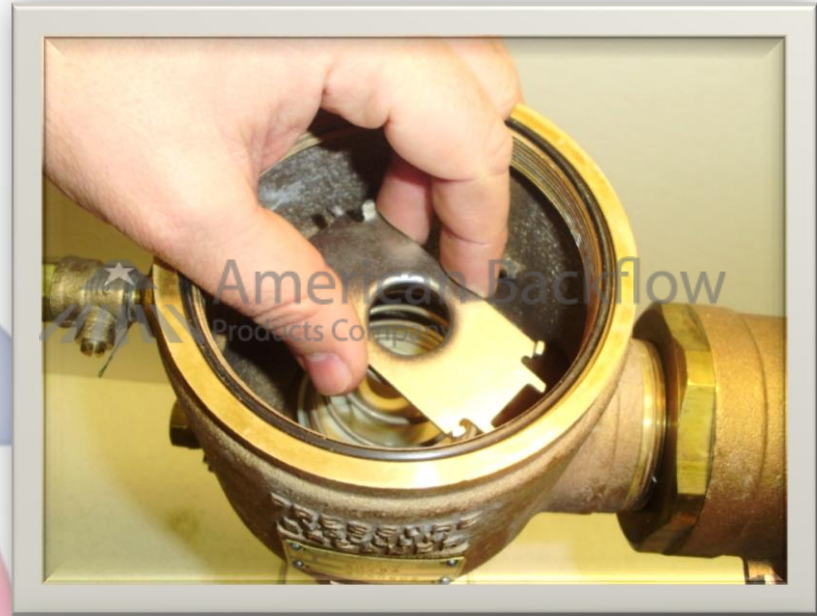
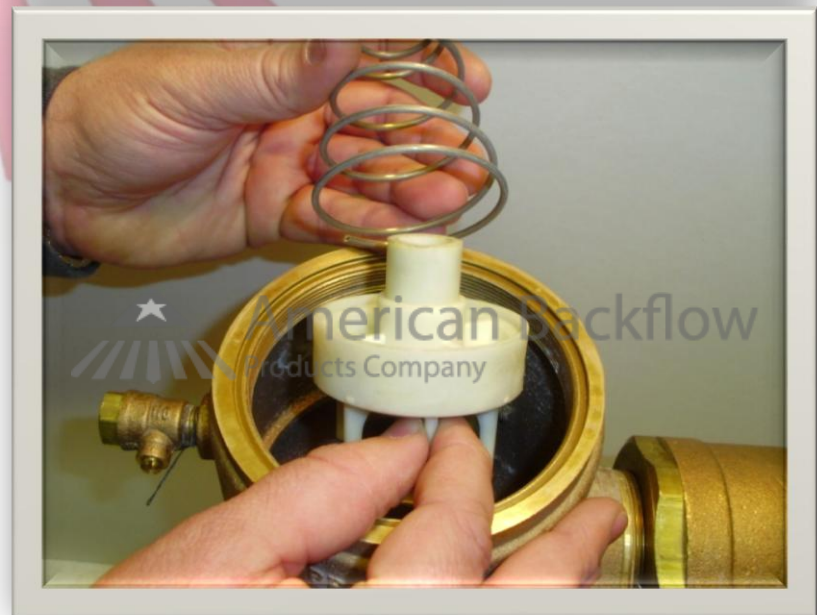
Check Disc Replacement

The check disc is free once the retaining screw and guide are removed.

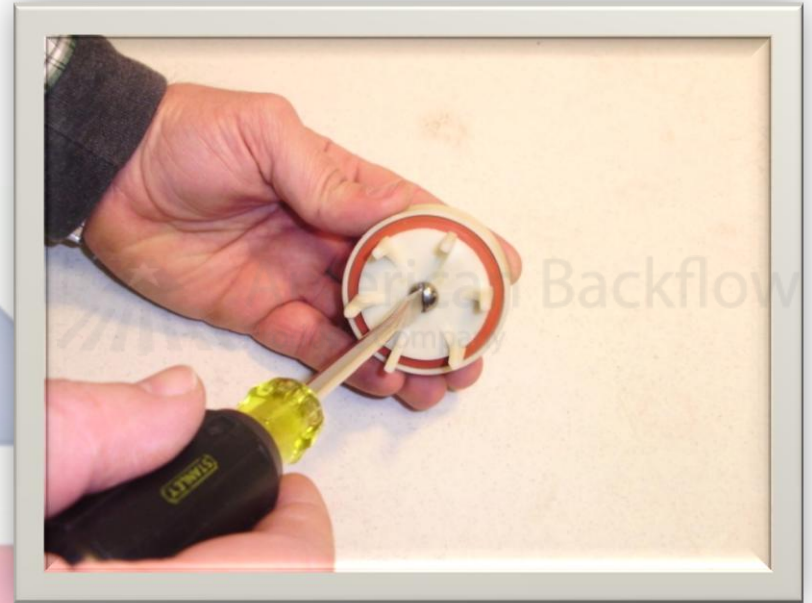
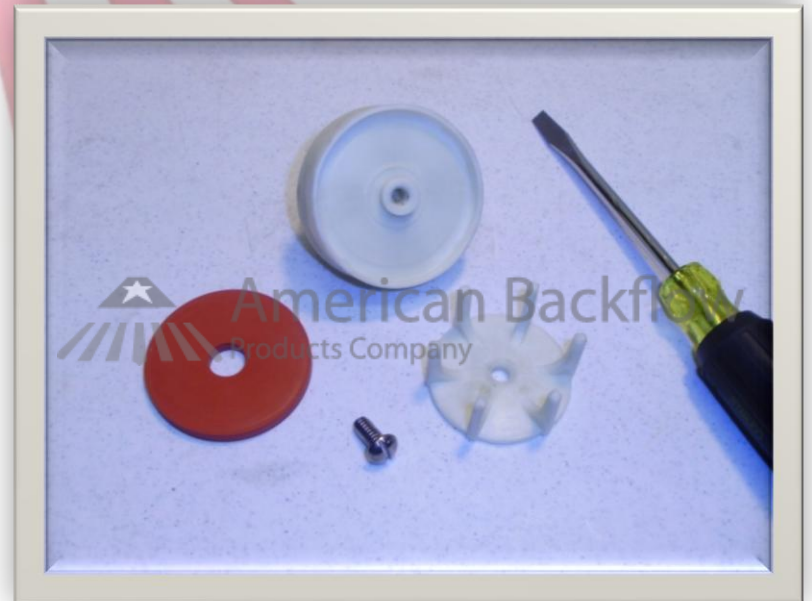
Check Seat Replacement

The check seat is part of the body.

If the seat is damaged the assembly must be replaced.

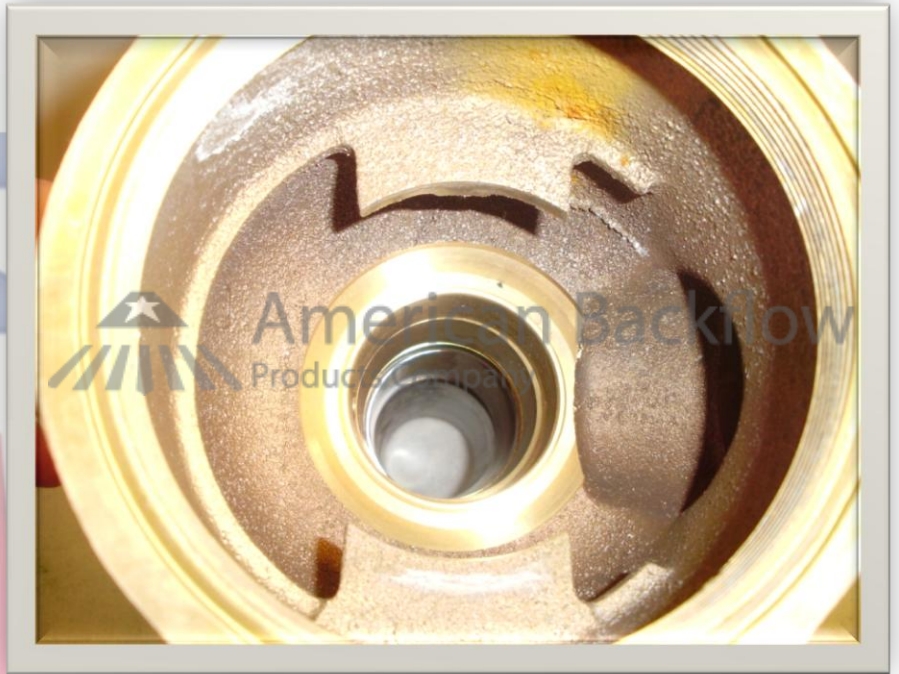
Reassembly Notes

Reassemble in reverse order.

Place large end of check spring down in body.

The lip on the retainer faces down toward the spring.

Make sure bonnet guide stem is inserted into center of float.
