4000CIV

2 1/2" - 10"

American Backflow
Products Company

Modification Overview

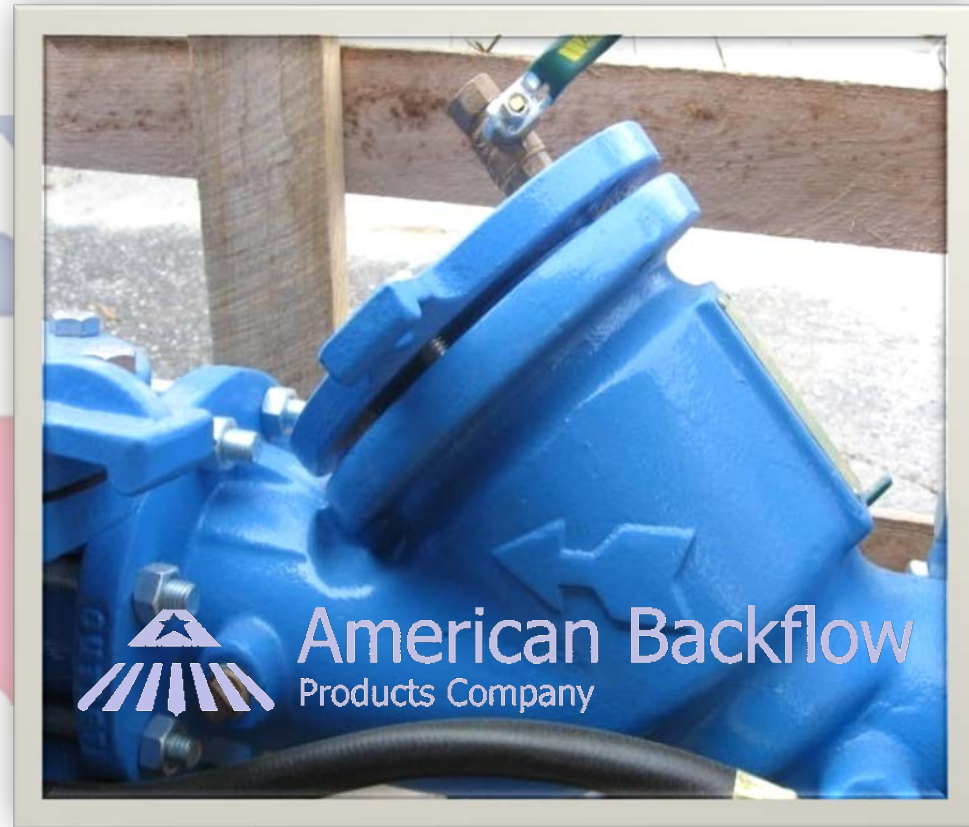
Check Valve Removal

Center stem guided
check assembly.

Disc & spring
subassembly.

Slide subassembly
straight out of seat
and body.

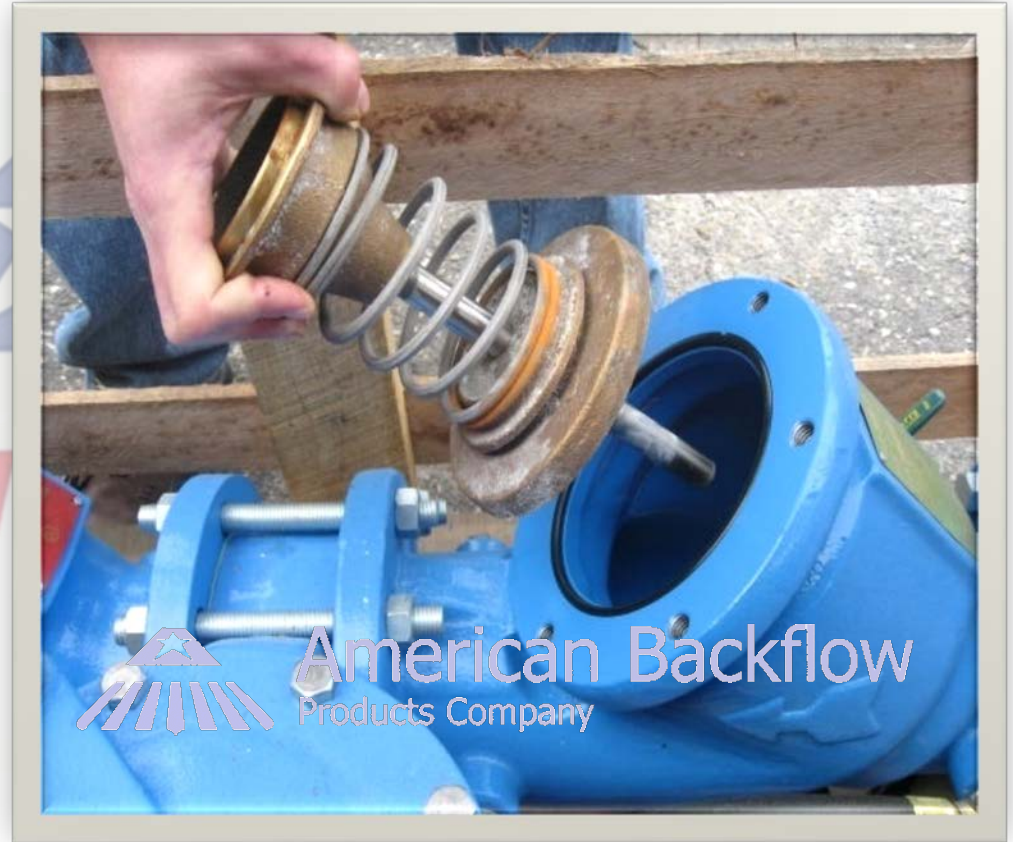
Check Seat Removal

2 ½" - 3" Seats removed by ¼ turn twist.

4"-10" Seats secured by two retaining wires. Each wire 10" long.

Pull one wire clockwise / one wire counter clockwise.

Seats are o-ring sealed and pull straight out of body.

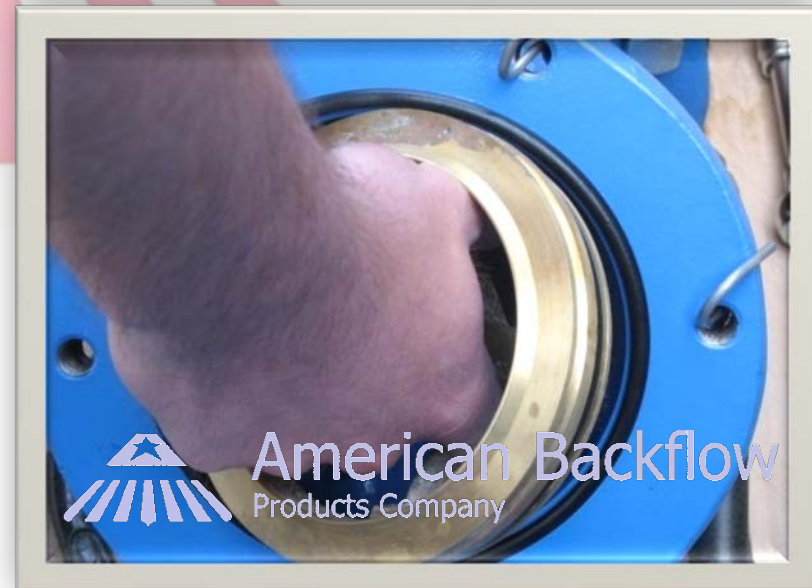
Check Disc Replacement

Remove retaining nut
for sizes 2 ½" - 4".

Remove allen head
screws in retainer
plate for sizes 6" - 10".

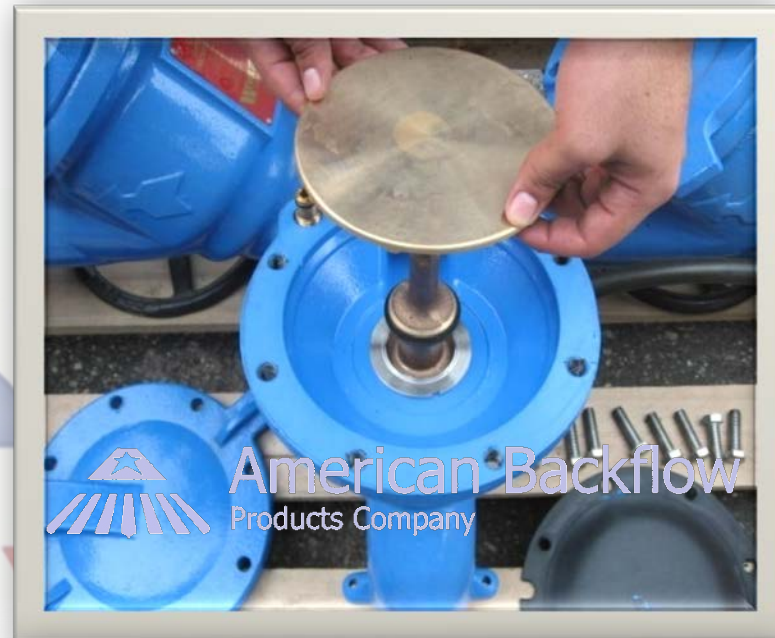
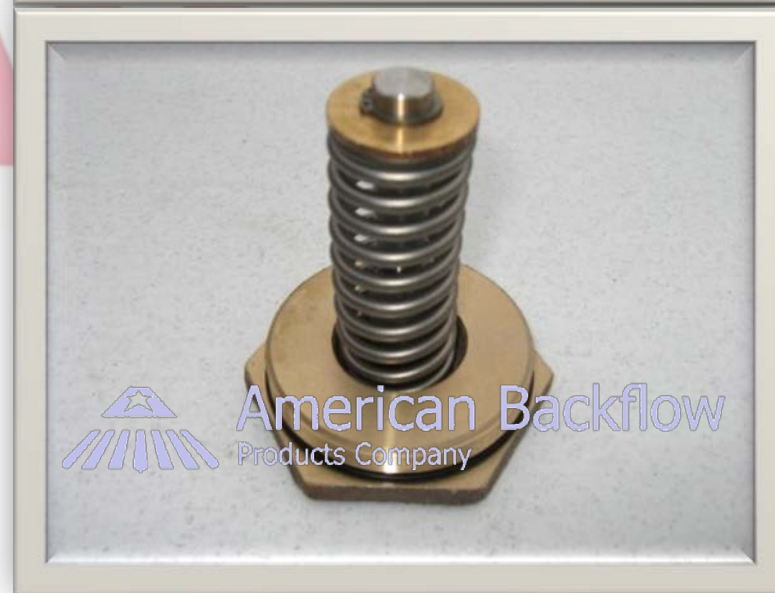
RV Seat Removal

Unless damaged,
there is no need to
remove the RV seat.

RV seat is threaded
and o-ring sealed.
