# 4V-500

# 1/2" - 2"

# Modification Overview

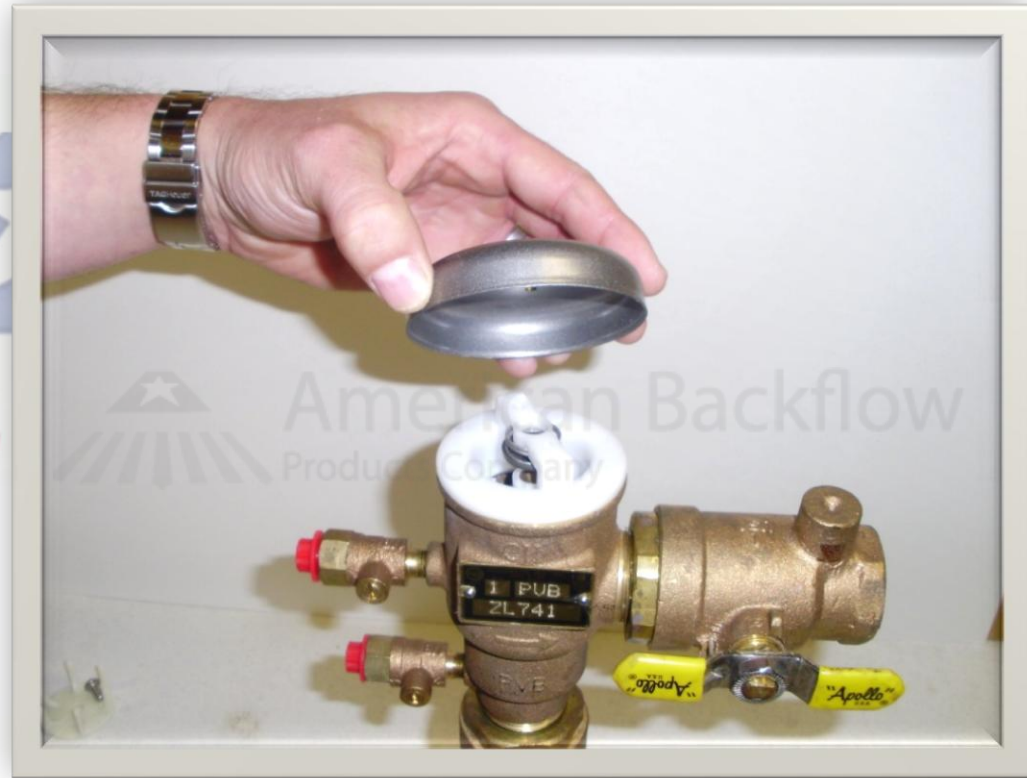
# Canopy Removal

The canopy is secured by two screws.

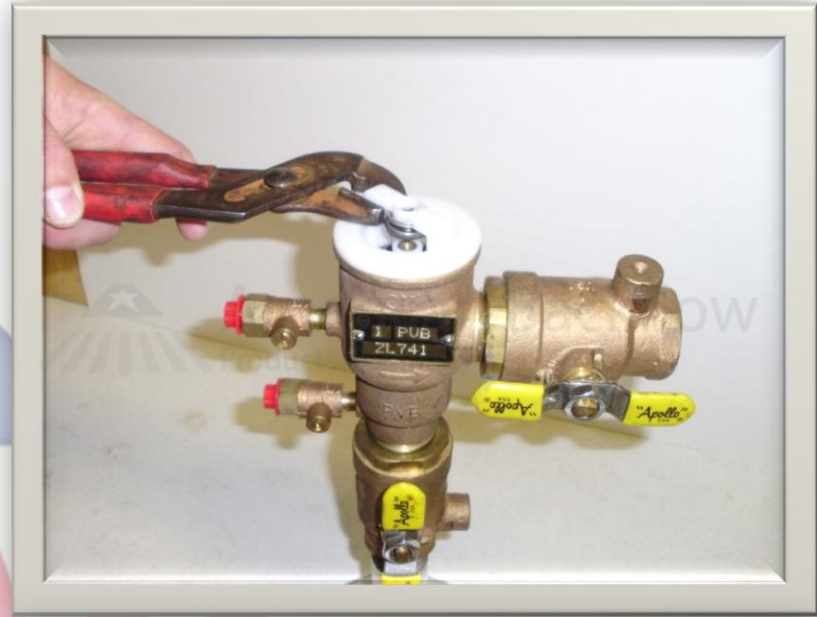
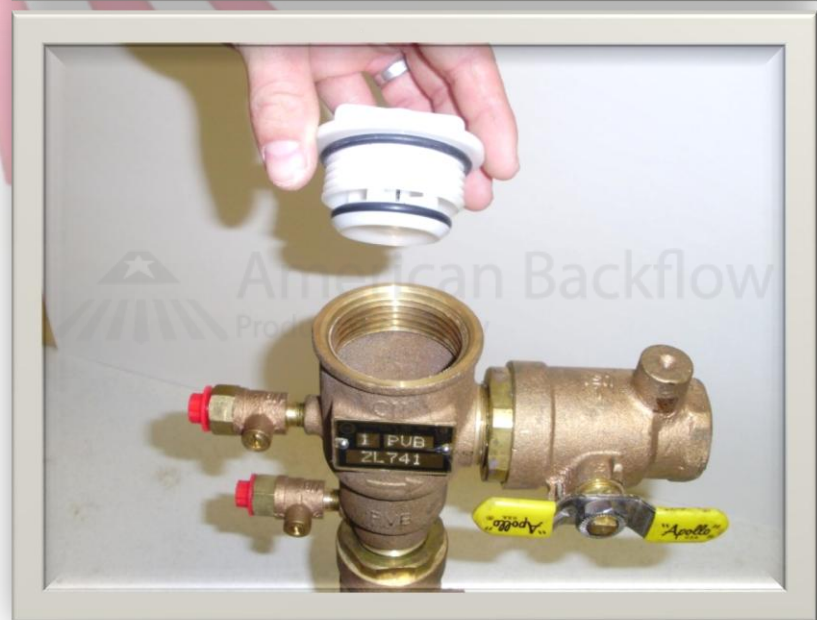
# Bonnet Removal

The bonnet is threaded into the body and sealed by an o-ring.

Unscrew the bonnet counter clockwise.

There is no spring load.

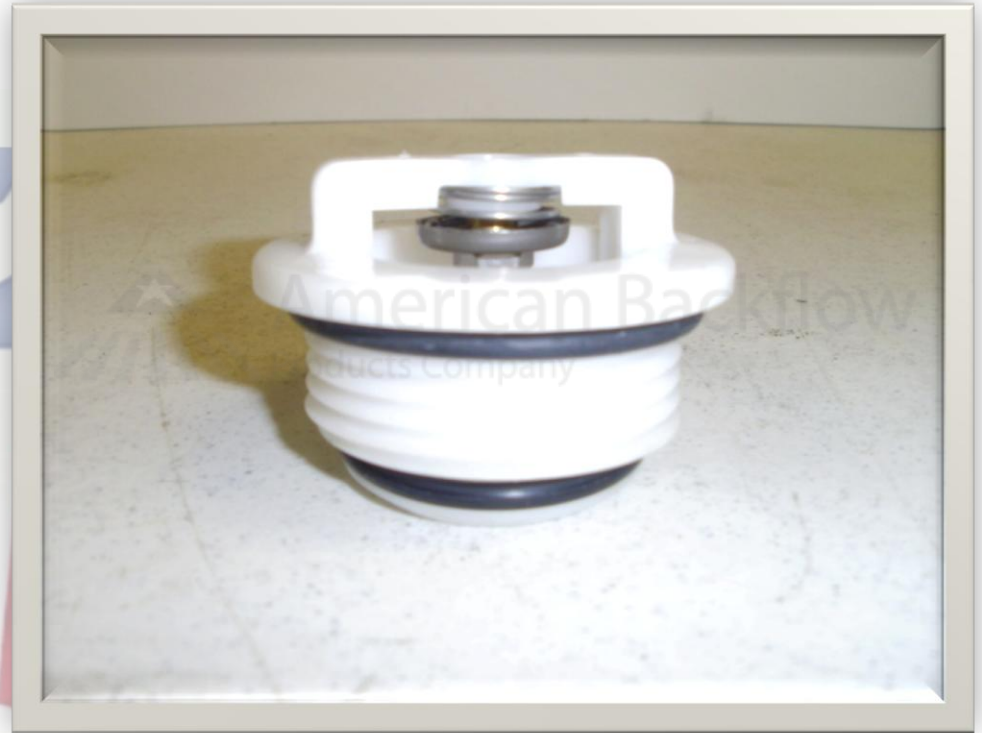
# Float Removal and Service

The float is part of the bonnet assembly.

If the float or float spring is damaged, the bonnet must be replaced.

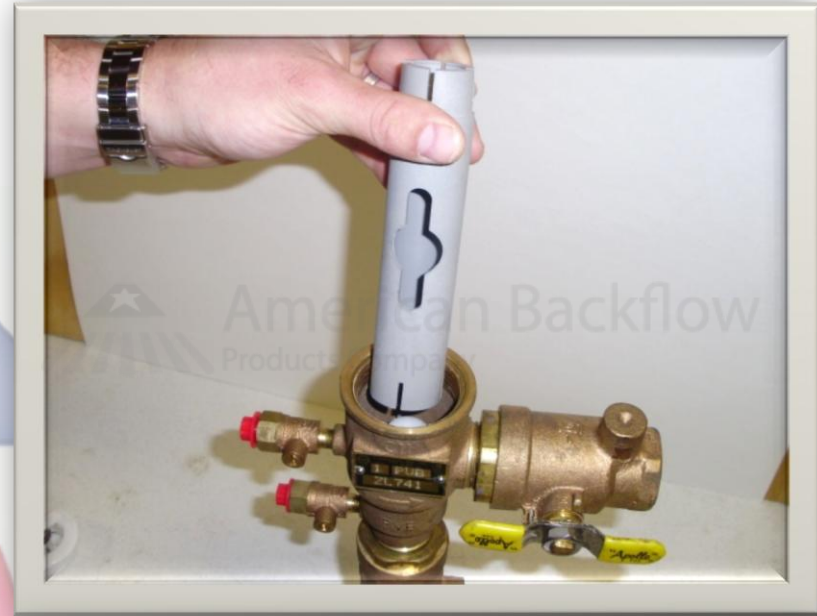
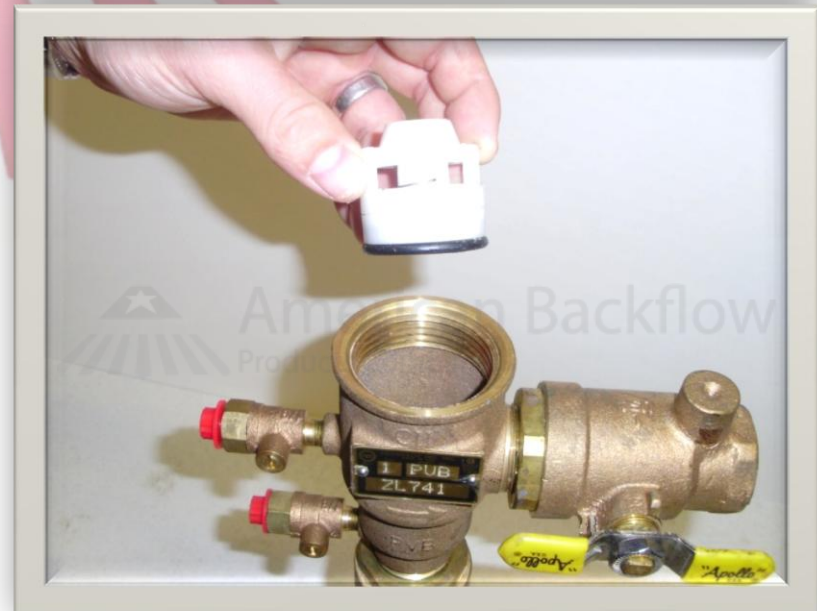
# Check Valve Removal ½”- 1”

The check valve is a module.

The check valve is threaded into the body and sealed by an o-ring.

A special tool is needed to remove the check module.

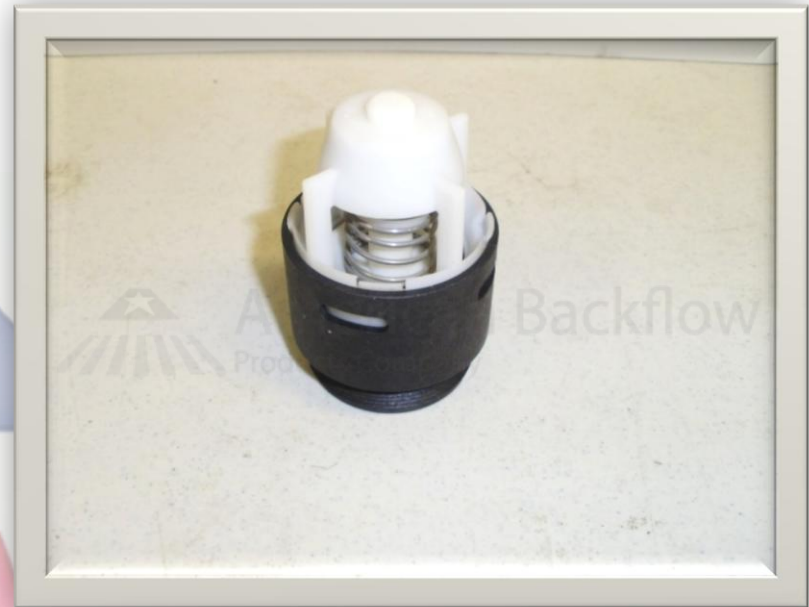
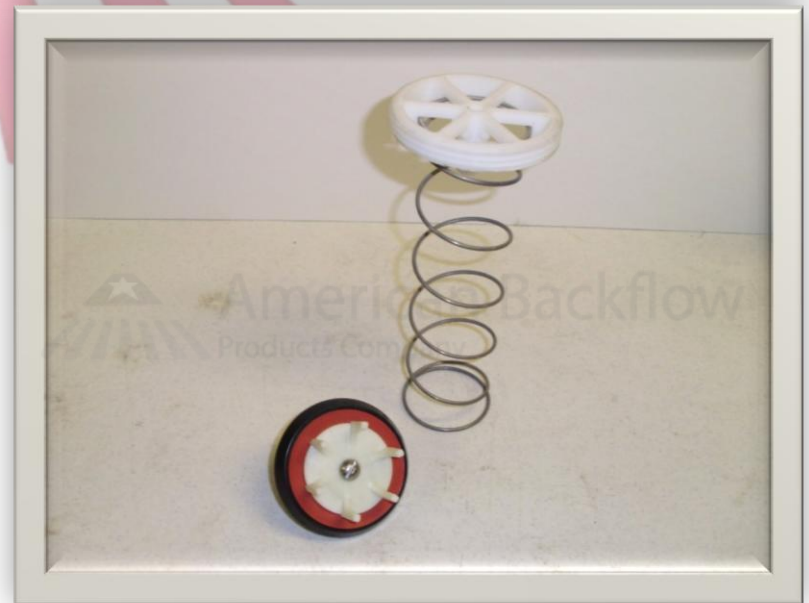
# Check Valve Removal 1 ¼" - 2"

The 1 ¼" & 1 ½" check modules are secured by a retainer that is threaded into the body.

The 2" check valve is not modular and is spring loaded.

Unscrew the spring retainer counter clockwise.

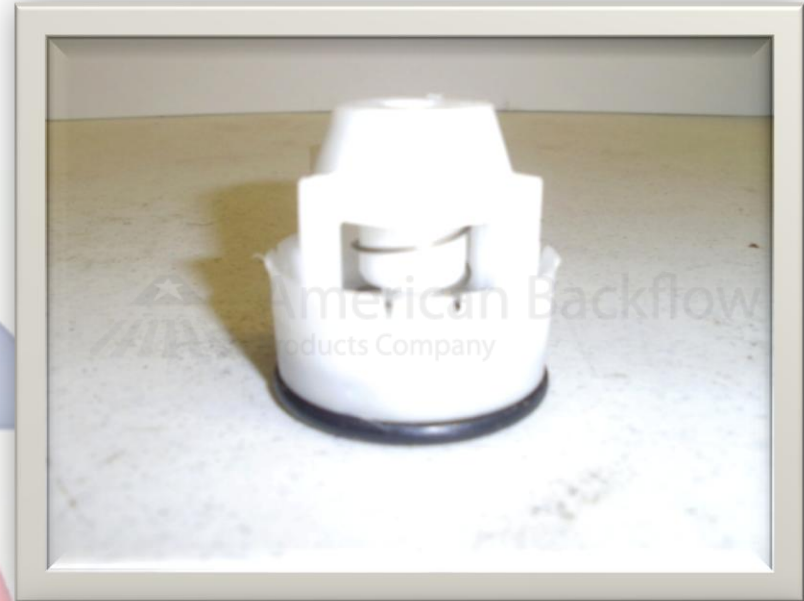
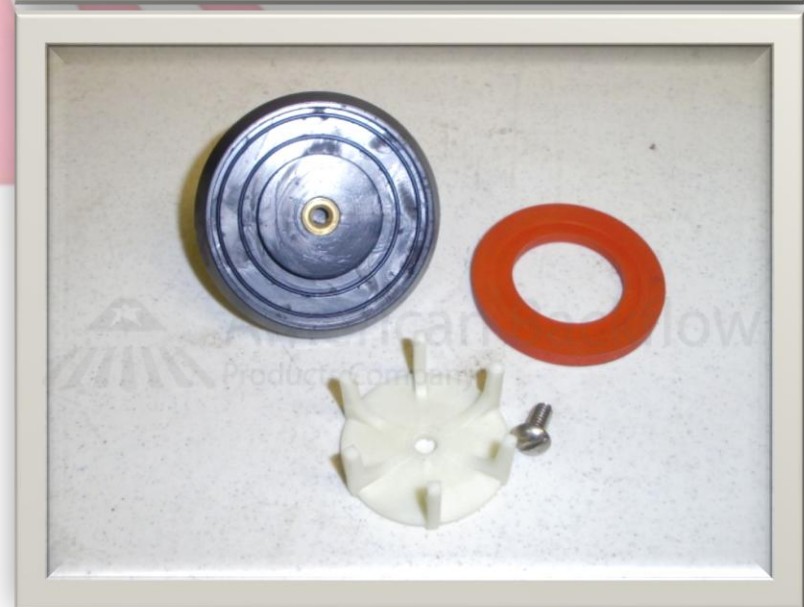
# Check Disc Replacement

The 1/2" - 1 1/2" rubber discs are part of the check module.

If the disc is damaged, the check module must be replaced.

The 2" disc is free once the screw and retainer are removed.

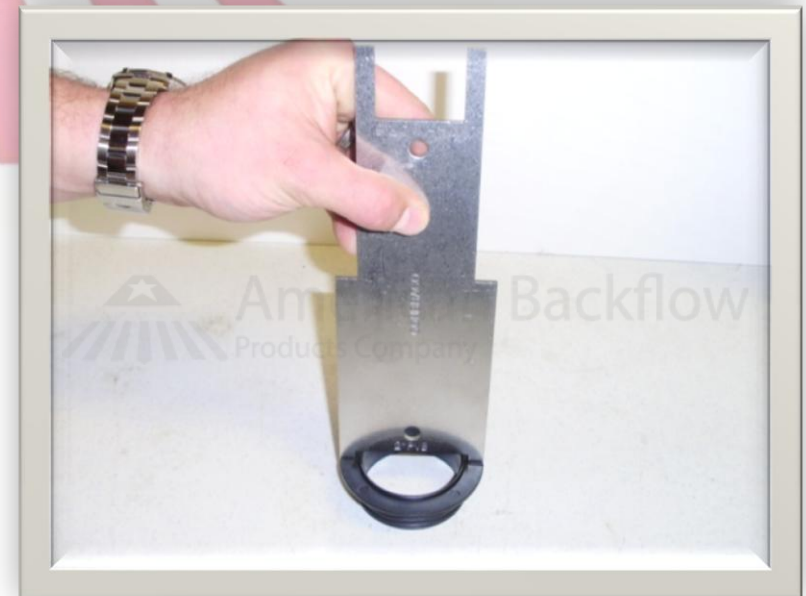
# Check Seat Replacement

The ½”- 1 ½” check seats are part of the check module.

If the seat is damaged, the module must be replaced.

The 2” check seat is threaded into the body and sealed by an o-ring.

A special tool is needed for seat replacement.

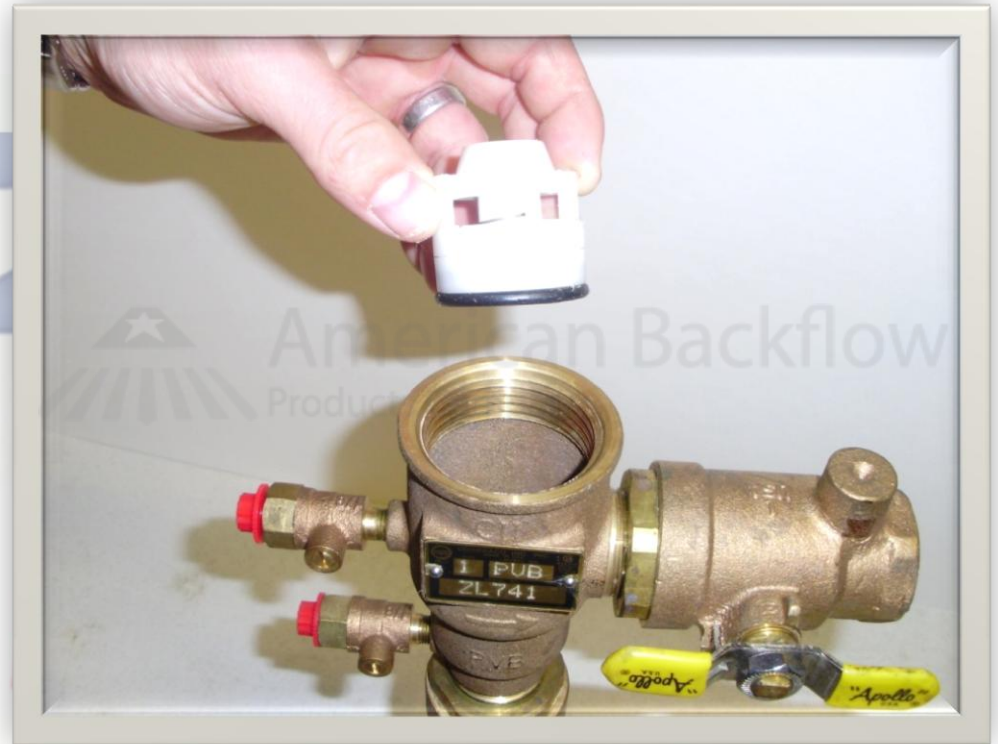
# Reassembly Notes

Reassemble in  
reverse order.

Lubricate the bonnet  
and check o-rings.
