5000 RPDA 4"-10"

American Backflow
Products Company

Modification Overview

Production of the 5000 RPDA began in 1989 and was discontinued in 2005.

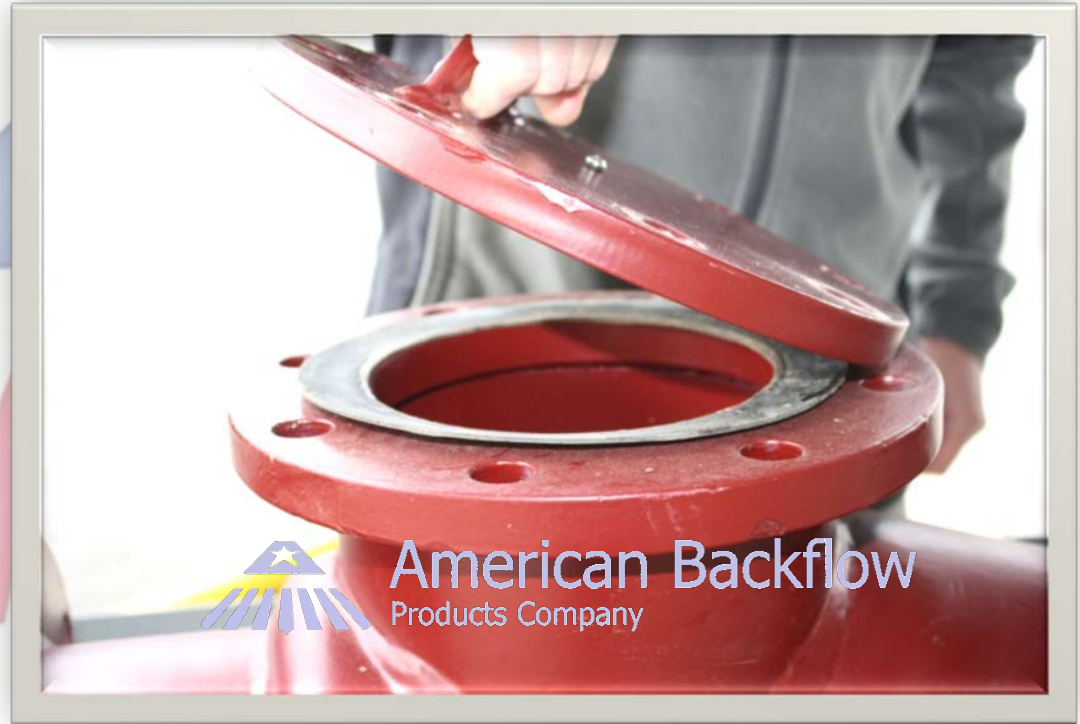
Check Cover Removal

Check covers are secured by bolts/nuts and sealed by a gasket.

There is no spring load on the cover.

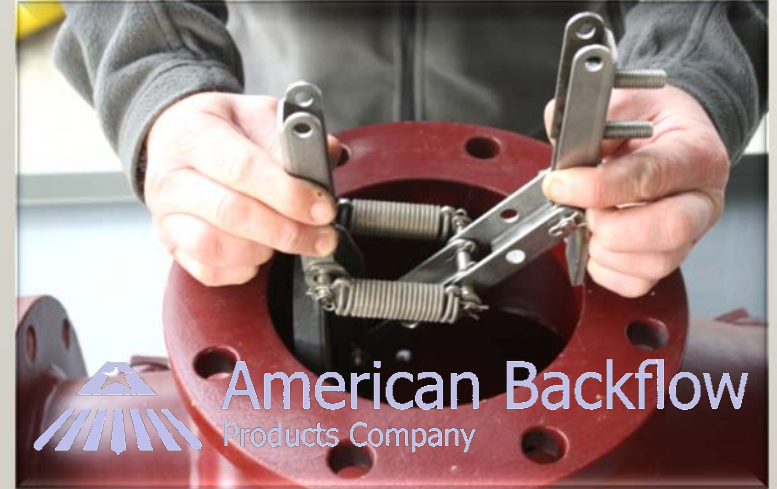
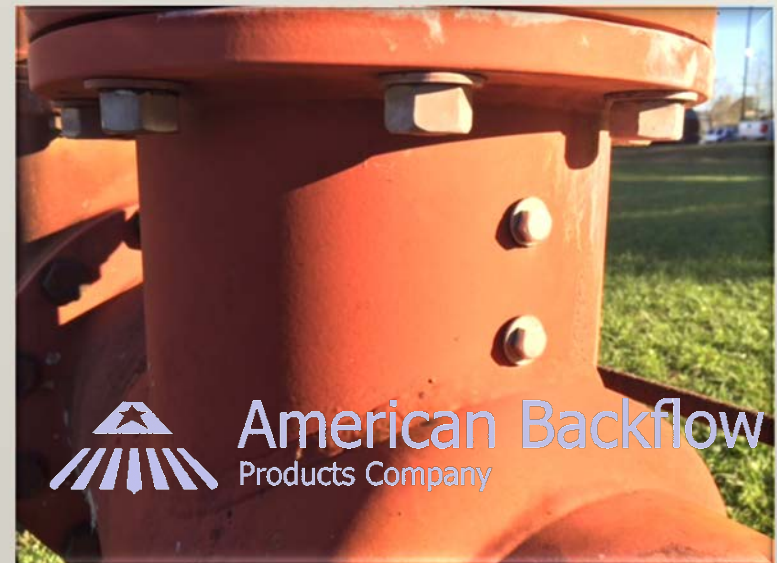
First Check Valve Removal

Check valves are knuckle joint assemblies that are ***turret mounted***.

The knuckle joint is secured with four mounting bolts/studs located on the exterior of the valve body.

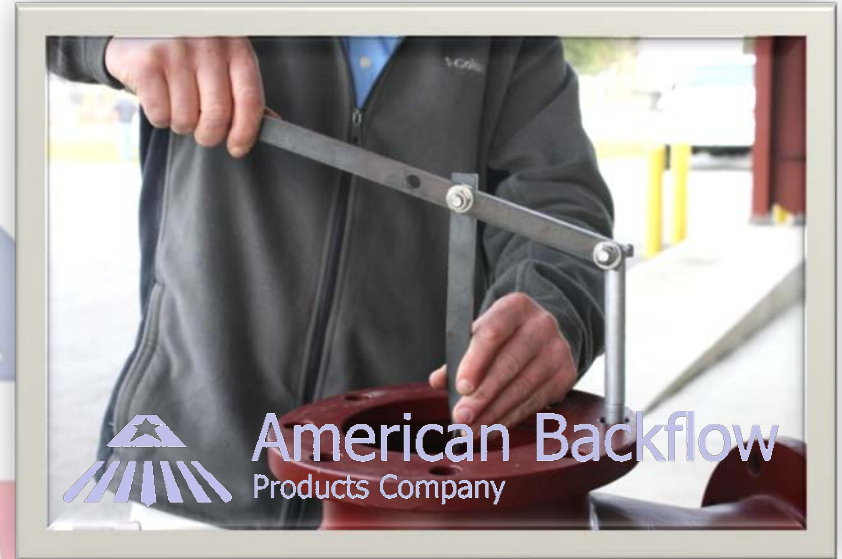
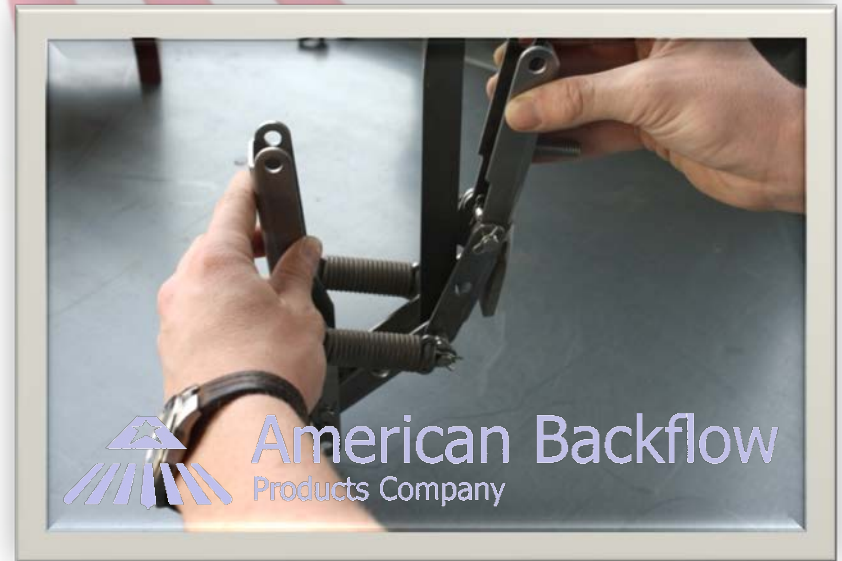
First Check Valve Removal

A ***tong tool*** is needed to remove the knuckle joint.

Secure the pivot arm of the tong tool to a bolt hole in the port flange.

Locate the drop down arm of the tong tool onto the link pin of the spring assembly.

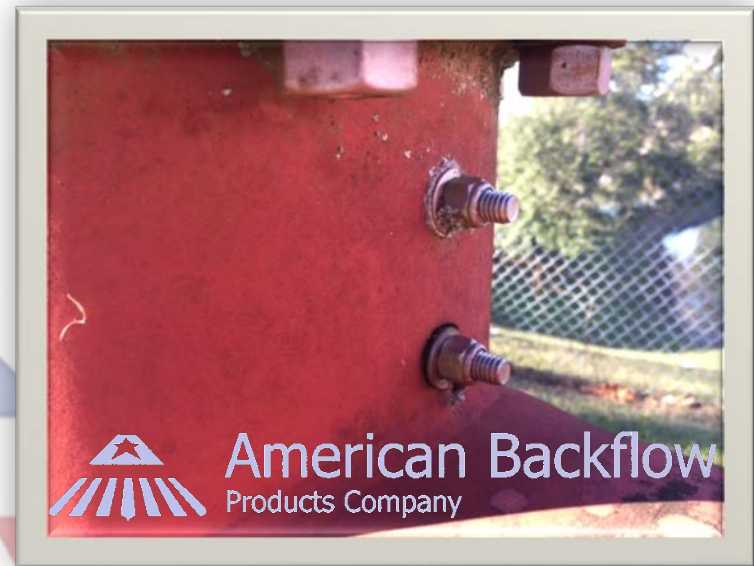
First Check Valve Removal

Remove the two rear mounting nuts from the exterior of the body.

While depressing the tong tool handle, work rear mounting linkage away from body.

****** There is considerable tension on the tong tool, slowly release pressure until all spring tension is released.

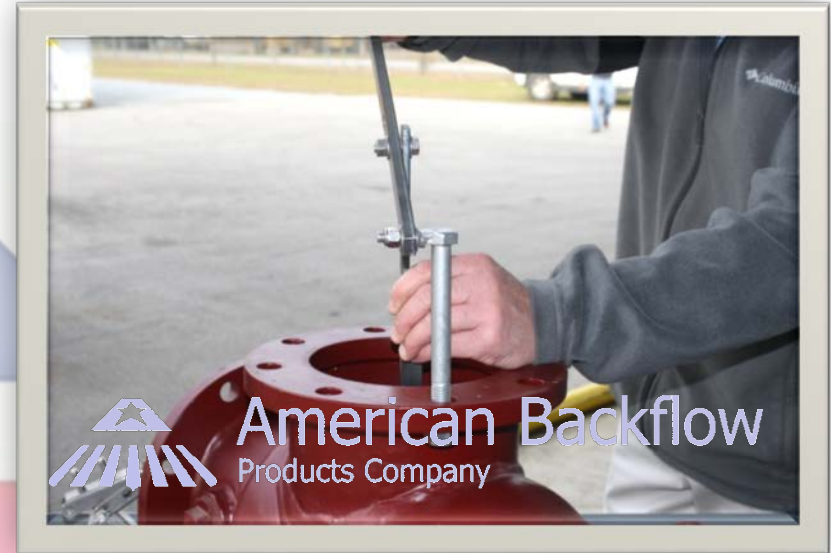
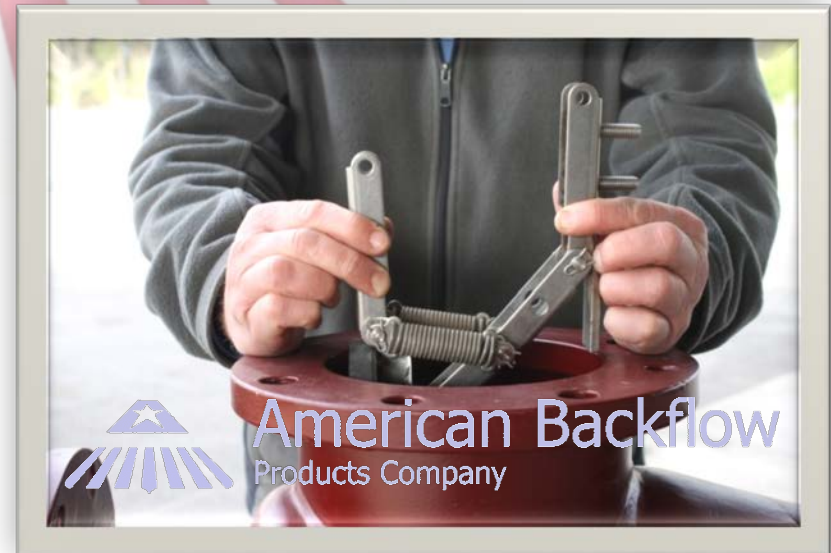
First Check Valve Removal

Remove tong tool
from device.

Remove the two front
mounting bolts from
the exterior of body.

The knuckle joint can
be removed from the
body.

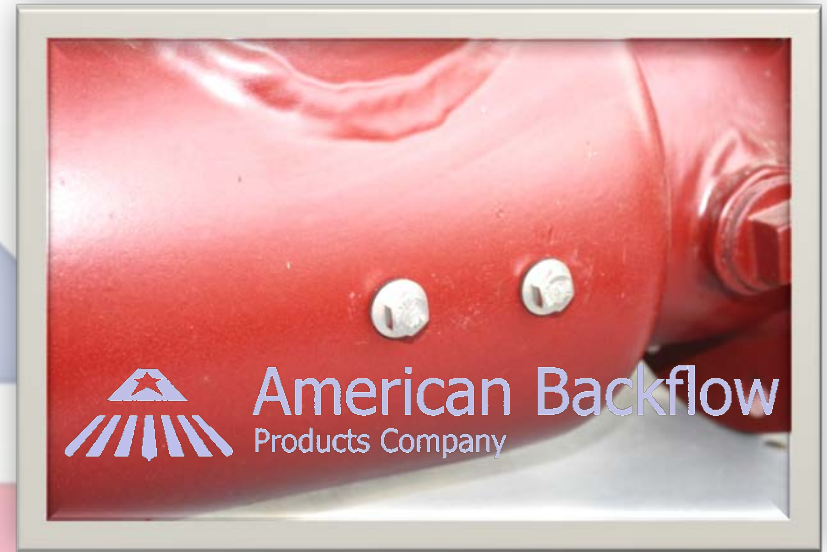
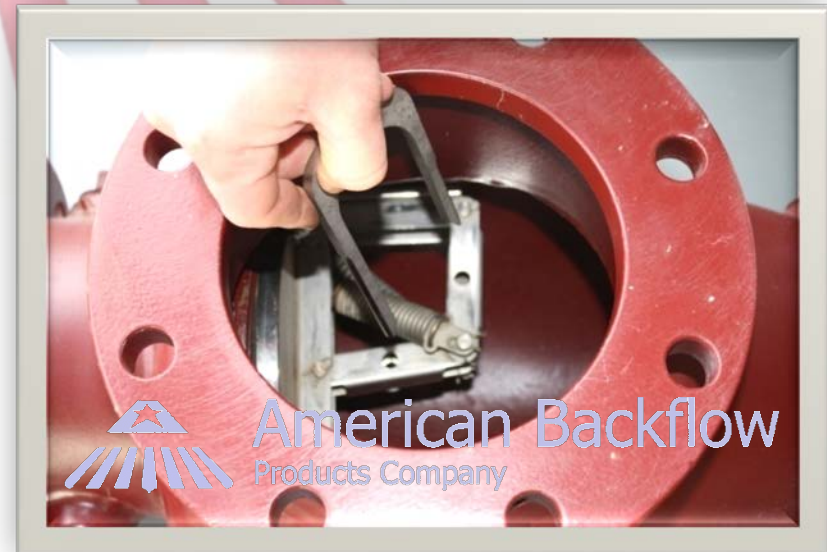
Second Check Valve Removal

Check valves are knuckle joint assemblies that are ***side mounted***.

The knuckle joint is secured with two mounting bolts that are located on the exterior of the valve body.

A retainer clip tool is needed to remove the second check.

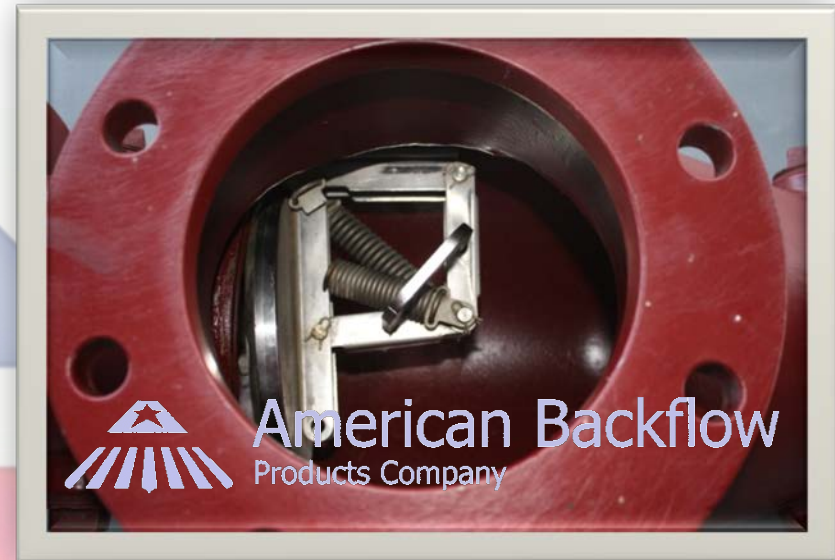
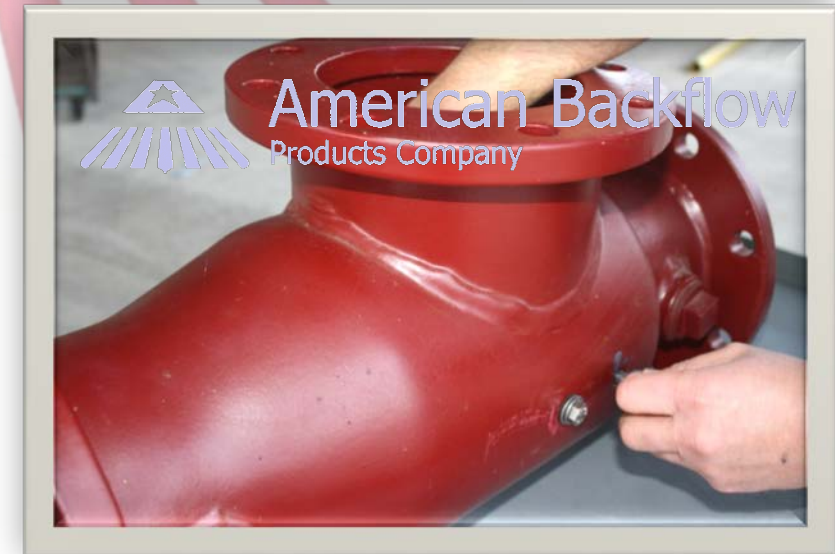
Second Check Valve Removal

Push retainer clip into the linkage holes on the knuckle joint.

****** The retainer clip will hold the springs under tension. (do not remove)

Loosen and remove the two mounting bolts located on the exterior of the body.

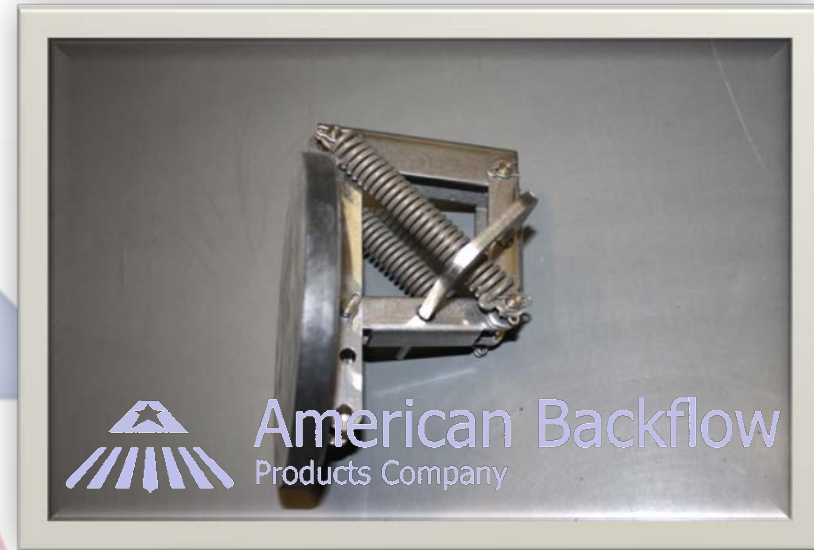
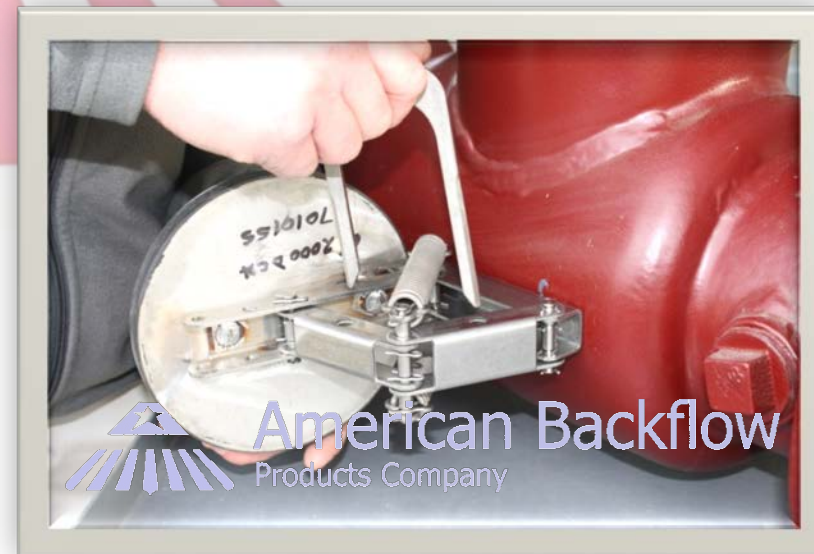
Second Check Valve Removal

The spring tension and retaining clip must be removed to service the second check.

Secure the knuckle joint to the outside of the valve body with mounting bolts.

Push on clapper while removing the retaining clip.

Slowly release spring tension.

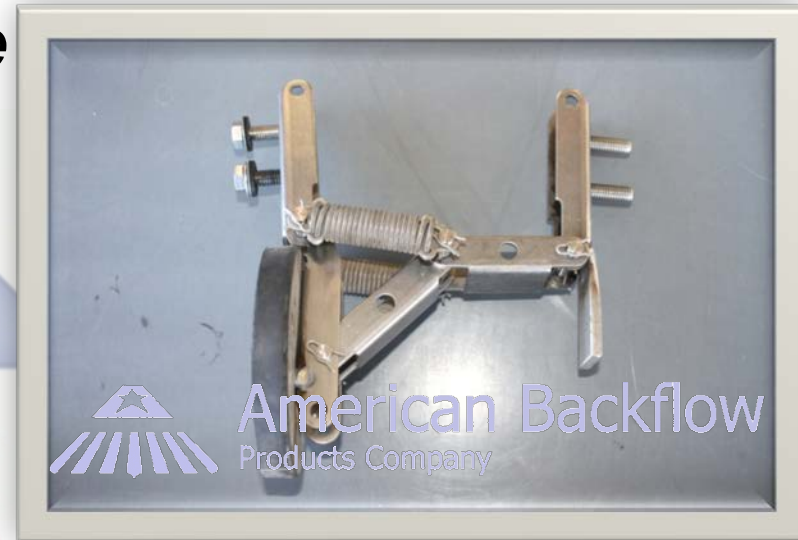
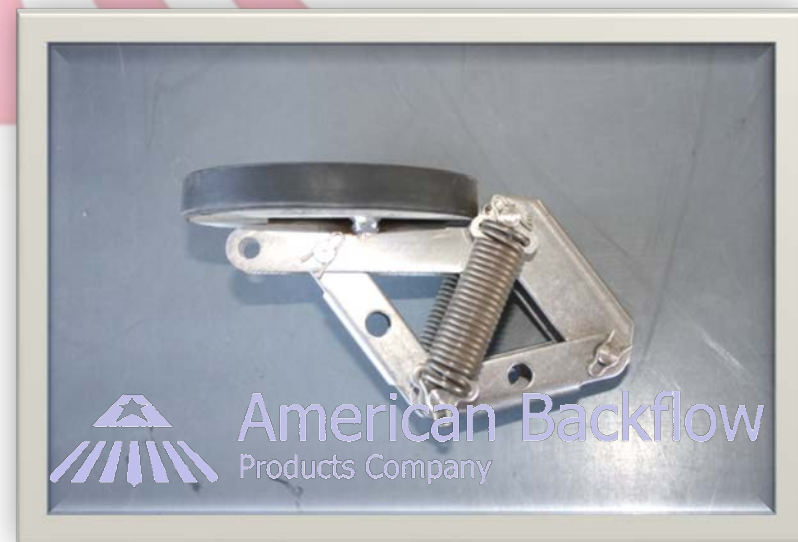
Check Disc Replacement

Both the *turret mount* and *side mount* knuckle joints utilize a vulcanized clapper plate.

The knuckle joints must be disassembled to replace the clapper plate.

****** Before disassembly, mark the holes used on the original clapper plate bracket.

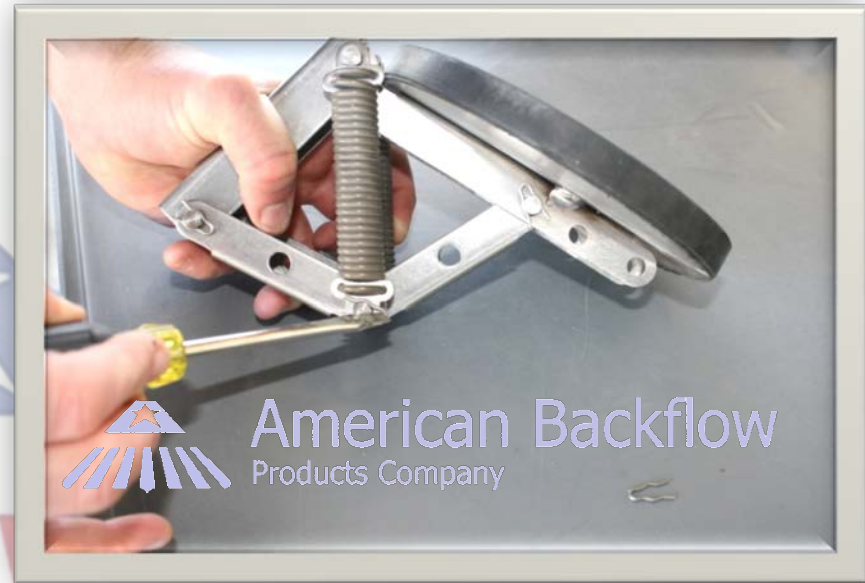
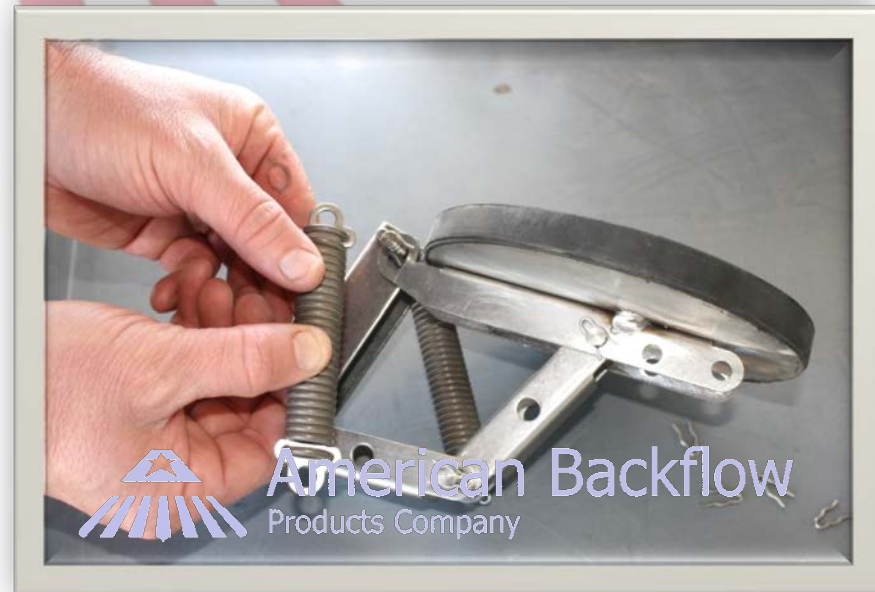
Check Disc Replacement

Remove the small retaining clips and springs from the knuckle joint.

**** Be careful not to lose the small retaining clips.**

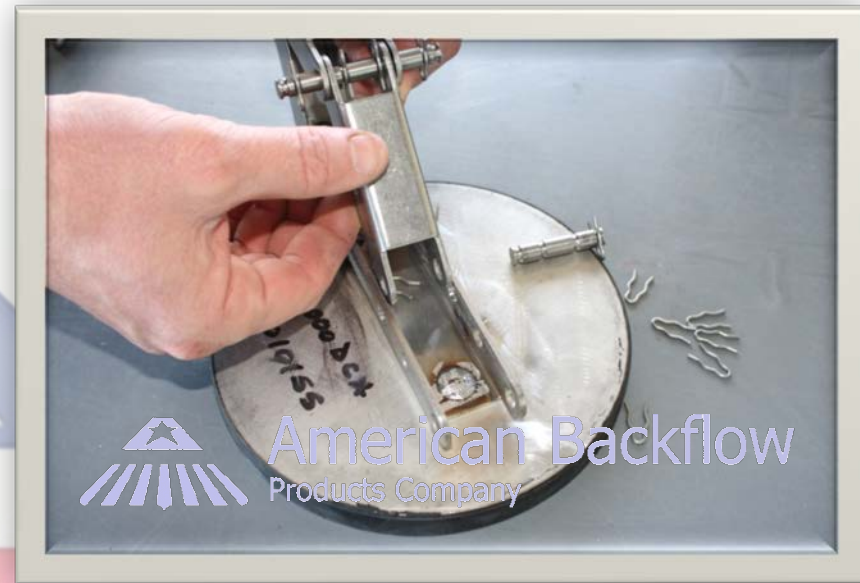
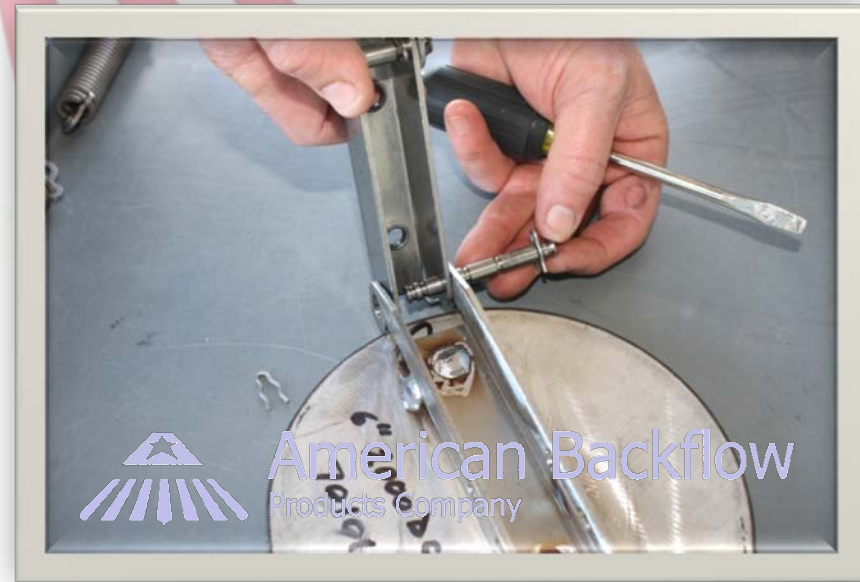
Check Disc Replacement

Remove the small retaining clips and two hinge pins located on the back of the clapper plate and the hinge point of the clapper plate.

Replace clapper plate.

****** Be aware of which set of holes were used on the original clapper plate bracket.

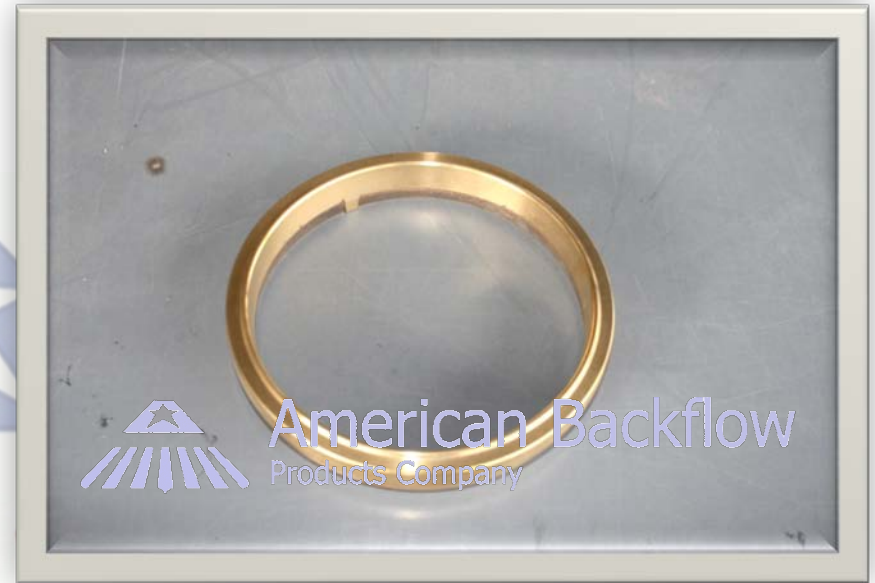
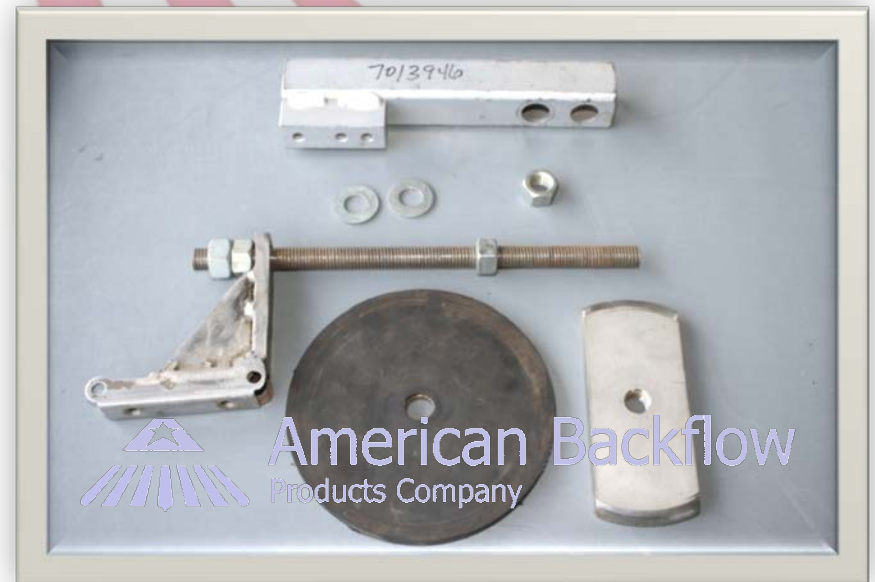
Check Seat Removal

The brass check seats are pressed into the body and sealed by an o-ring.

A special tool is needed to remove and install the seat.

The seat tool will mount inside the body based on which check is being serviced.

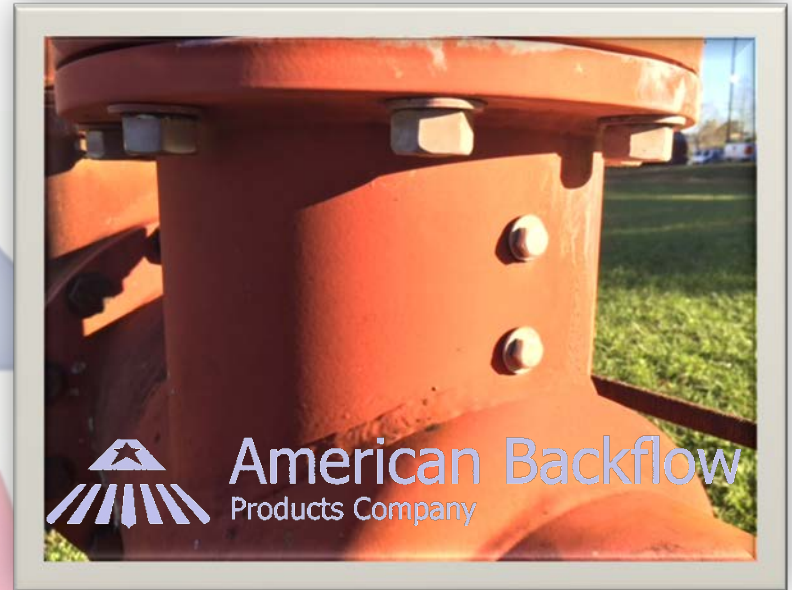
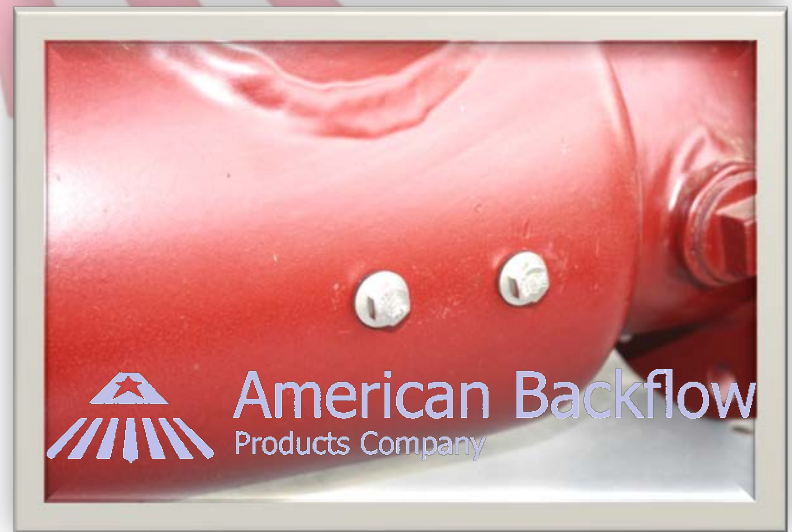
Check Valve Reassembly Notes

Reassemble in reverse order.

Be sure to replace the rubber faced washers for each of the exterior mounted bolts or nuts.

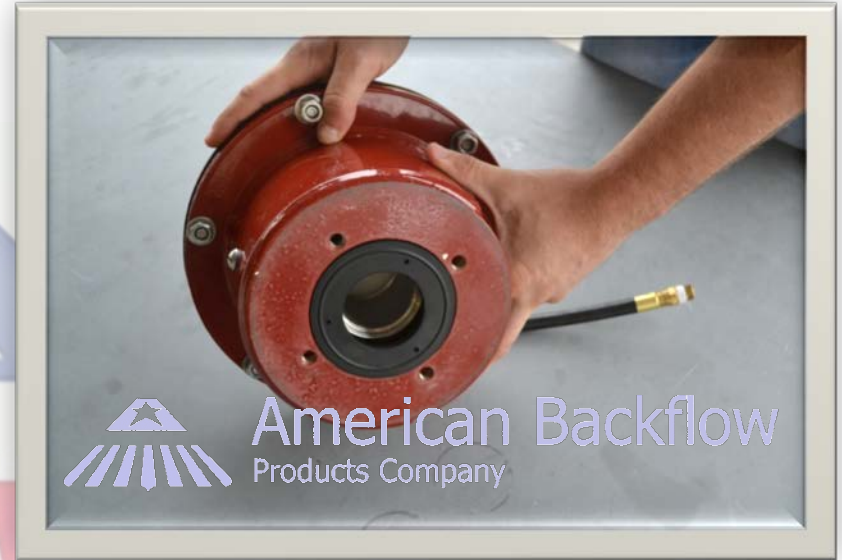
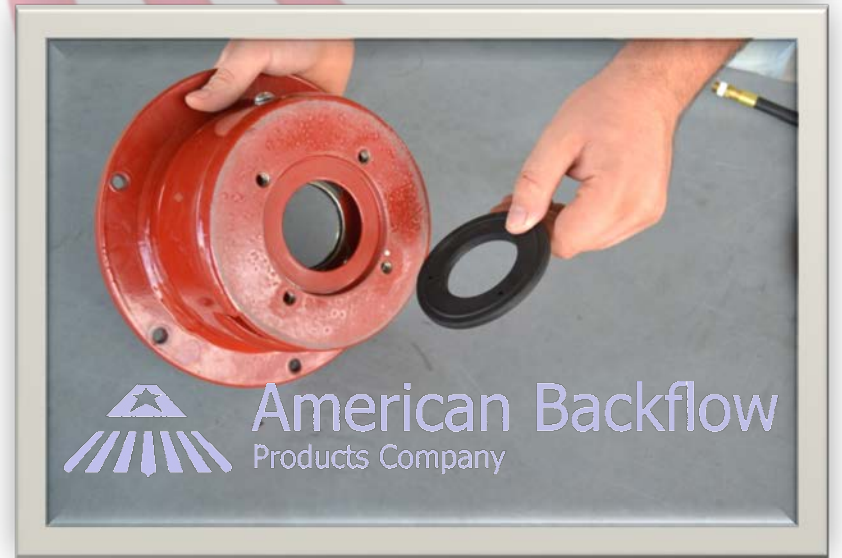
Relief Valve Service

The complete RV must be removed from the elbow flange for service.

Remove the 4 mounting bolts.

The seat disc is free once the RV has been removed.

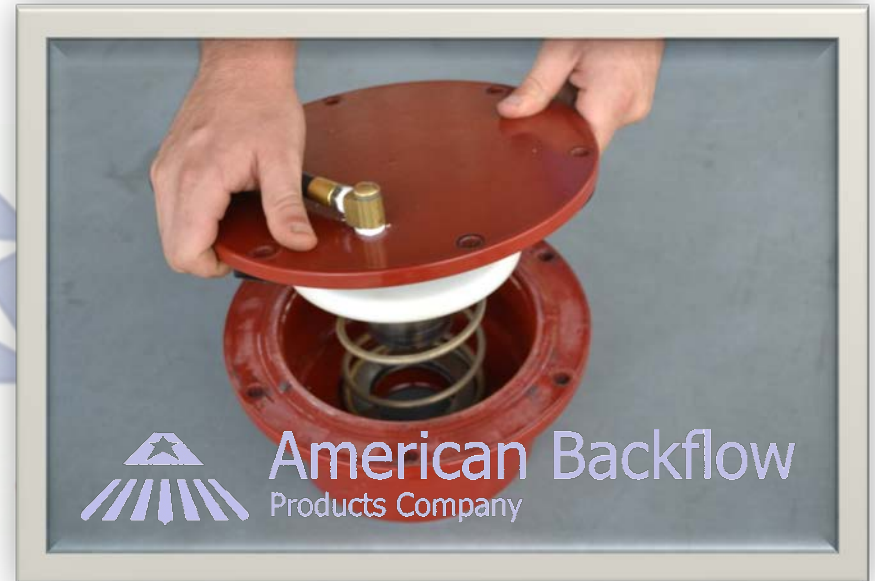
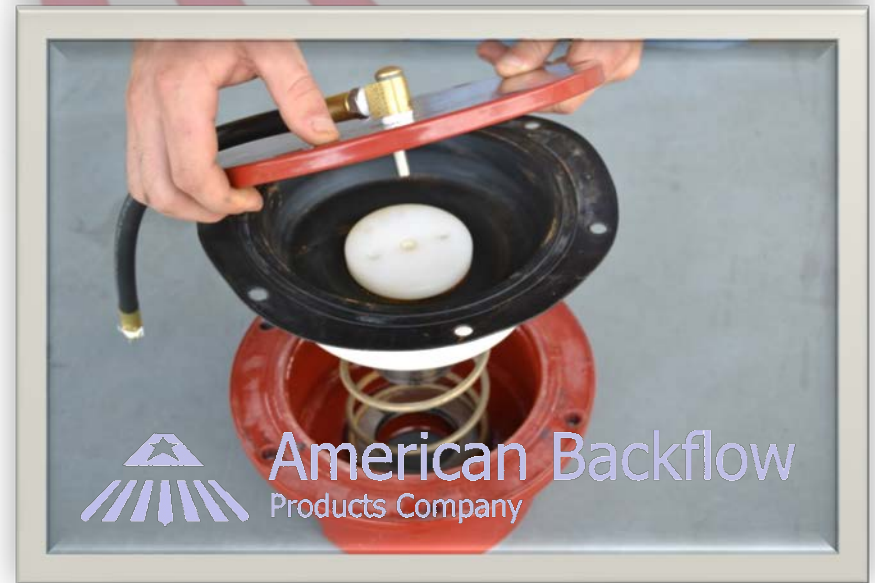
RV Cover Removal

RV Cover is sealed by the diaphragm and secured by 6 bolts.

Be aware of spring load when removing cover and bolts.

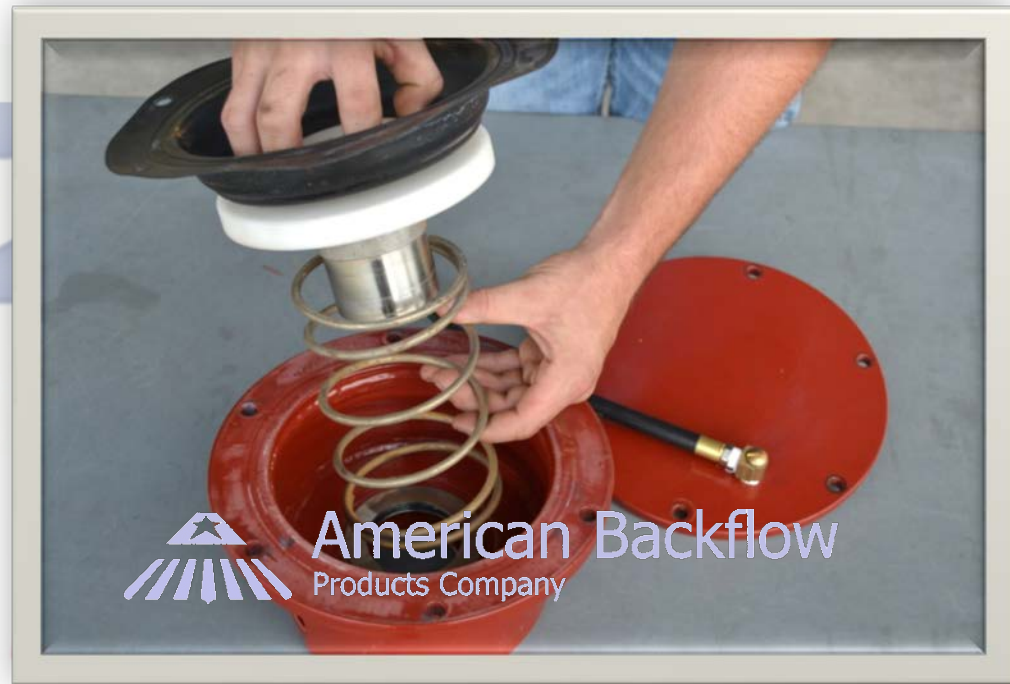
RV Piston Removal

The RV piston assembly and spring are free once the cover is removed.

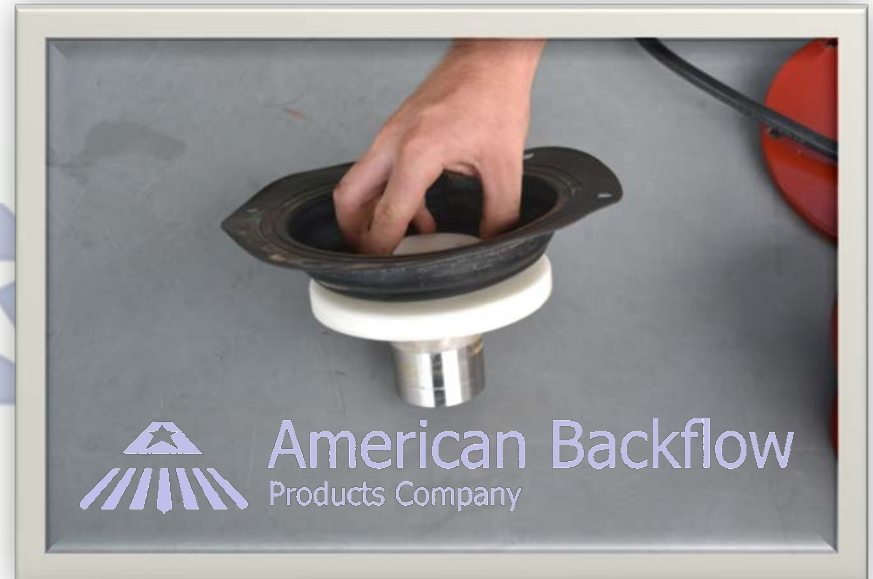
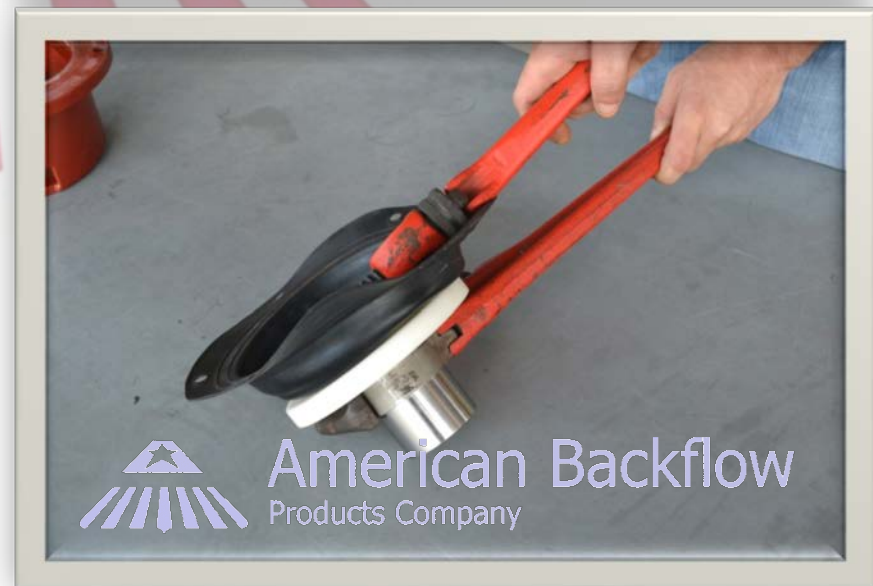
RV Piston Disassembly

Disassemble the piston assembly by unscrewing the top diaphragm plate from the seat tube.

****Note:** Do not place wrench on the polished section of the seat tube.

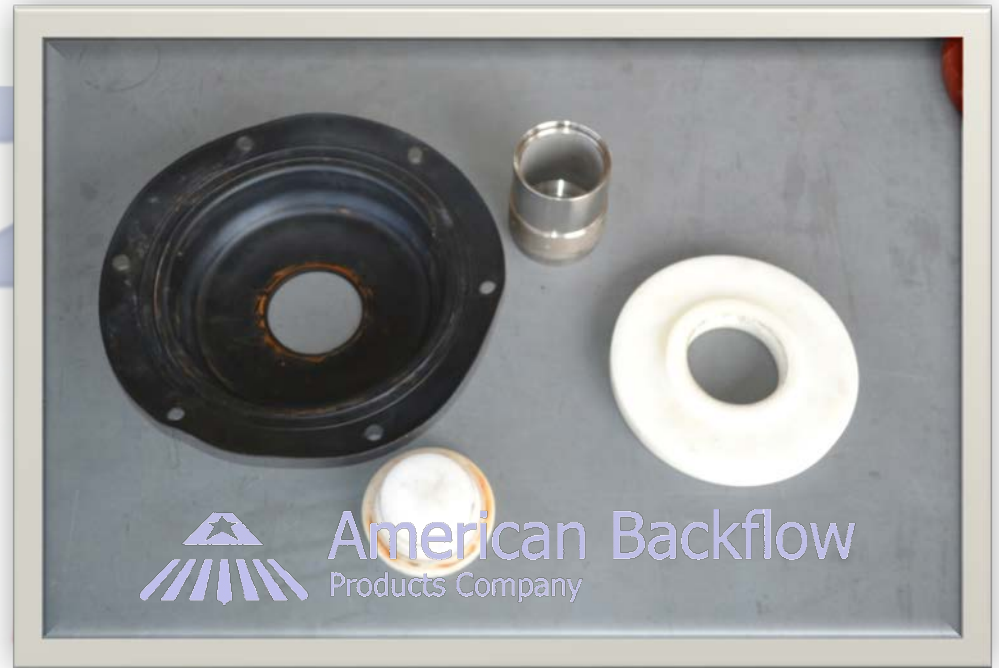
RV Piston Disassembly

The diaphragm, top plate, bottom plate and seat tube are free once fully disassembled.

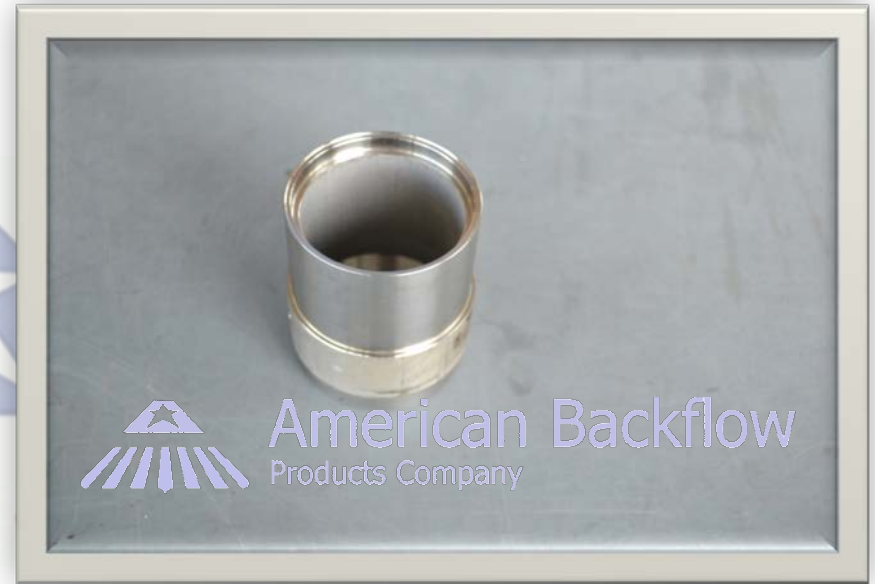
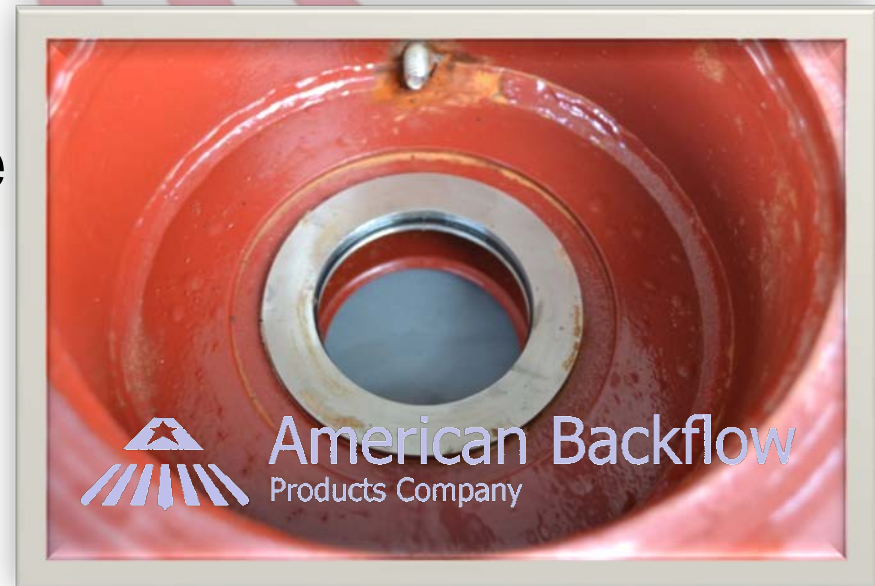
RV Piston Disassembly

Take care not to damage seating surface of the seat tube during service.

The piston o-ring is located in stainless insert of the housing.

**** Simply remove and replace the o-ring from the groove and apply lubricant.**

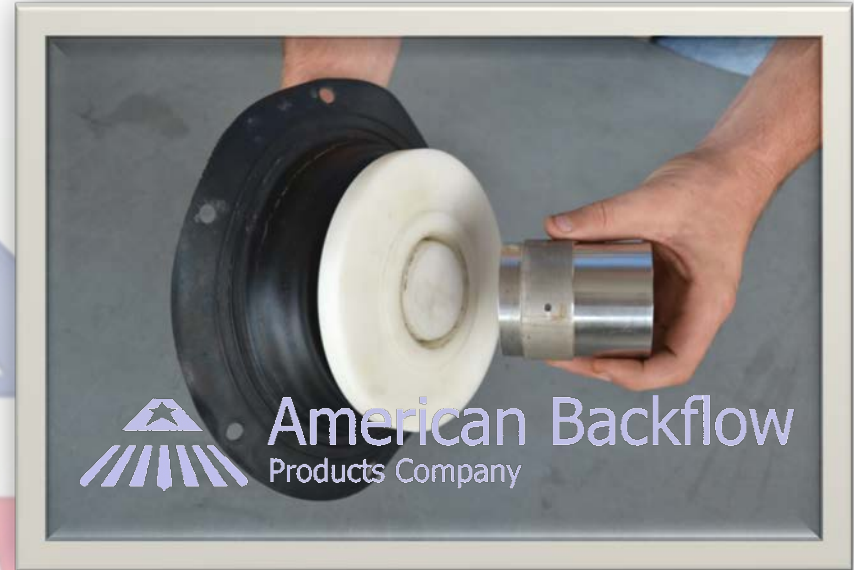
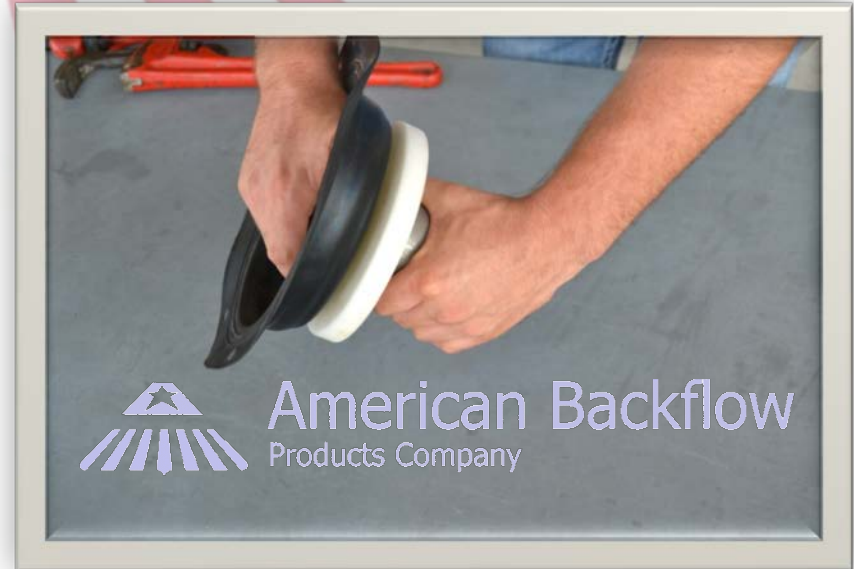
RV Reassembly

The diaphragm is positioned so that the “top hat” is between the diaphragm plates.

The bottom plate should be positioned so the spring shoulder is away from diaphragm.

****Note:** Place a small amount of lubricant on the top plate threads.

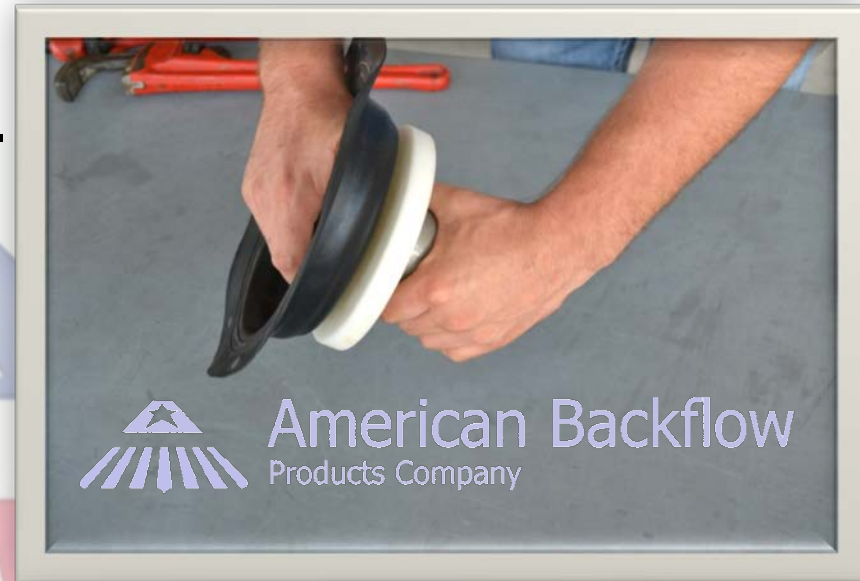
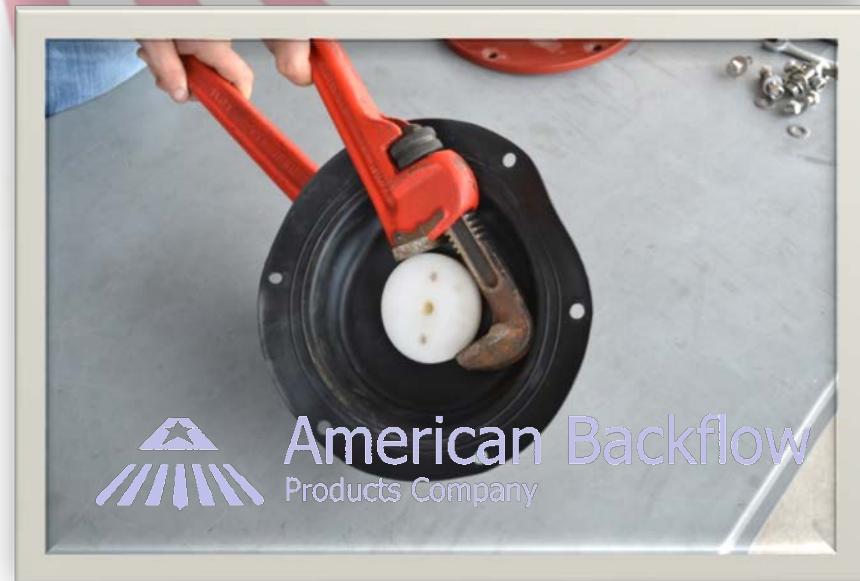
RV Reassembly

Be sure to first hand tighten seat tube onto plate threads.

**** Take care not to cross thread.**

Finish tightening until diaphragm is secured between plates.

**** Note: Do not place wrench on polished section of the seat tube.**

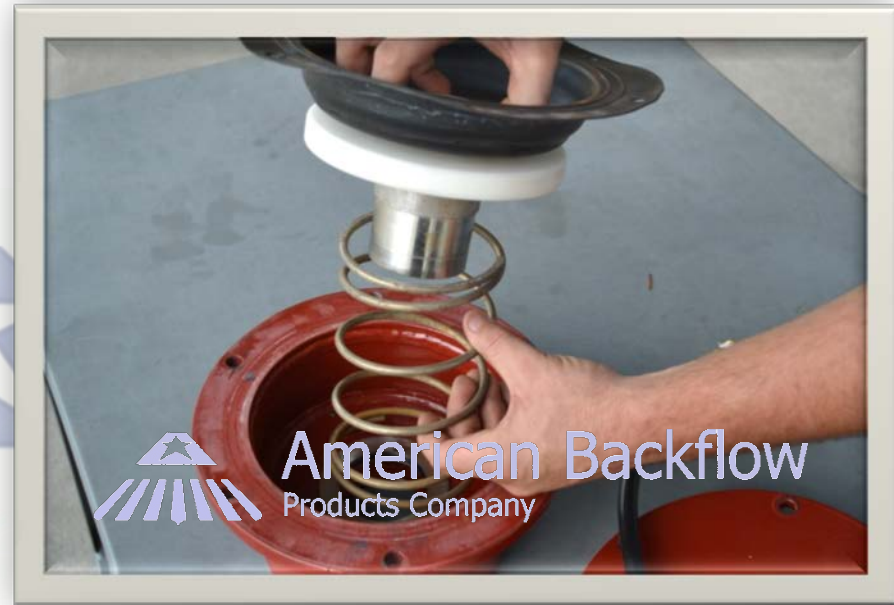
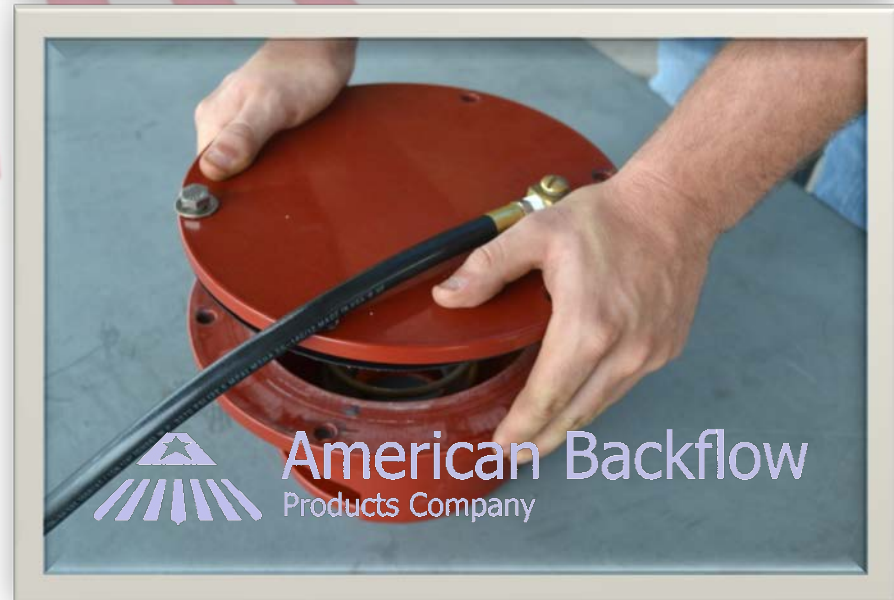
RV Reassembly

Place spring in body and piston assembly in position on the spring.

Line up bolt holes and replace bolts.

**** Be aware of spring tension on cover.**

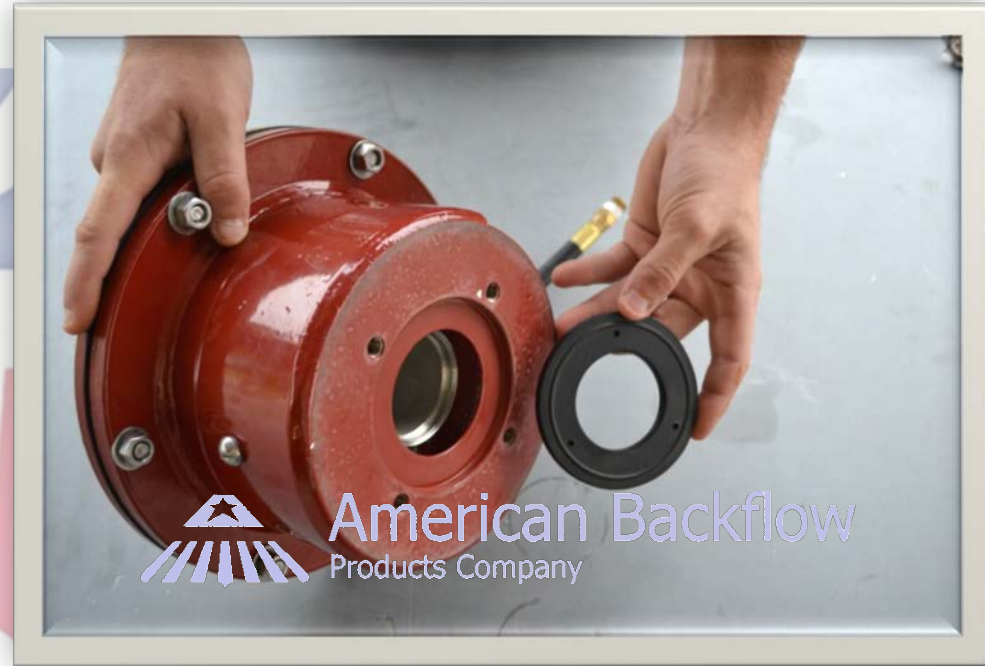
RV Reassembly

Replace seat disc on the back of the housing.

**** Note:** the seat disc also seals the RV housing to the elbow flange.

The seat disc should be positioned with bead side facing out.
