# 950, 950XL, 950XLT <sup>3</sup>/<sub>4</sub>" - 2"

## **Modification Overview**

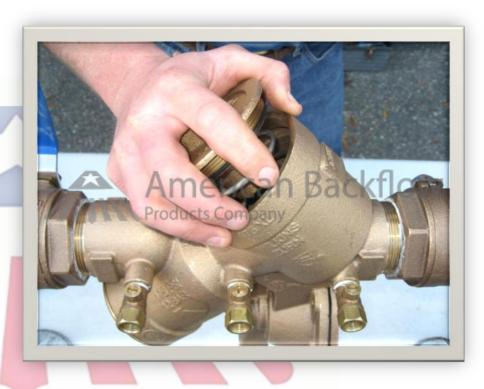
## **Check Cover Removal**

Cover is threaded into body and o-ring sealed.

Cover is spring loaded.

Loosen cover with wrench, then remove by hand while holding tightly against spring pressure.

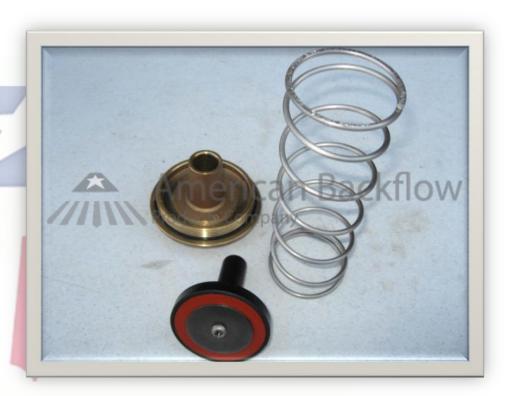
#### Check Valve Removal

Poppet style check valve.

The poppet and spring are free once the cover is removed.

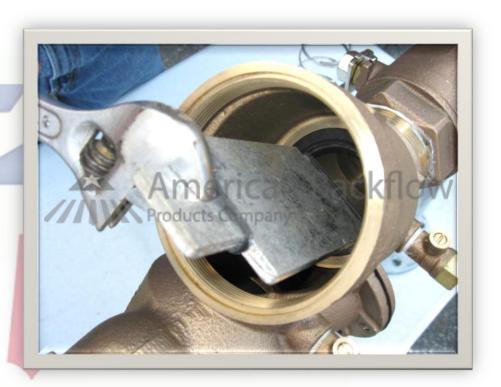
#### **Check Seat Removal**

Check seats are threaded into body and o-ring sealed.

A "special tool" is needed for removal.

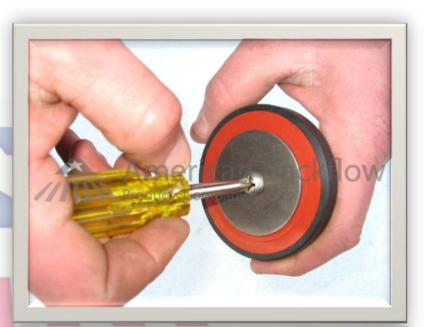
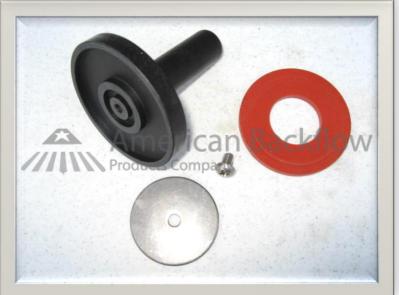
# Check Disc Replacement

Remove screw and disc washer from poppet.

Reassemble in reverse order.

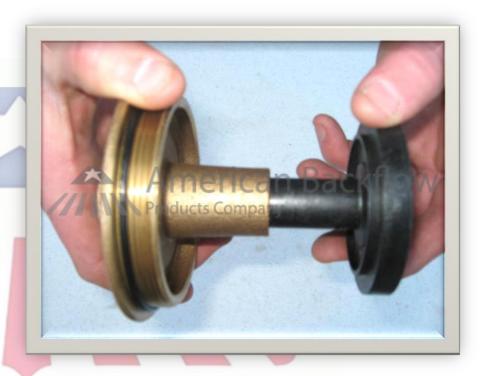
## Check Valve Reassembly Notes

Inspect and clean the guide bore on the cover.

The stem must move freely in the guide bore.

Reassemble in reverse order.
