975DA 21⁄2" - 10"

## **Modification Overview**

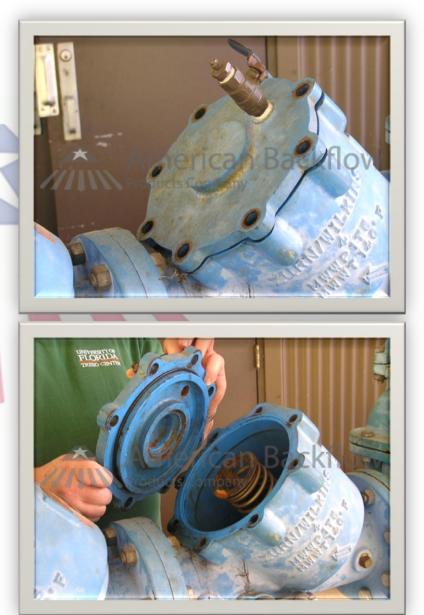
## **Check Cover Removal**

Cover is o-ring sealed.

Loosen bolts 1/2". The spring load is now released from the cover and retained by the check subassembly.

\*\* Verify spring load before removing all the bolts.

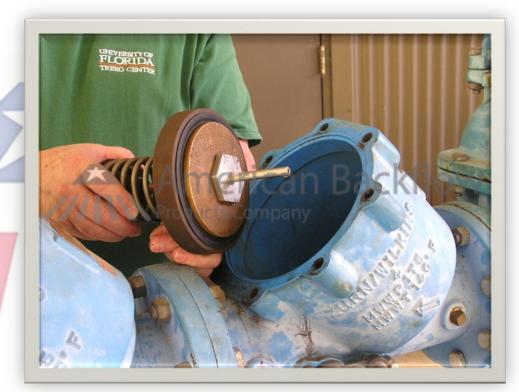
## **Check Valve Removal**

Center stem guided check assembly.

Disc & spring subassembly.

Slide subassembly straight out of seat and body.

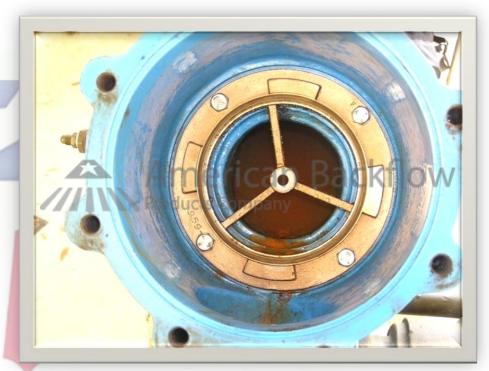
# **Check Seat Removal**

Seats are bolted into the body and o-ring sealed.

Remove the bolts and pull the seat straight out of the body.

4" - 10" - Inspect plastic guide bushing in center of seat.

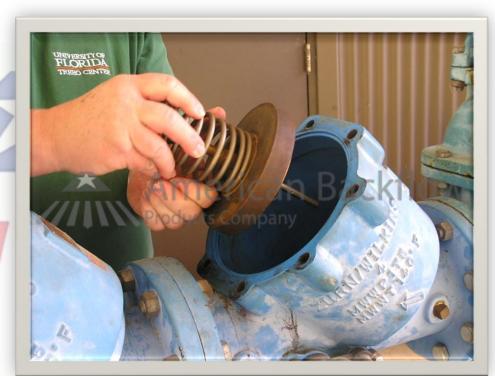
# **Check Valve Reassembly Notes**

Reassemble checks in reverse order.

Lubricate o-rings.

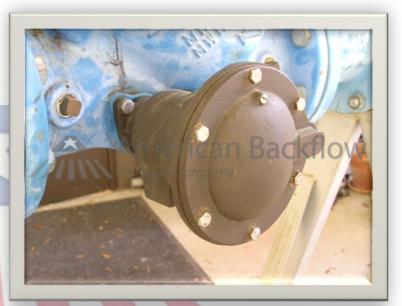
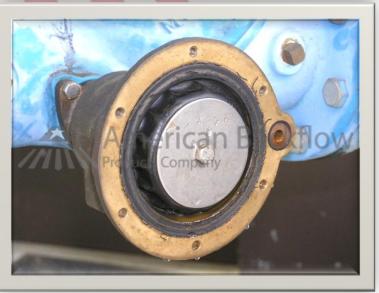
# **RV Cover Removal**

- Cover is sealed by the diaphragm.
- There is no spring load on cover.
- Remove bolts.

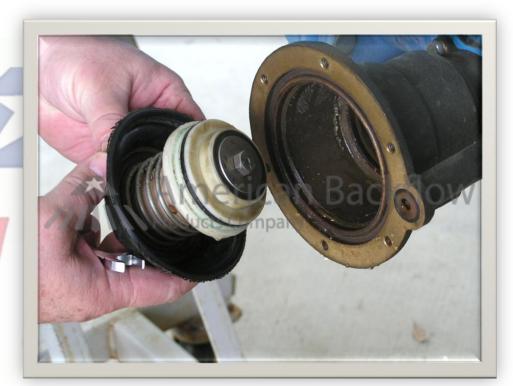
# **RV Module Removal**

Module is o-ring sealed.

Pull the module straight out of body.

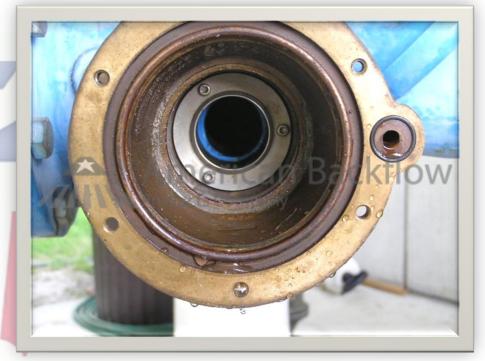
# **RV Seat Removal**

$2\frac{1}{2}$ " - 6" RV seat is bolted into body and o-ring sealed.

Remove the allen screws and pull seat straight out of body.

8" - 10" RV seat is threaded and o-ring sealed.

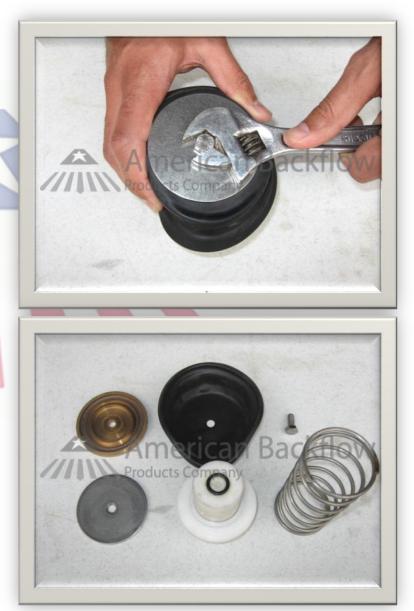
## **Disassemble RV Module**

Module is spring loaded.

Holding the module firmly, remove the stem bolt.

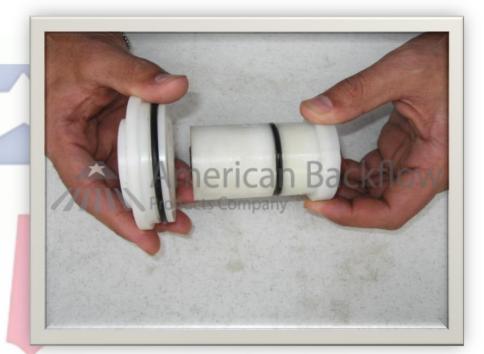
#### **Disassemble RV Module**

Remove the guide bushing from the stem.

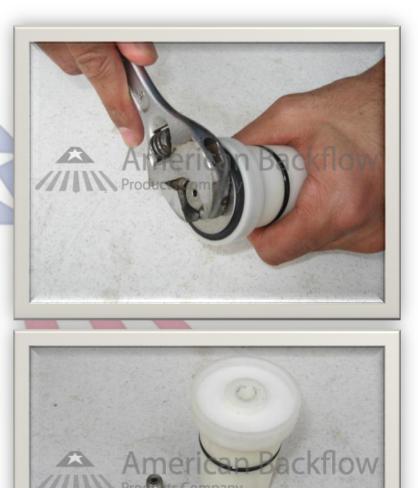
### **RV Disc Replacement**

Remove retaining bolt, disc washer, and disc.

Reassemble in reverse order.

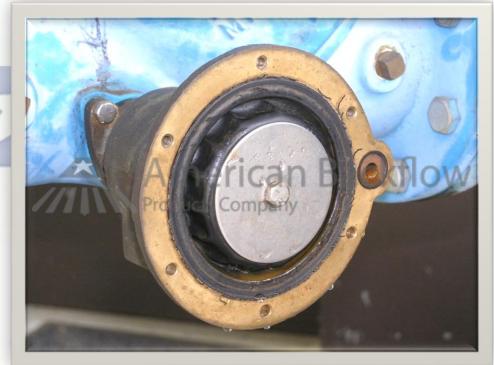
# **RV Reassembly Notes**

Bead on the edge of the diaphragm should face the disc end of the module.

Lubricate o-rings.

Push the module straight into the body.

Diaphragm bead will line up with the groove on the RV body.

Check the sensing line o-ring on the cover.
