PVB

3/4" - 2"

FLOMATIC

Modification Overview

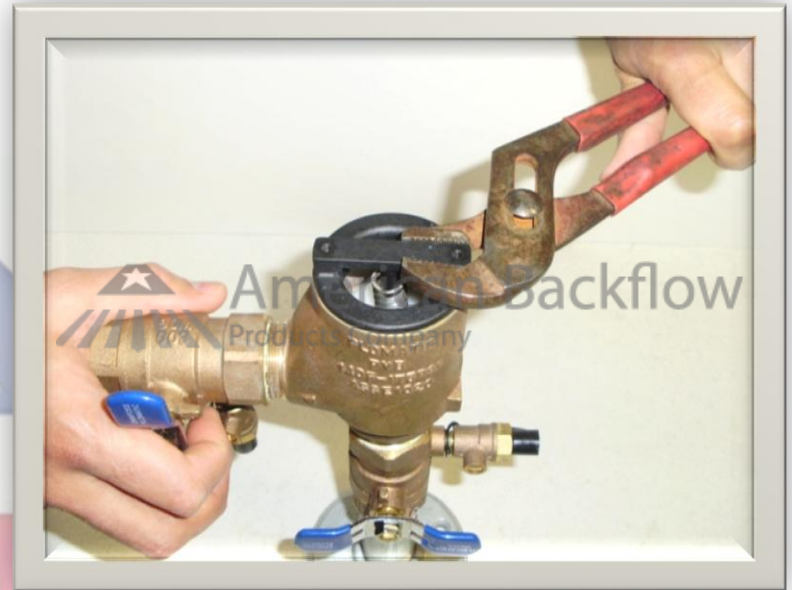
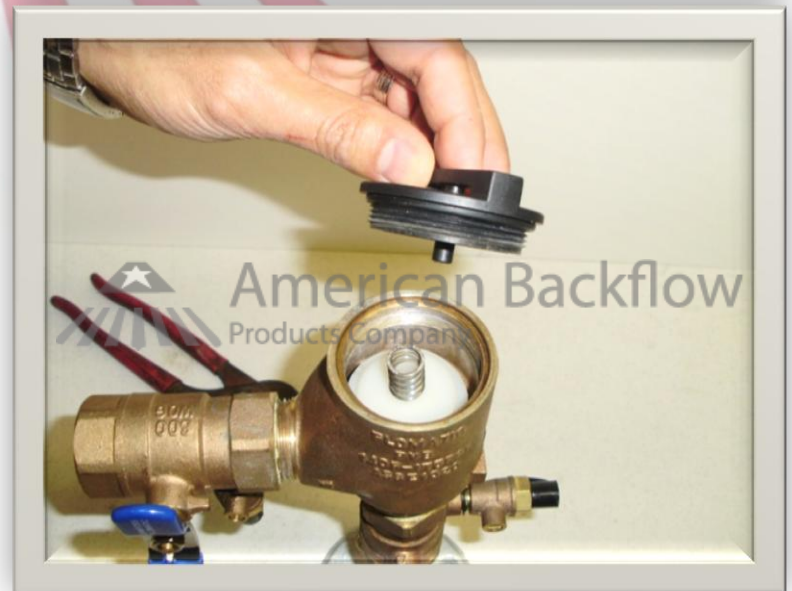
Bonnet Removal

The bonnet is threaded into the body and sealed by an o-ring.

Unscrew the bonnet counter clockwise.

There is no spring load.

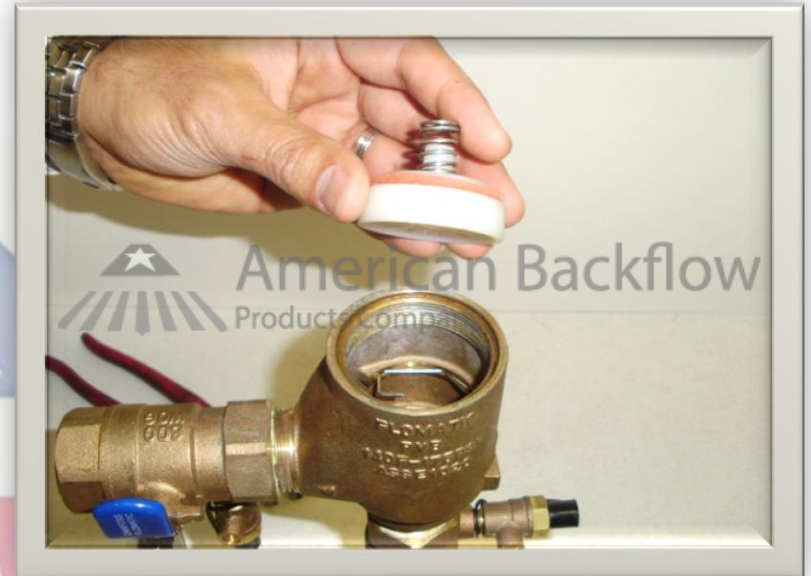
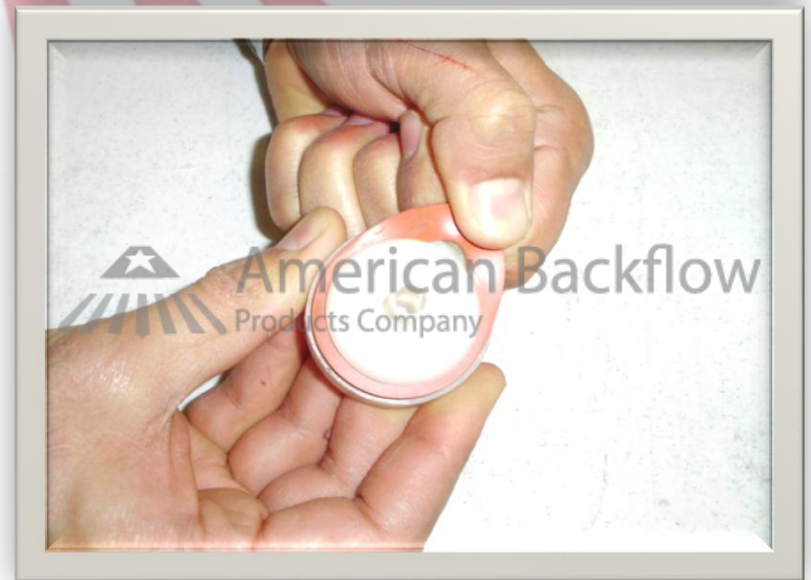
Float Removal and Service

The float and float spring are free once the bonnet has been removed.

Replace the rubber seal by pulling it from the groove on the float.

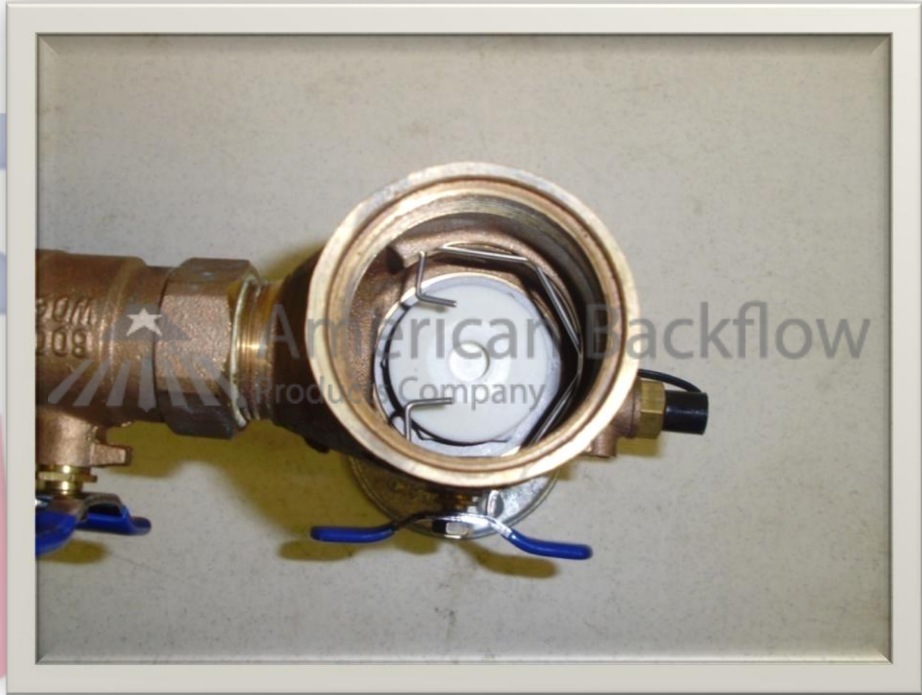
Check Valve Removal

The spring clip must be removed on versions made after July 2005.

Pinch the ends of the spring clip together and pull out of the body.

** Note: Use pliers if necessary.

The body of the $\frac{3}{4}$ " – 1" PVB was modified in July of 2005. A spring clip was added under the float assembly for serial numbers P0001 or larger.

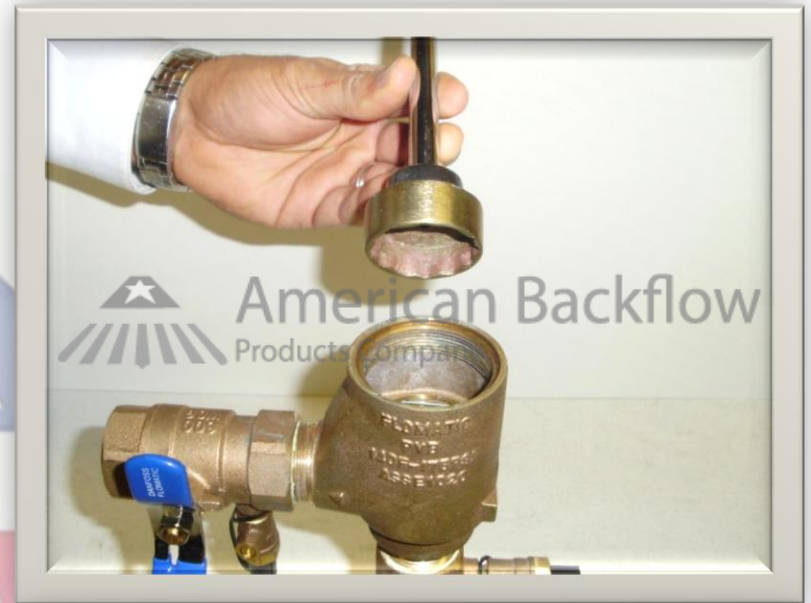
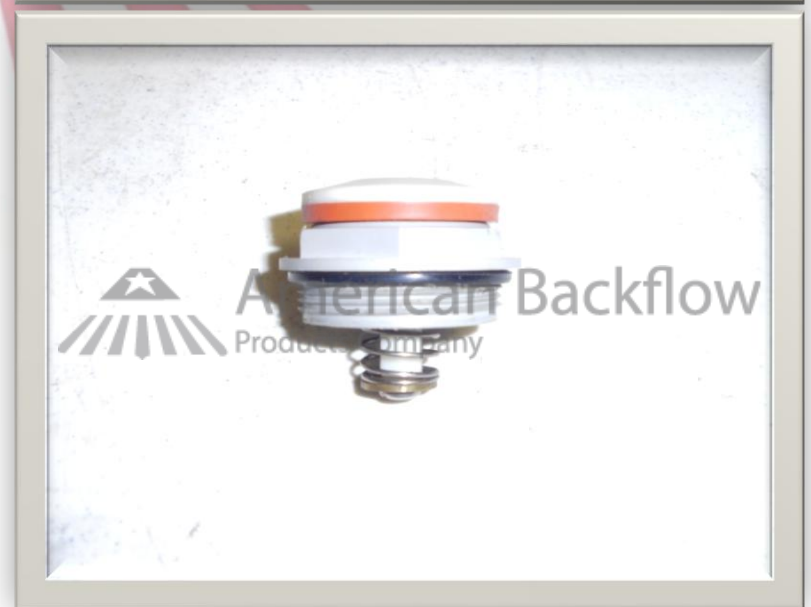
Check Valve Removal

The check valve is a module.

The check valve is threaded into the body and sealed by an o-ring.

* * Note: A special tool is needed to remove the check module.

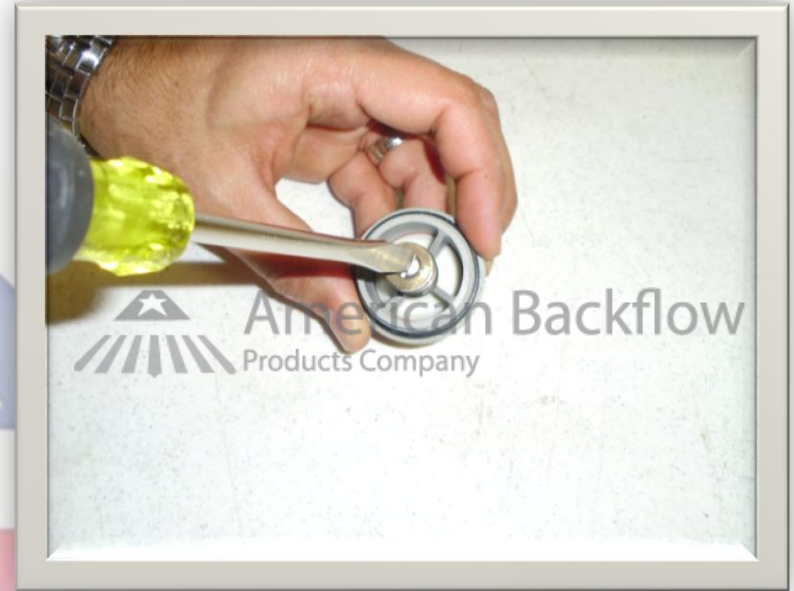
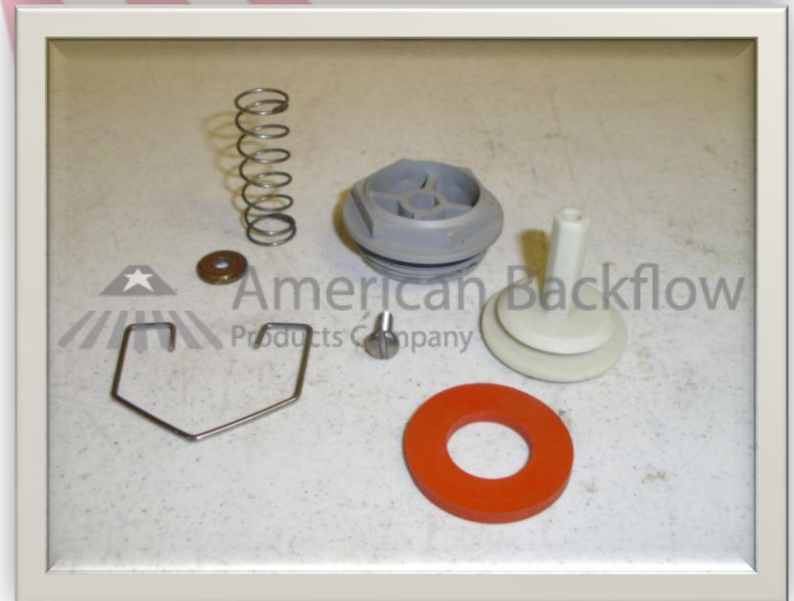
Check Valve Disassembly

The check module is
spring loaded.

Hold the check firmly
while removing the
retaining screw.

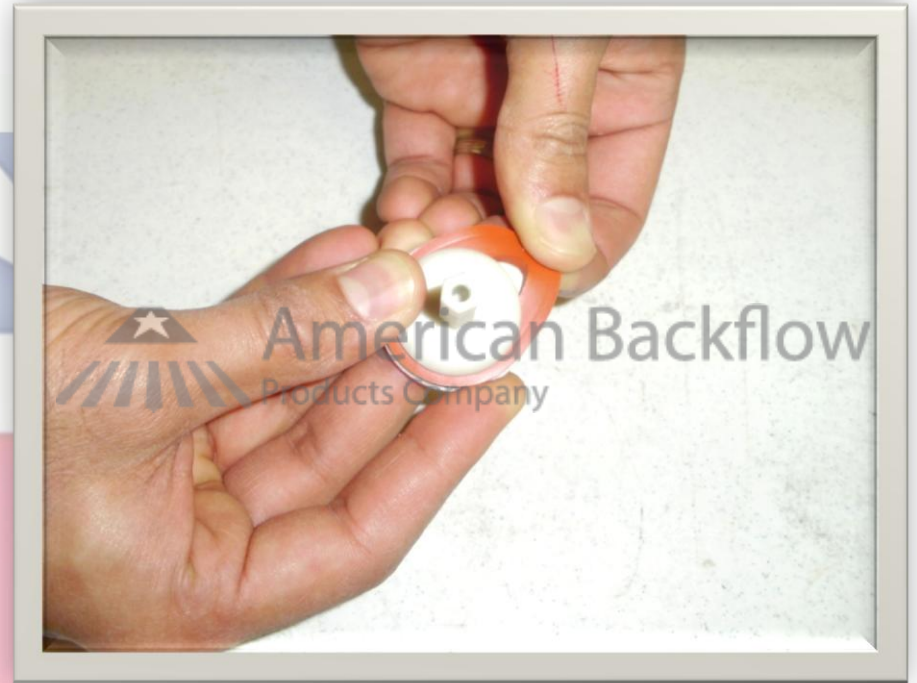
Check Disc Replacement

Replace the rubber disc by pulling it from the groove on the poppet.

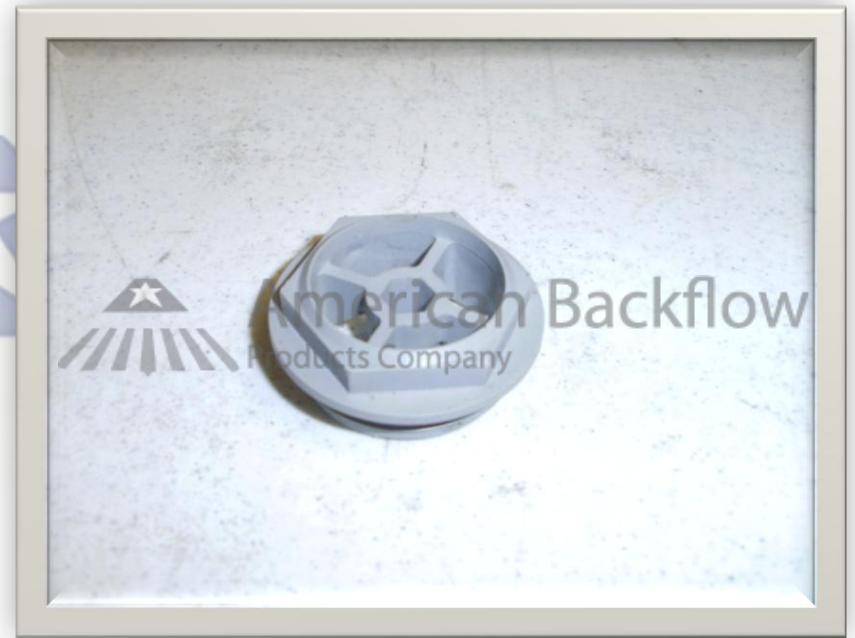
Check Seat Replacement

The check seat is free once the module is disassembled.

If the seat is damaged, the check module must be replaced.

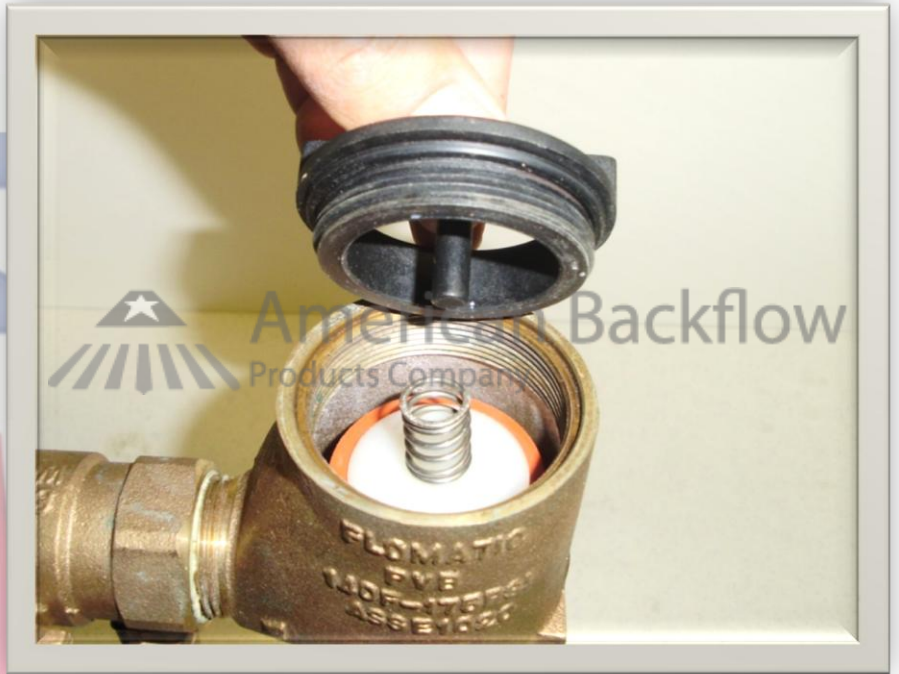
Reassembly Notes

Reassemble in reverse order.

Make sure the bonnet spring is in place.

Make sure the guide stem is inserted into the center of the float.
