Model RP-1EX

2" - 10"

American Backflow
Products Company

Product Overview

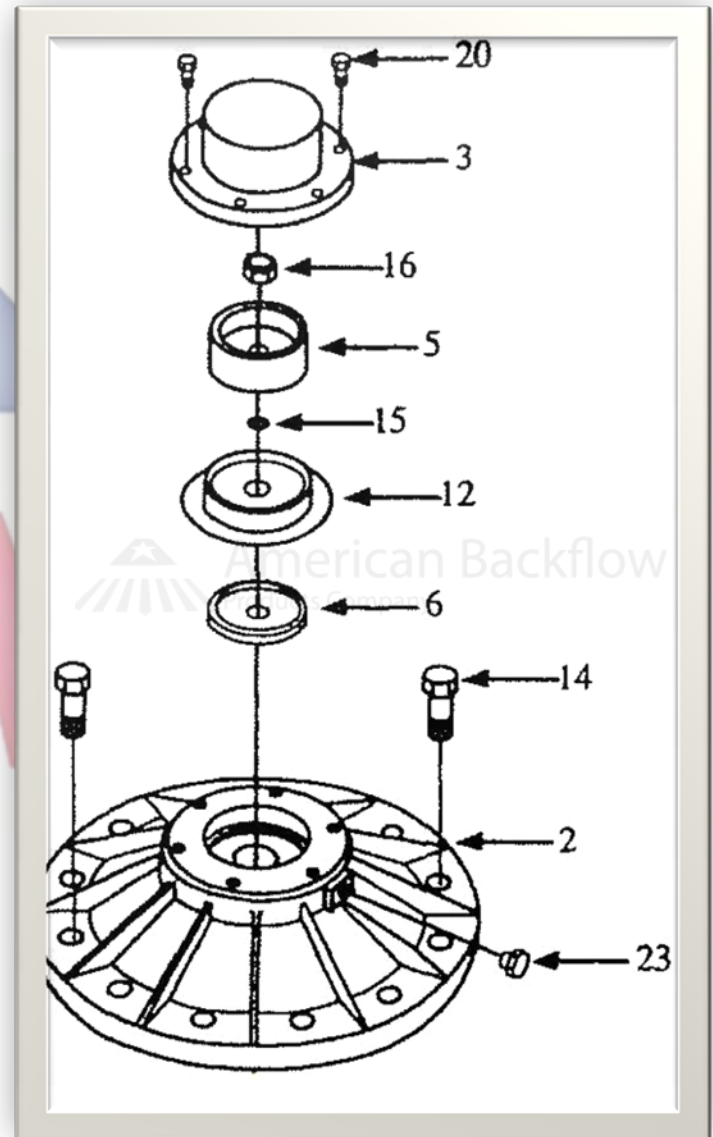
Upper Stem Reassembly

Reassemble the bellofram (12), piston (5), retainer (6) and stem o-ring (15) on the upper stem and replace stem nut.

Position the retainer (6) with its outer lip facing up.

Position the bellofram with the glossy side against the retainer(6). The fabric side against the piston(5)

Position the piston (5) with the recess around the stem hole facing down toward the o-ring (15).

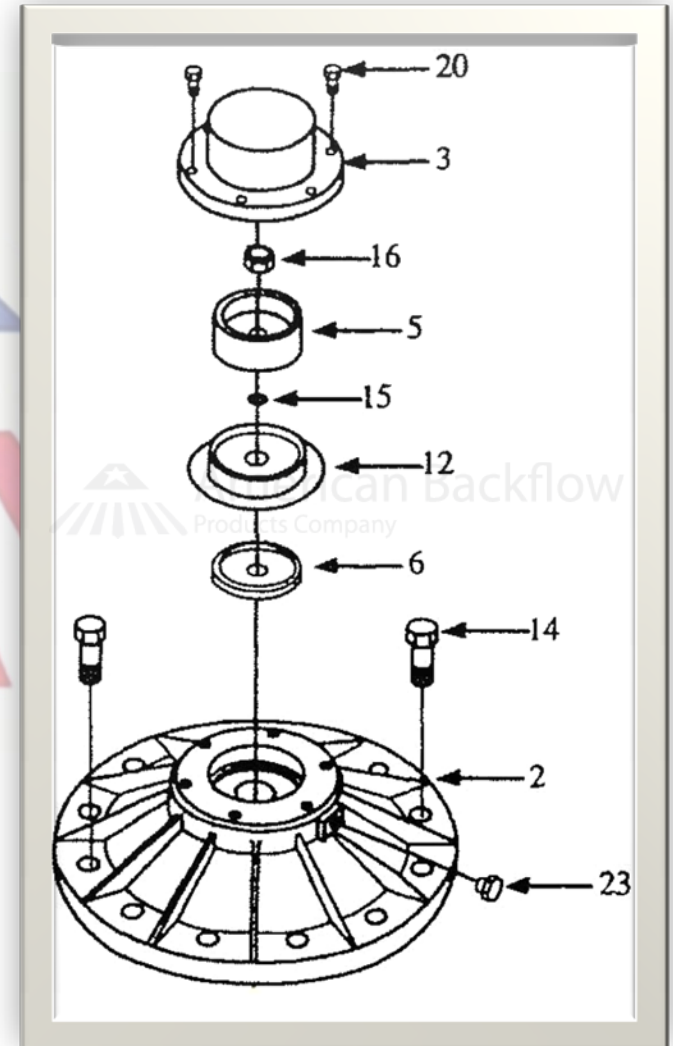
Bellofram Reassembly

Carefully push bellofram(12)
“brim” straight down over itself
so that the “brim” is flat and
smooth against the
intermediate body.

Make sure the bellofram is not
twisted or wrinkled.

Install cover (3) so that weep
hole faces out away from
backflow.

Do not rotate cover after
placing over the “brim”, this can
twist and tear the bellofram.
