Model RP-1

2" - 10"

American Backflow
Products Company

Product Overview

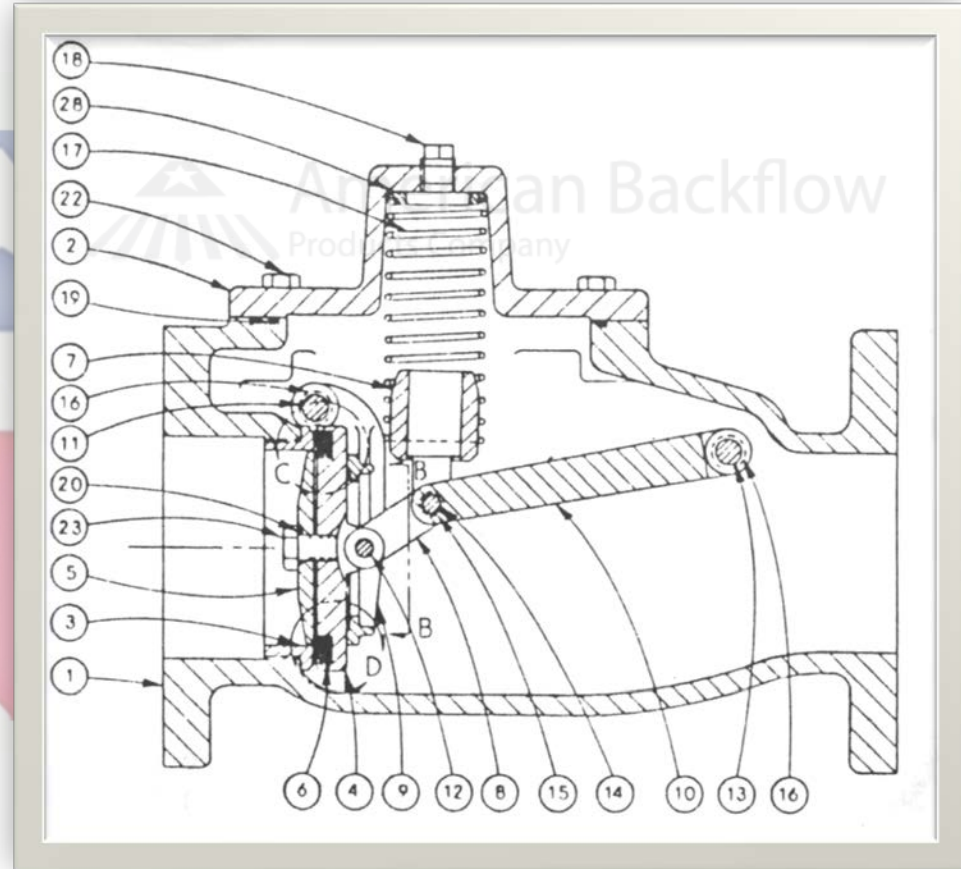
Check Valve Removal

Remove the two pipe plugs on each side of the valve body, to expose the lever arm pin (item 13) and the hinge pin (item 11).

Using a brass rod (smaller in diameter than the pins), gently tap out the rear lever arm (item 13) pin first.

CAUTION: Support the lever arm (item 10) while completely removing the lever arm pin. Let the lever arm rest gently in the bottom of the check valve.

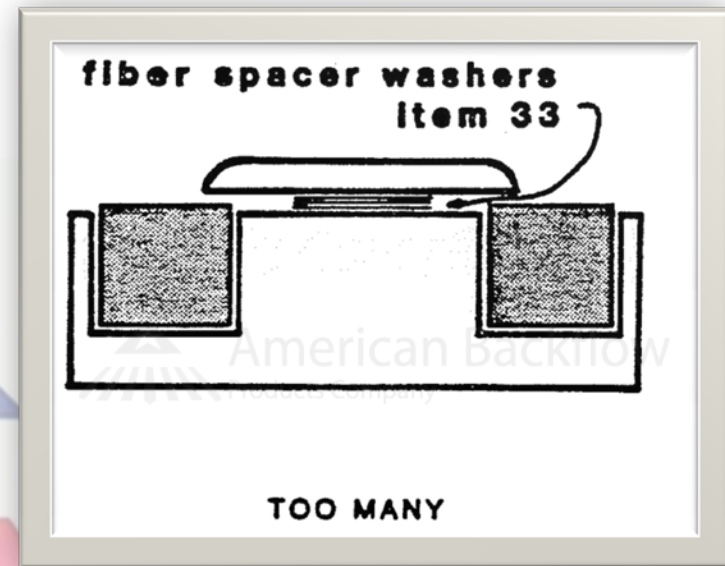
Check Disc Replacement

When installing a new check disc, fiber spacer washers between the retainer and guide MAY or MAY NOT be required.

Fiber spacer washers (item 33) are installed to ensure the proper “squeeze” on the disc (item 6).

Too many washers will not allow sufficient squeeze on the disc (not a water tight seal). This will cause the check valve to fail.

Too few washers between the guide and retainer can generate TOO MUCH squeeze on the disc, causing it to bulge around the guide. This will also cause the check to fail.

Proper squeeze on the disc is achieved when the disc cannot be rotated and no bulge appears.

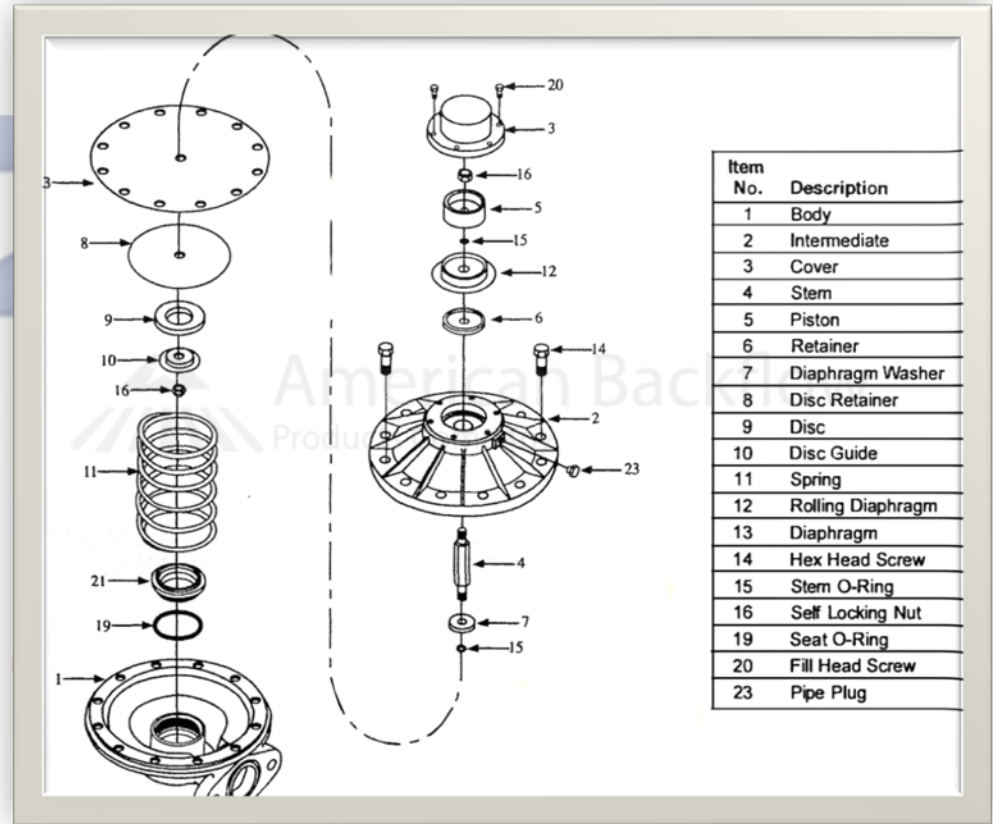
Relief Valve Cover Removal

The intermediate body (item 2) is secured by cap screws and sealed by the diaphragm.

There is a slight spring load on this cover, so exert pressure downward on the cover as the cap screws are removed.

The RV stem assembly is mounted through the intermediate body.

The RV spring is free once cover is removed.

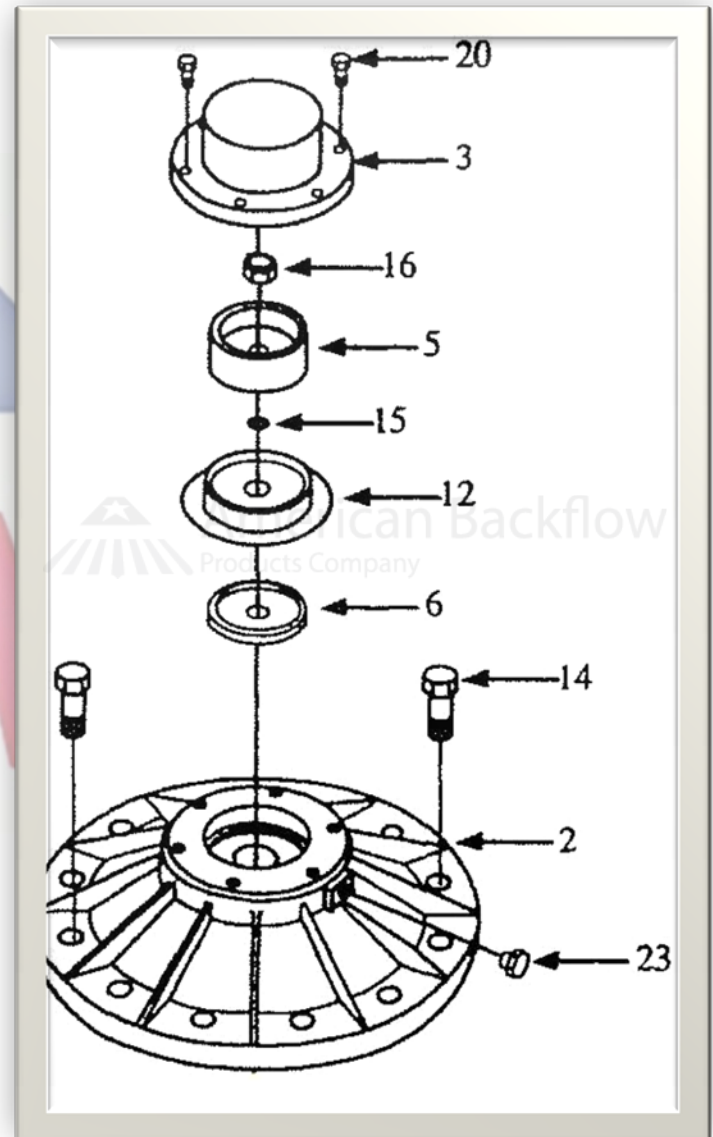
Upper Stem Reassembly

Reassemble the bellofram (12), piston (5), retainer (6) and stem o-ring (15) on the upper stem and replace stem nut.

Position the retainer (6) with its outer lip facing up.

Position the bellofram with the glossy side against the retainer(6). The fabric side against the piston(5)

Position the piston (5) with the recess around the stem hole facing down toward the o-ring (15).

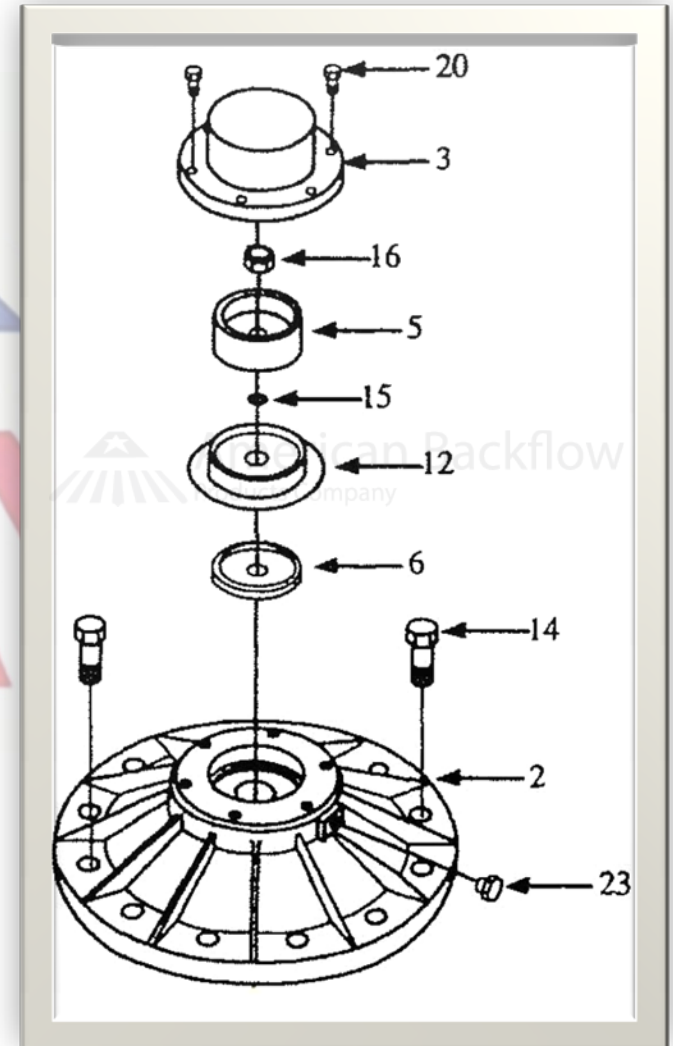
Bellofram Reassembly

Carefully push bellofram(12)
“brim” straight down over itself
so that the “brim” is flat and
smooth against the
intermediate body.

Make sure the bellofram is not
twisted or wrinkled.

Install cover (3) so that weep
hole faces out away from
backflow.

Do not rotate cover after
placing over the “brim”, this can
twist and tear the bellofram.
