Model RP-2

$\frac{3}{4}$ " - $1 \frac{1}{2}$ "

American Backflow
Products Company

Product Overview

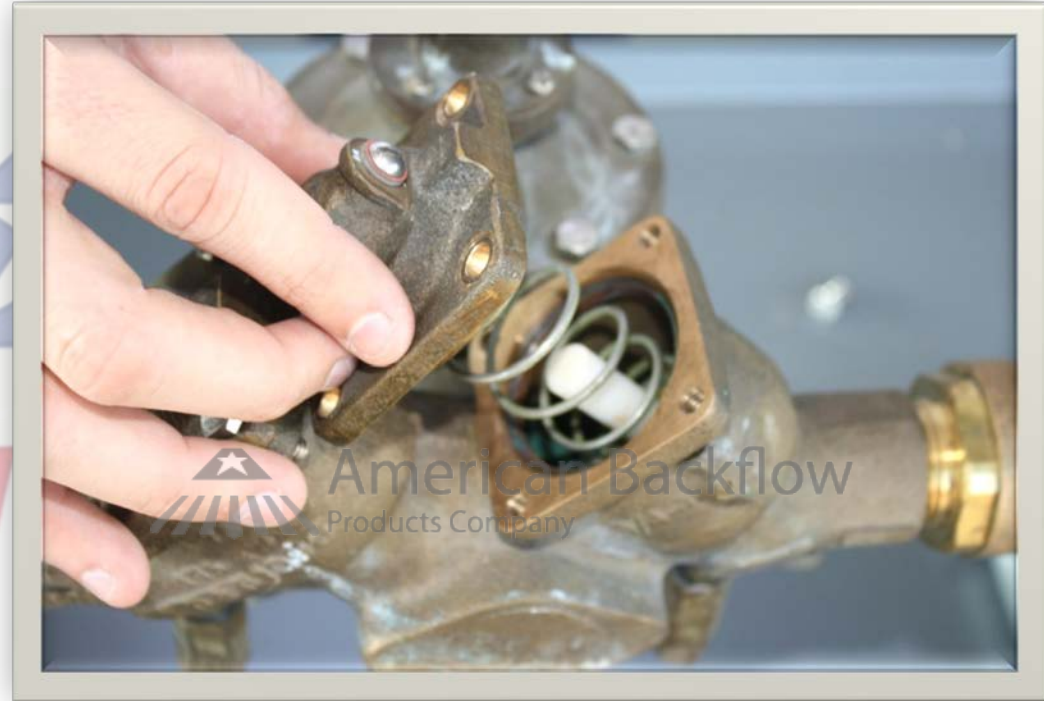
Check Cover Removal

The check covers are secured by 4 cap screws and sealed by an o-ring.

The covers are spring loaded.

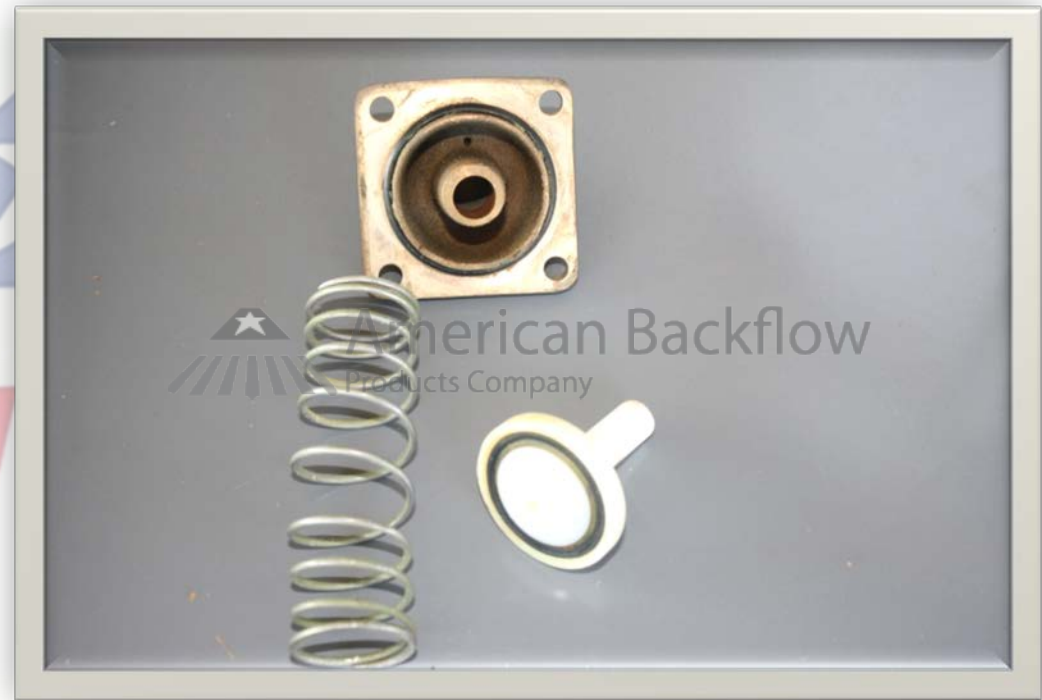
Check Valve Removal

Poppet style checks.

Once the cover is removed the poppet and spring are free.

Green Spring indicates first check.

Orange spring indicates second check.

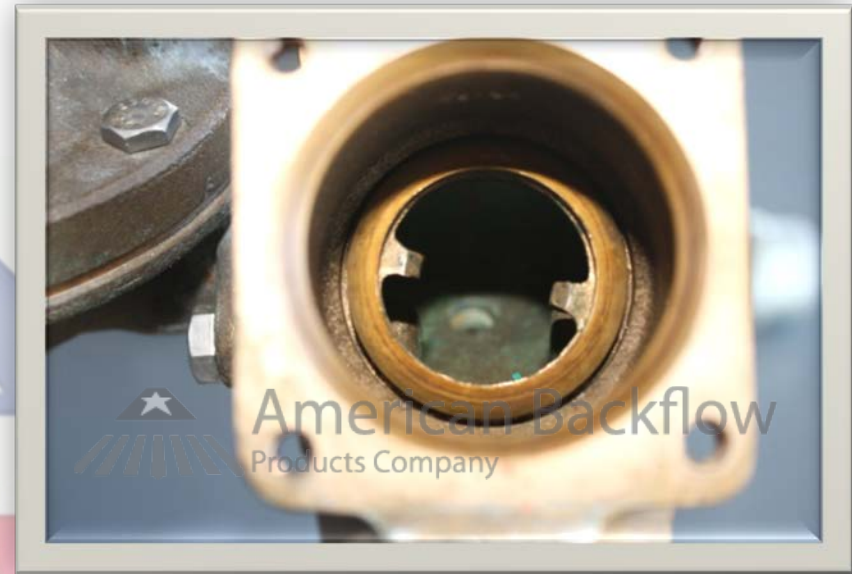
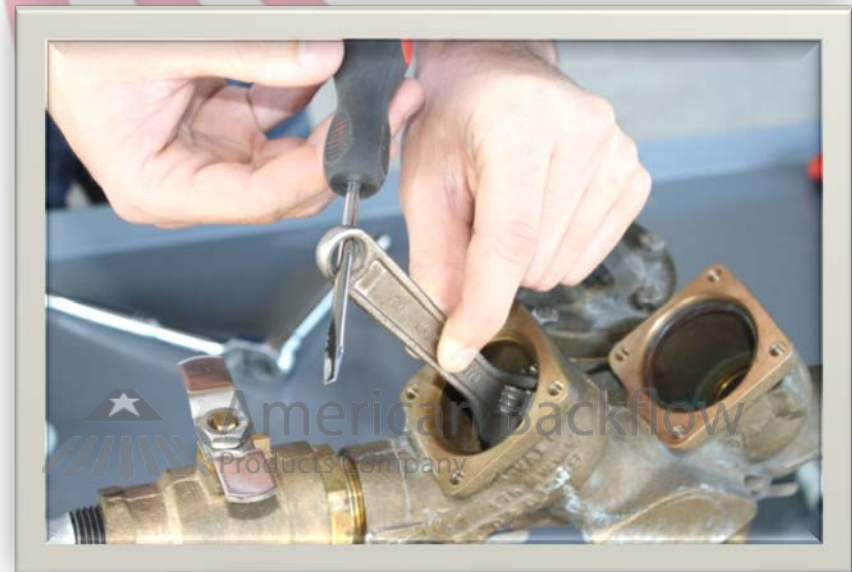
Check Seat Service

Check seats are o-ring sealed and threaded into the body.

Replacement seats are no longer in production.

Very fine nicks on the seating edge can be restored by slowly working 400 wet or dry sandpaper on the beveled edge of the seat.

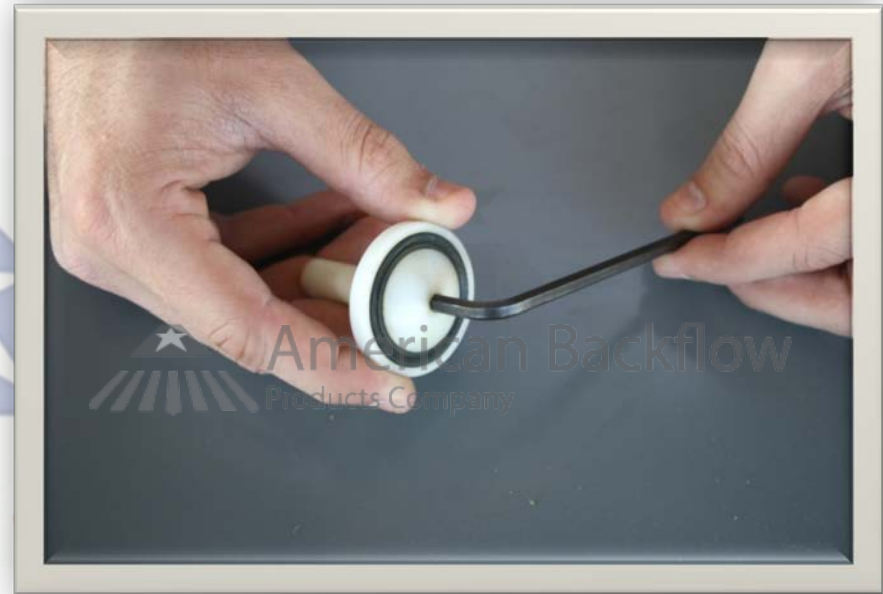
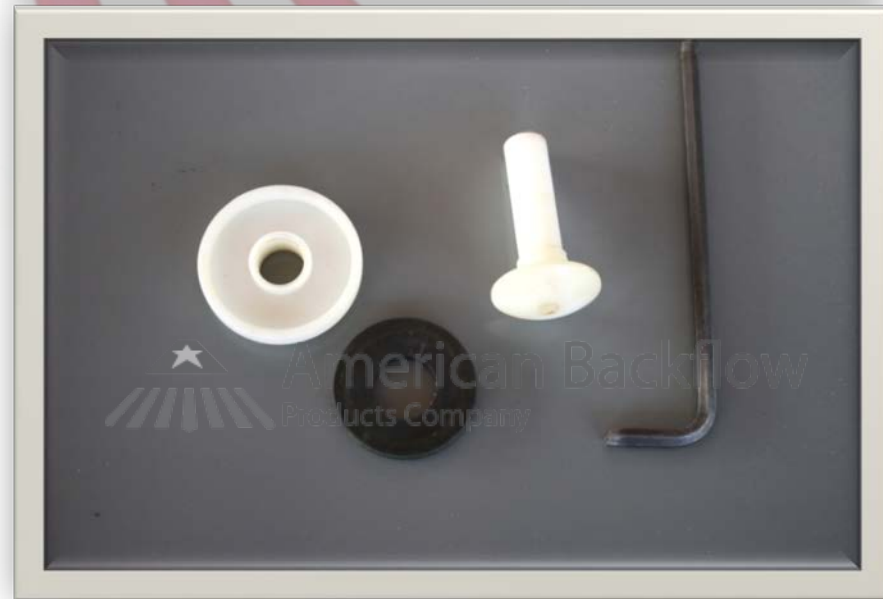
Check Disc Replacement

Hold the disc retainer in one hand and with an allen wrench, unscrew the stem from the disc retainer.

Replace the disc as necessary.

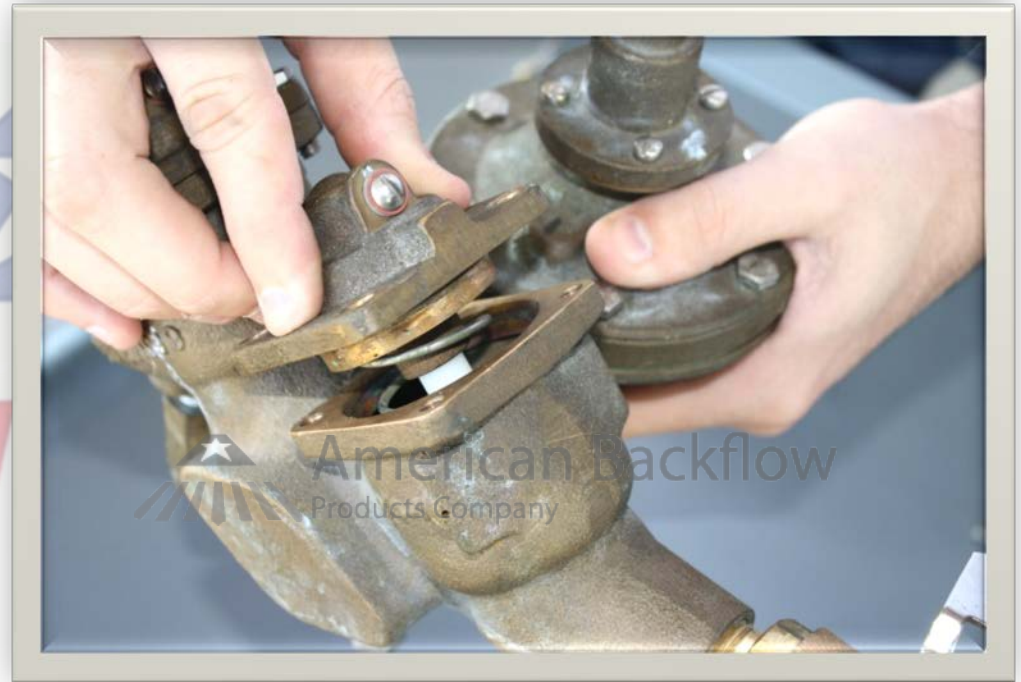
Check Valve Reassembly Notes

Inspect and clean the guide bore on the cover.

The stem must move freely in the guide bore.

Reassemble in reverse order.

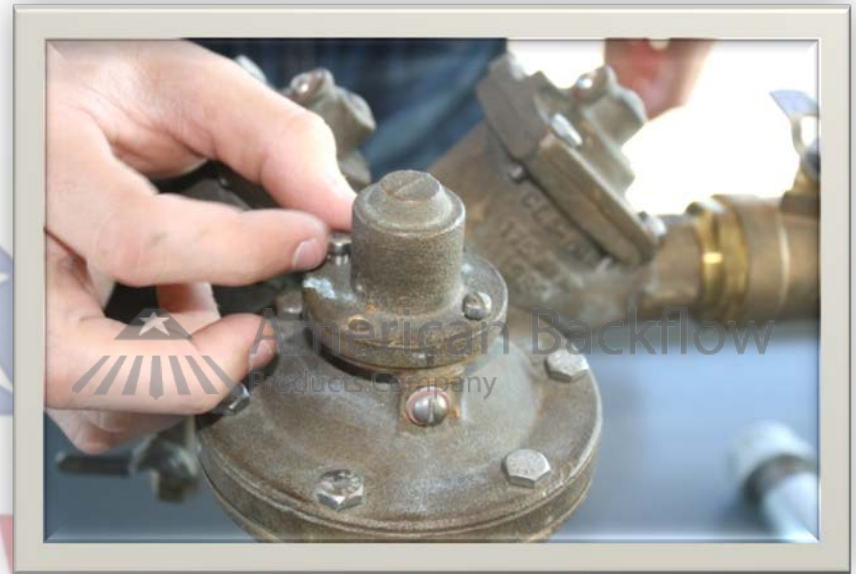
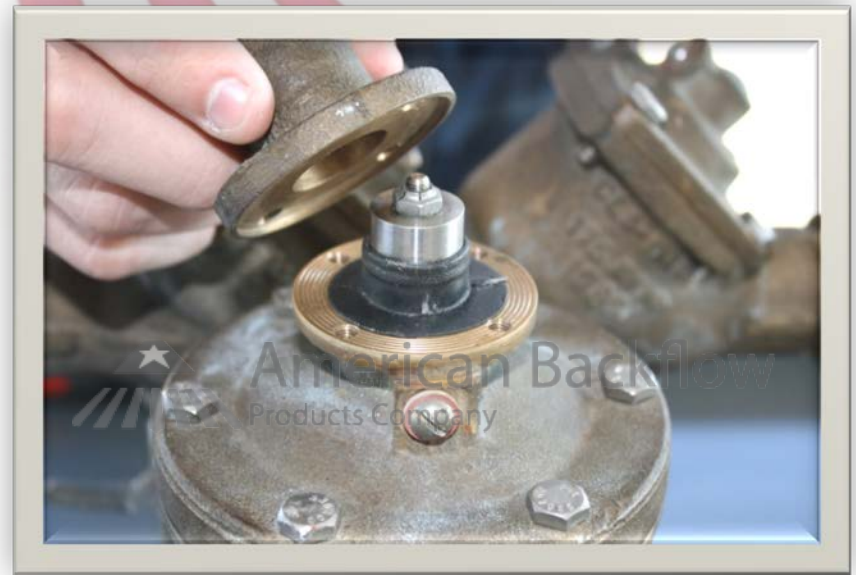
Relief Valve Cover Removal

The CDHS-20 RV has two covers. The belloram cover (item 3) and the intermediate body or “diaphragm cover” (item 2).

The belloram cover (item 3) is located on top of the RV assembly.

The belloram cover is secured by screws and sealed by the belloram.

There is no spring load on this cover.

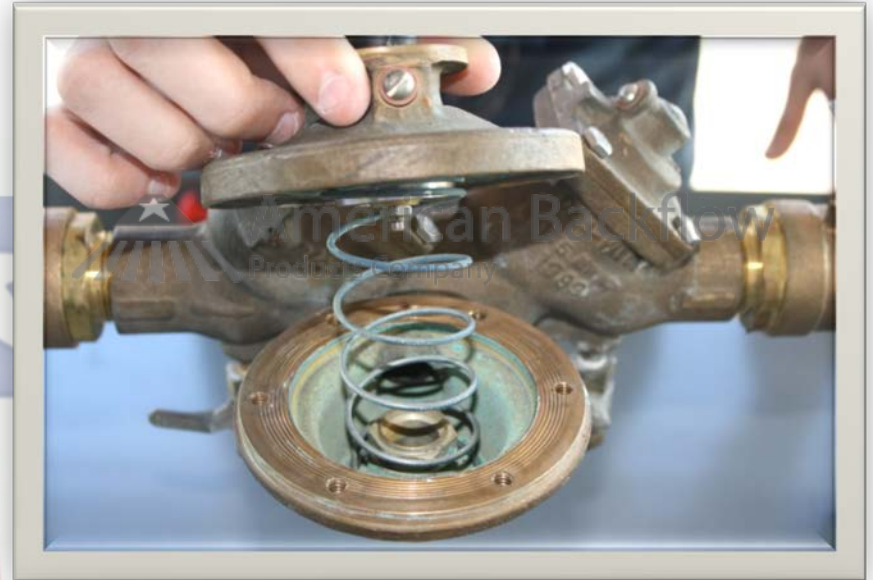
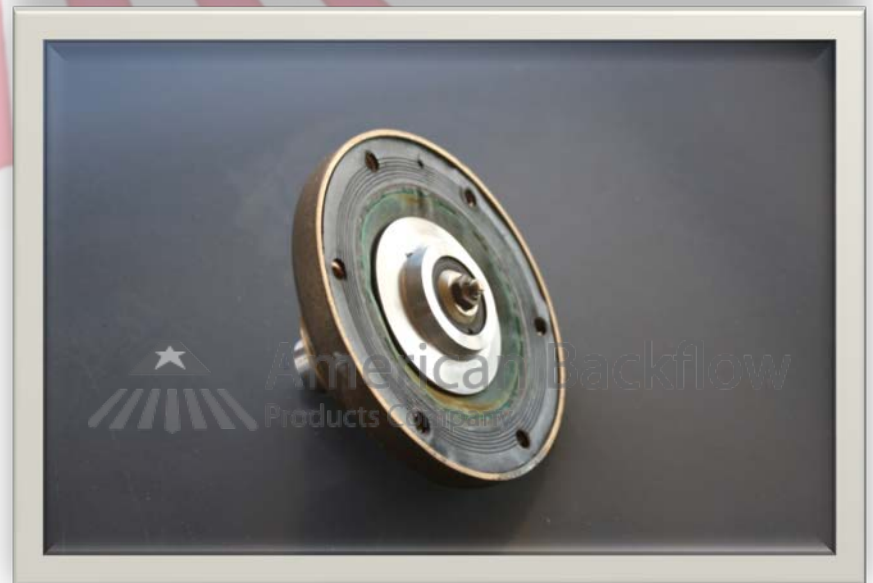
Relief Valve Cover Removal

The intermediate body (item 2) is secured by cap screws and sealed by the diaphragm.

There is a slight spring load on this cover, so exert pressure downward on the cover as the cap screws are removed.

The RV stem assembly is mounted through the intermediate body.

The RV spring is free once cover is removed.

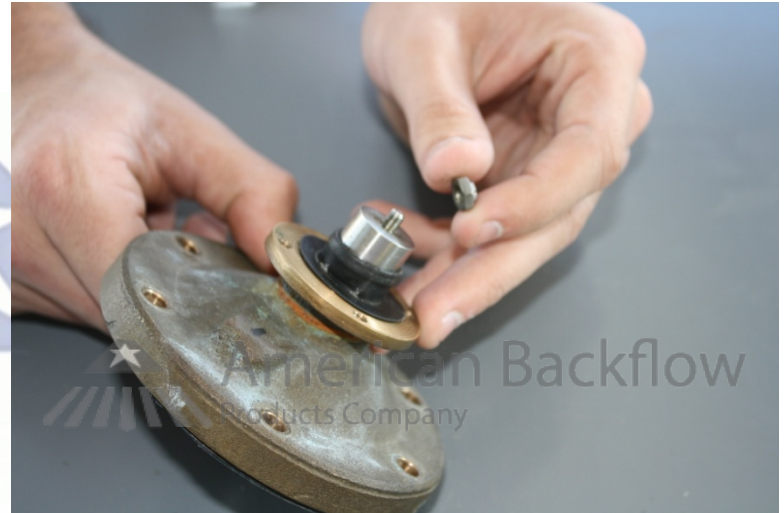
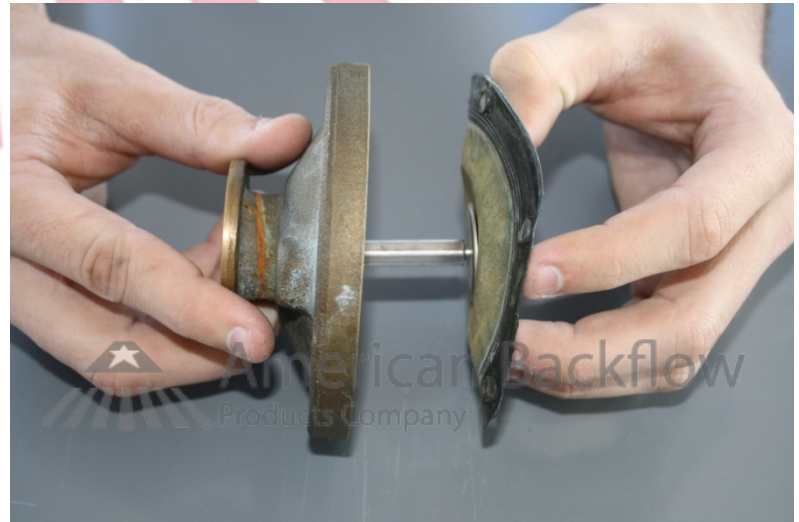
Disassemble RV Stem

- The stem is secured by the upper and lower stem nuts (item 16).
- Remove the upper stem nut first.
- The bellofram, piston and retainer can now be removed from the upper stem.
- Remove the stem along with the diaphragm and disc from the body.

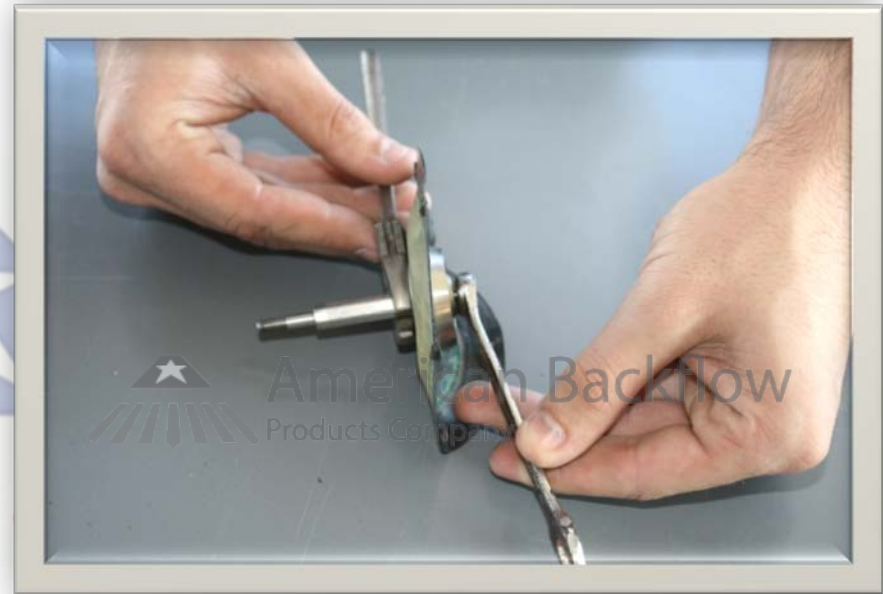
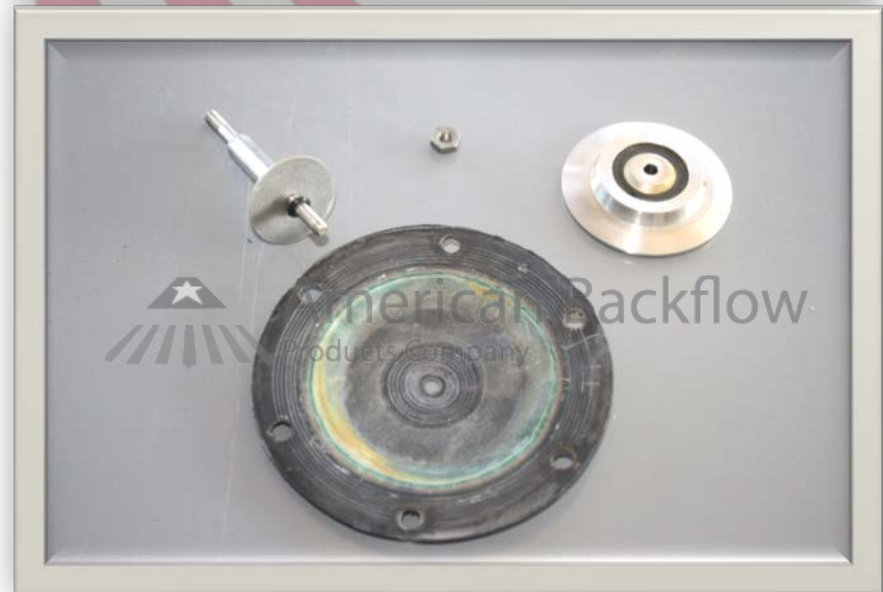
Disassemble RV Stem

Remove lower stem nut
(item 16).

Remove the diaphragm
(item 13), the lower stem
o-ring (item 15) and
washer (item 7) from
stem.

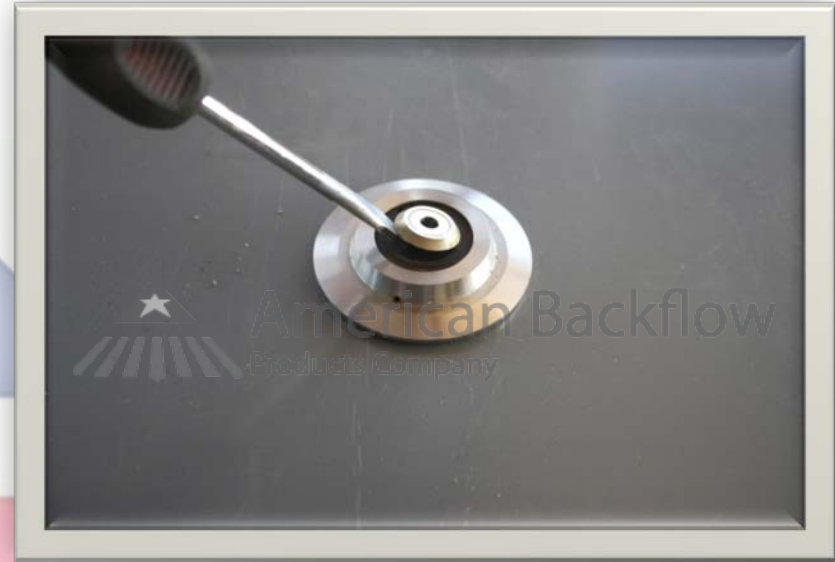
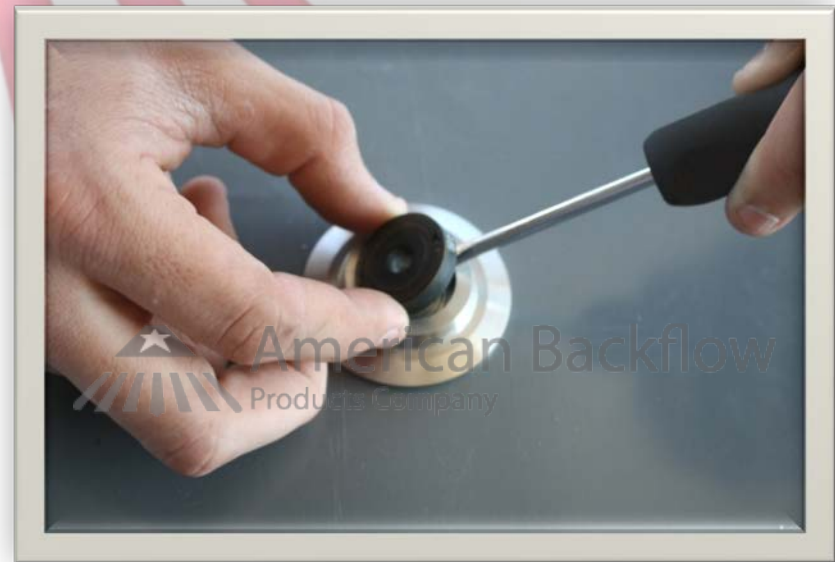
RV Disc Replacement

The RV disc (9), disc retainer (8), and guide (10) are removed as one assembly.

Remove guide and pry disc from retainer.

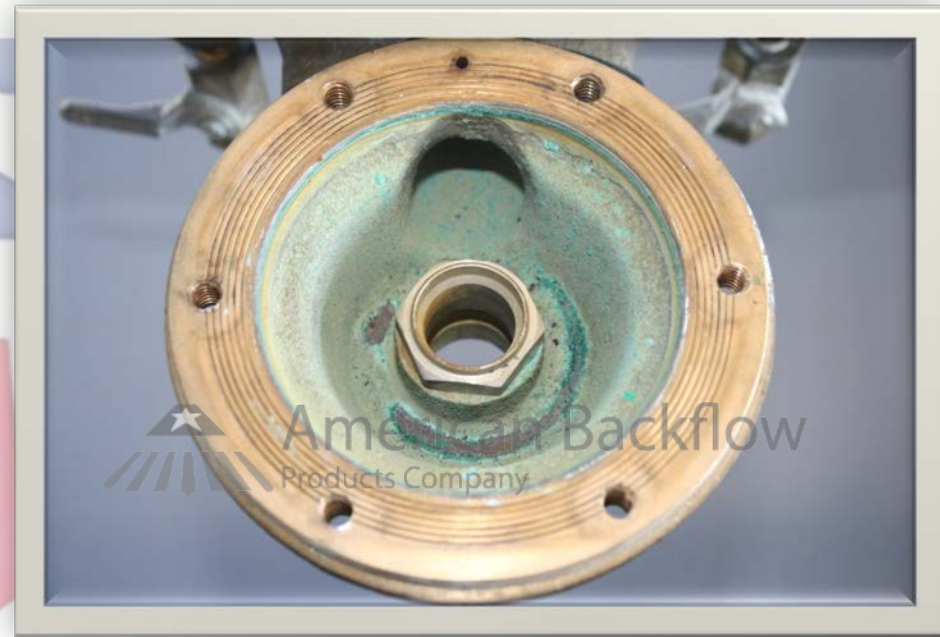
RV Seat Service

The RV seat is o-ring sealed and threaded into the main RV body.

Replacement seats are no longer in production.

Very fine nicks on the seating edge can be restored by slowly working 400 wet or dry sandpaper on the beveled edge of the seat.

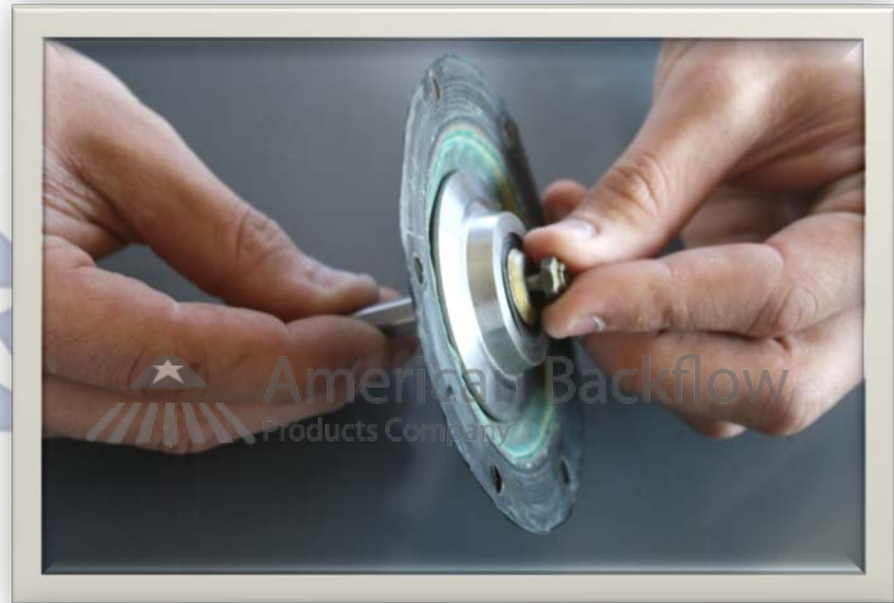
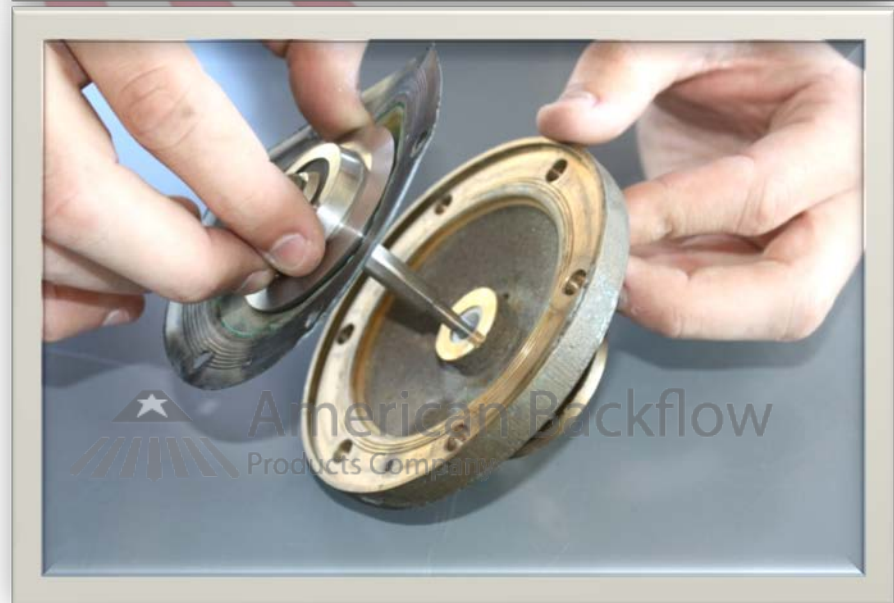
Diaphragm Reassembly

Reassemble the diaphragm (item 13), lower stem o-ring (item 15) and washer (item 7) on the lower stem (4).

Reassemble the RV disc, disc retainer, and guide as one assembly on the lower stem.

The serrated area of the disc retainer (8) is positioned against the diaphragm.

Insert the stem (4) with diaphragm and disc retainer intact, into the intermediate body.

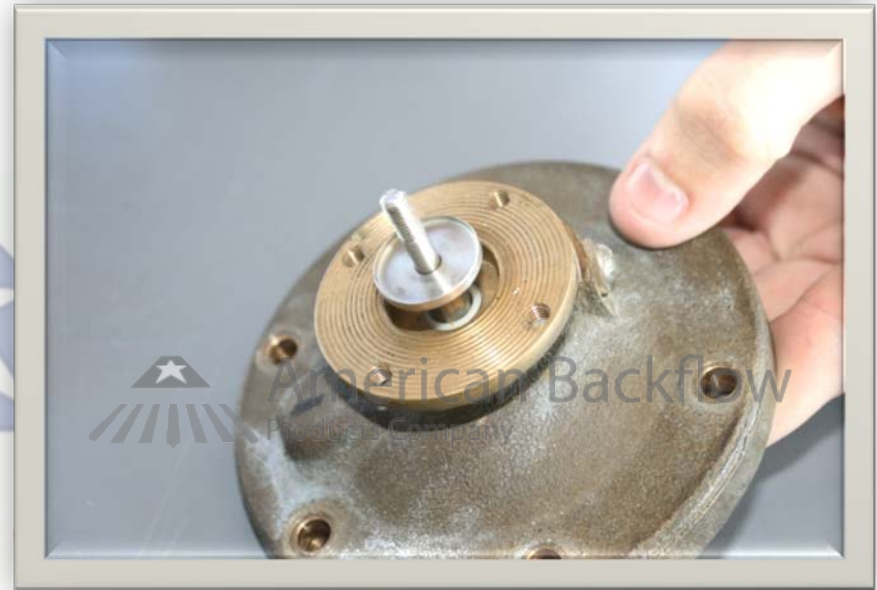
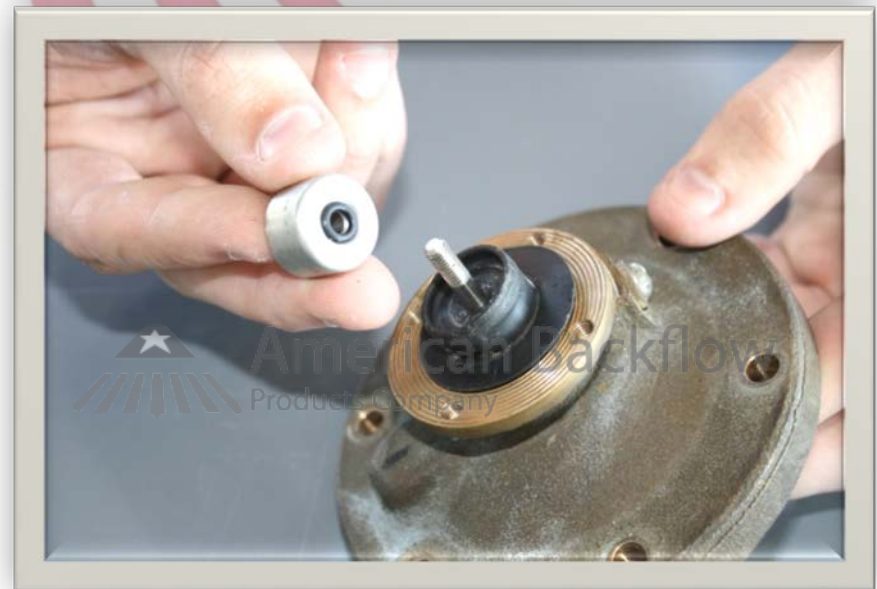
Upper Stem Reassembly

Reassemble the bellofram (12), piston (5), retainer (6) and stem o-ring (15) on the upper stem and replace stem nut.

Position the retainer (6) with its outer lip facing up.

Position the bellofram with the glossy side against the retainer(6). The fabric side against the piston(5)

Position the piston (5) with the recess around the stem hole facing down toward the o-ring (15).

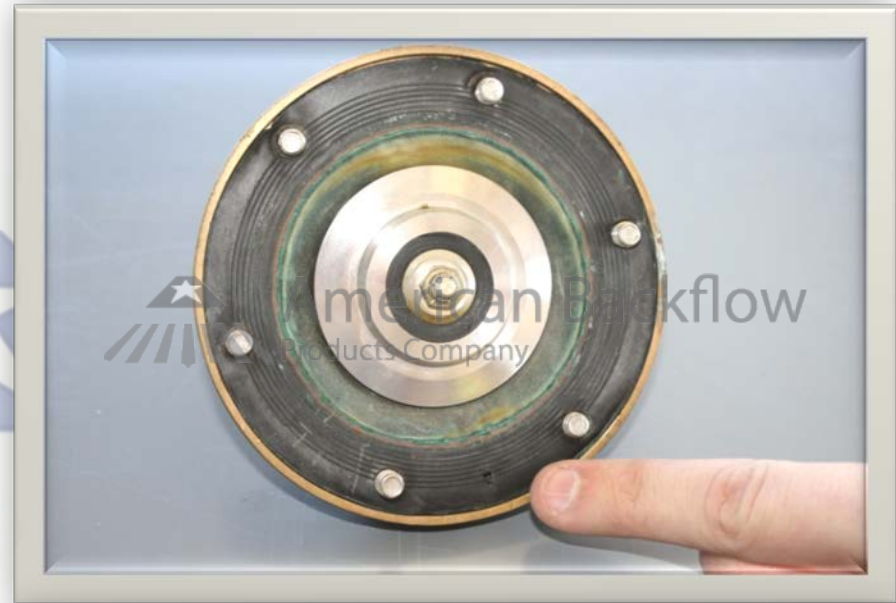
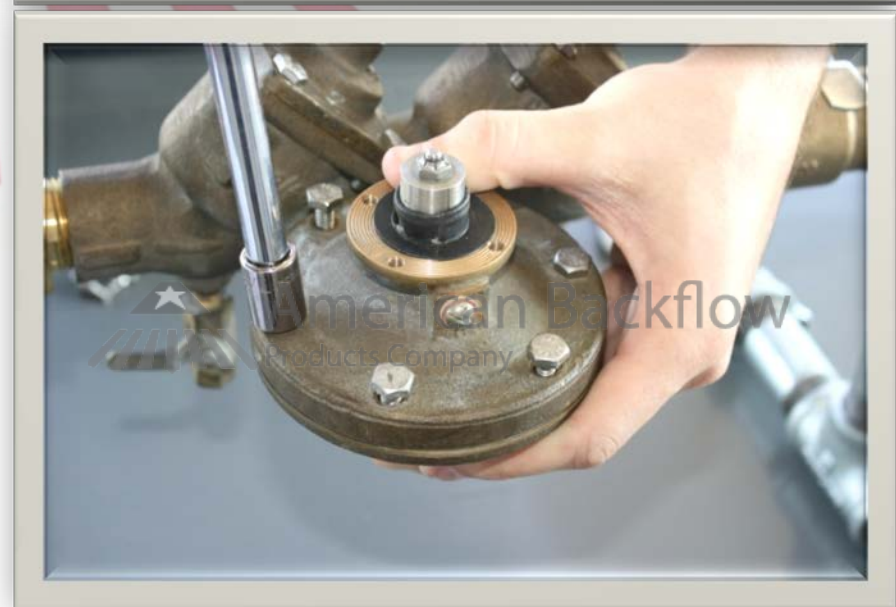
Intermediate Body Reassembly

Position the RV spring over the seat in the main body.

Insert cap screws through intermediate body and diaphragm.

Make sure the sensing passage is aligned properly.

Press the intermediate body down on the main body and start cap screws.

Be sure to evenly cross tighten cap screws.

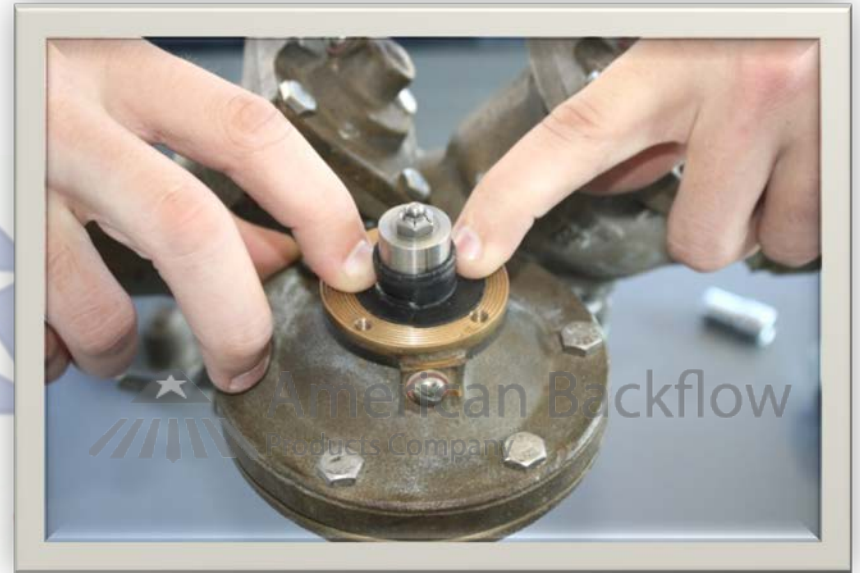
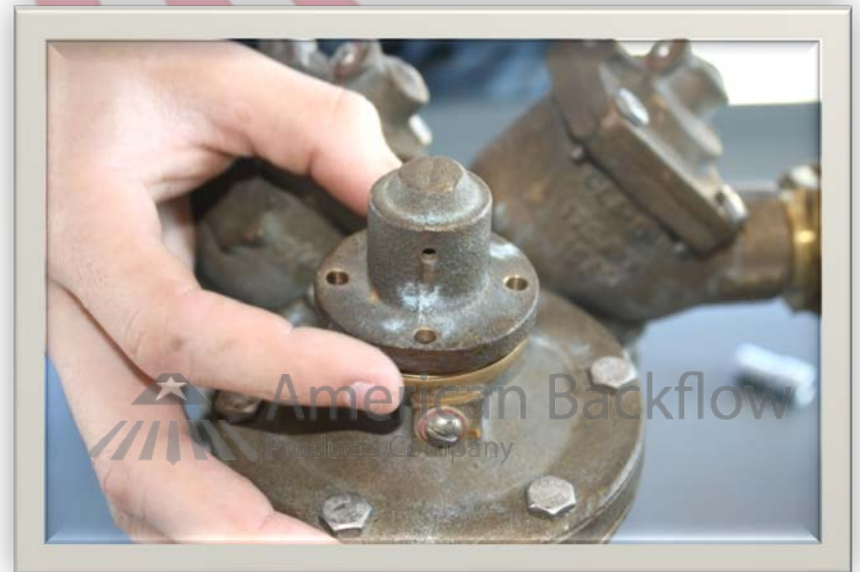
Bellofram Reassembly

Carefully push bellofram(12) “brim” straight down over itself so that the “brim” is flat and smooth against the intermediate body.

Make sure the bellofram is not twisted or wrinkled.

Install cover (3) so that weep hole faces out away from backflow.

Do not rotate cover after placing over the “brim”, this can twist and tear the bellofram.
