975XL3

1/2" - 2"

American Backflow
Products Company

Modification Overview

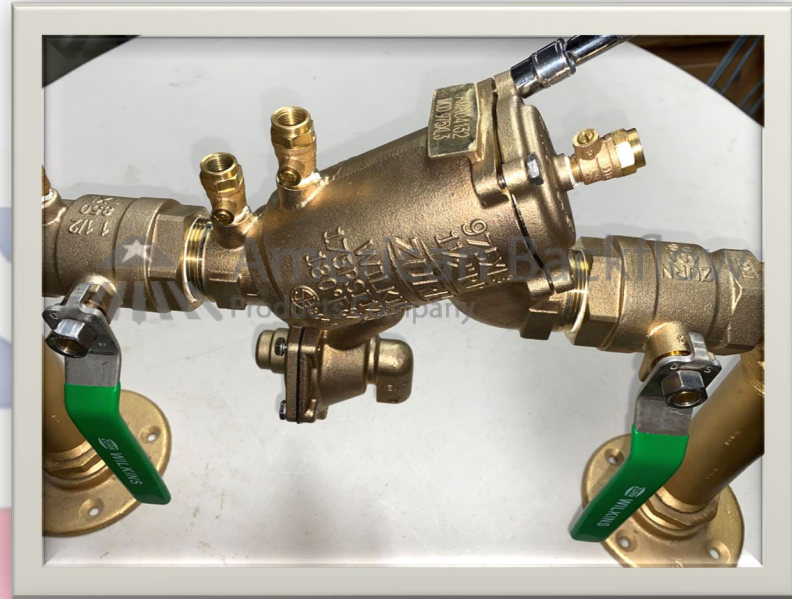
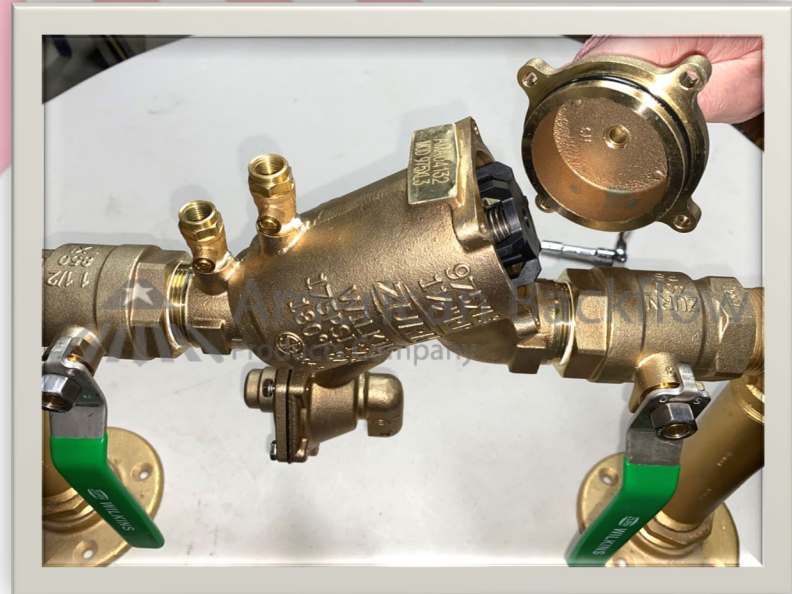
Check Cover Removal

Cover is bolted onto body and o-ring sealed.

There is no spring load on cover.

Loosen bolts and remove cover.

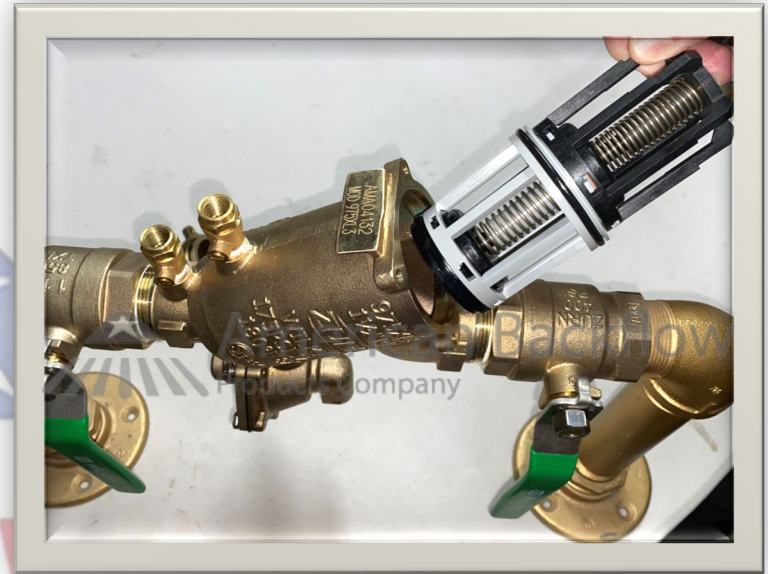
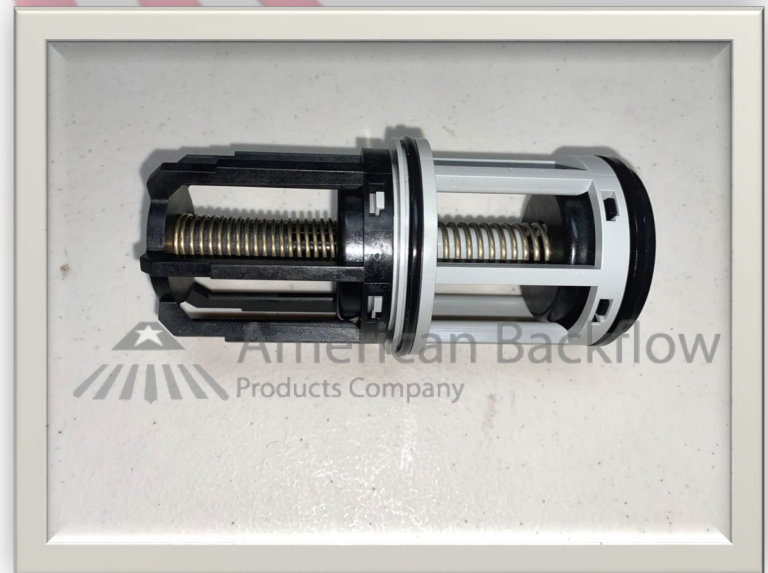
Check Valve Removal

The check cartridge is o-ring sealed and pushed into the body.

Both checks are mounted together.

Pull cartridge straight from body.

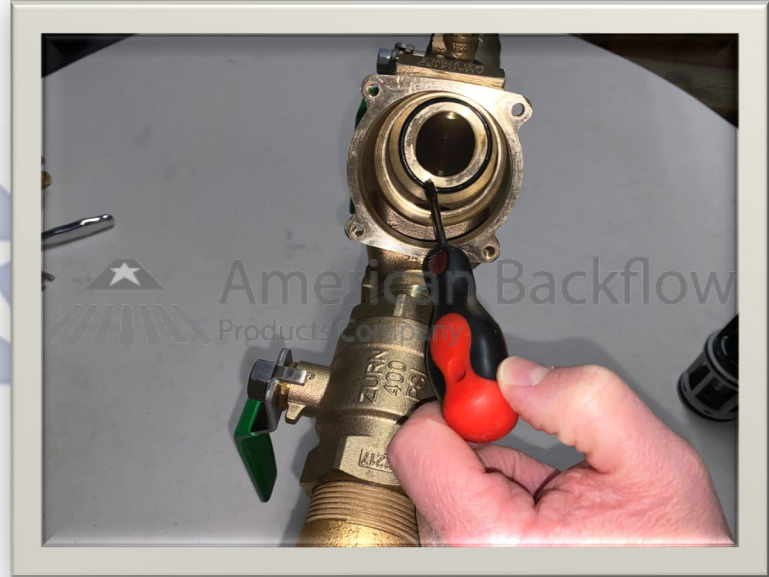
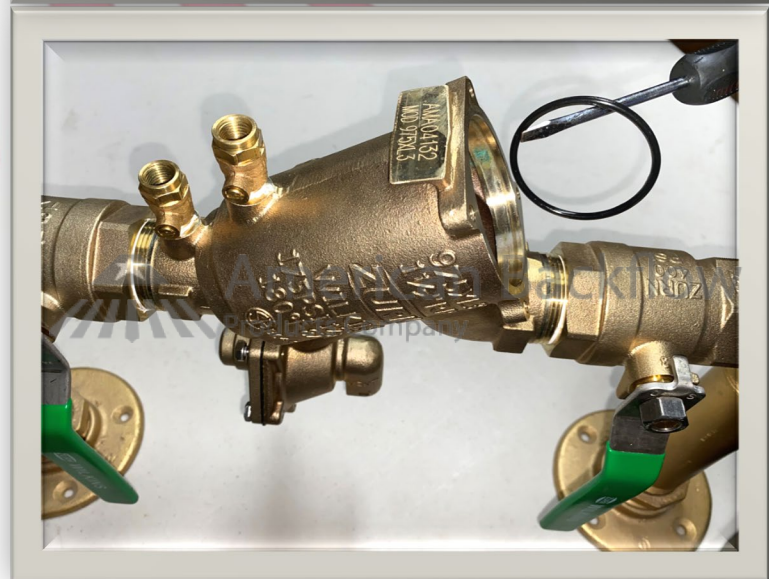
Check Valve Removal

If the check cartridge o-ring does not come out with cartridge, make sure to remove it from the body.

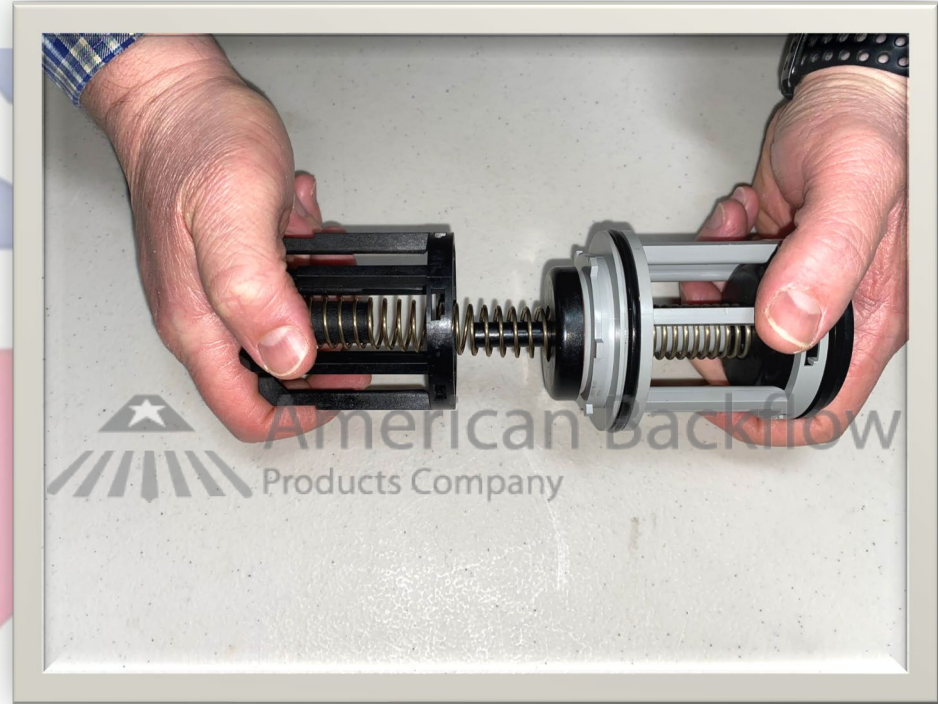
Check Valve Disassembly

Cartridge is spring loaded.

Press and rotate #2 spring retainer to release the #2 poppet and spring.

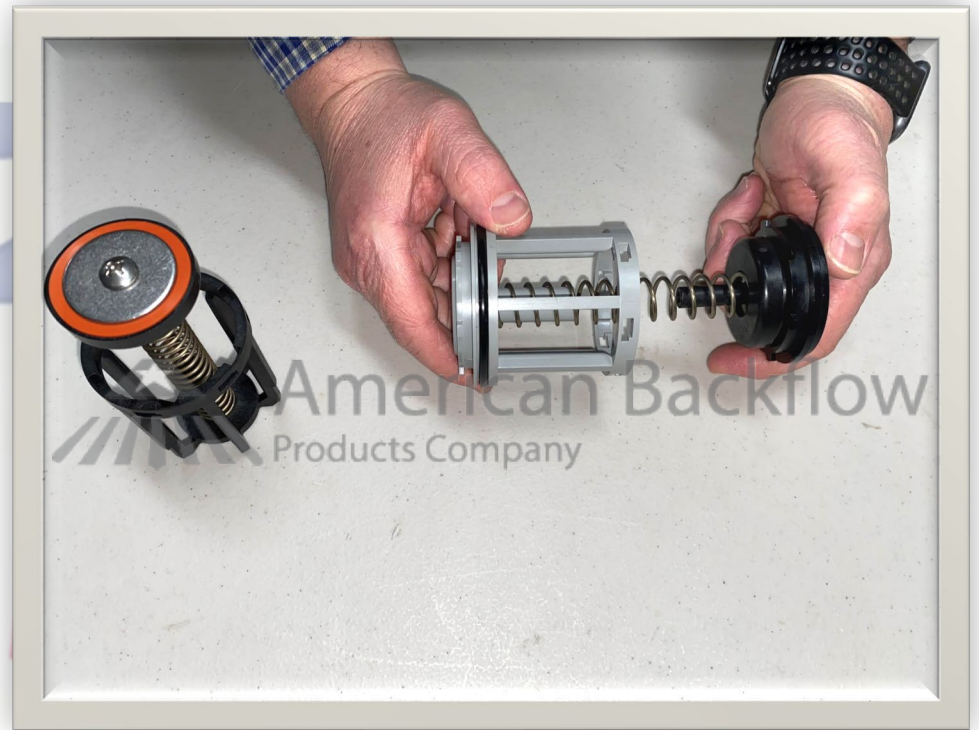
Check Valve Disassembly

Cartridge is spring loaded.

Press and rotate #1 check seat to release the #1 poppet and spring.

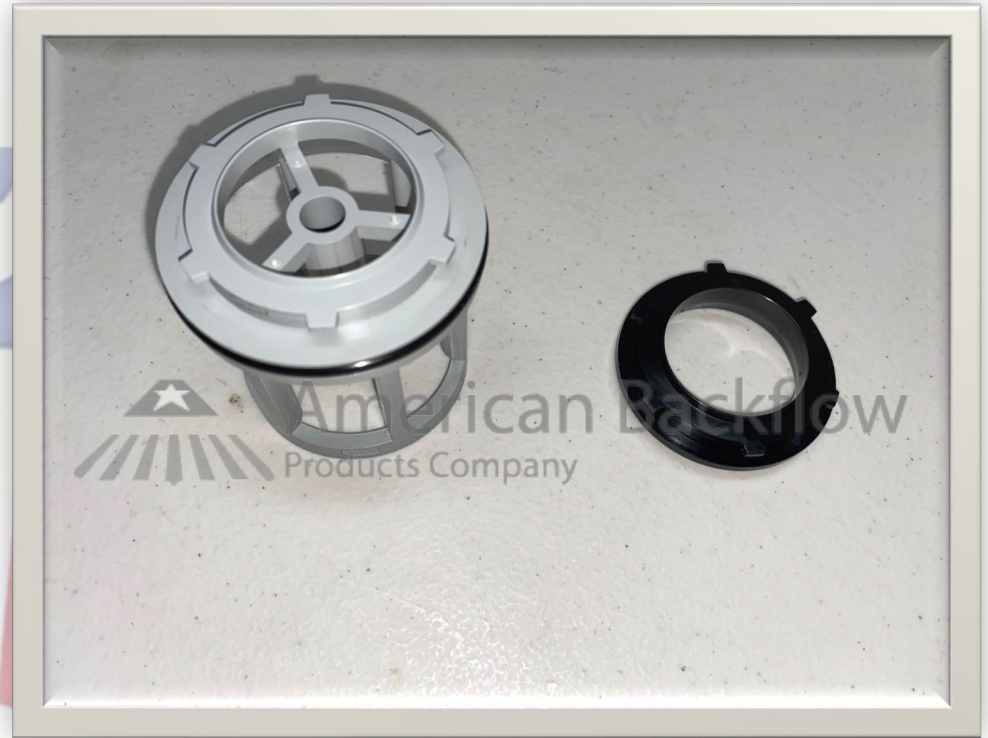
Check Seat Removal

Check seats are part of the cartridge.

If seats are damaged, the cartridge must be replaced.

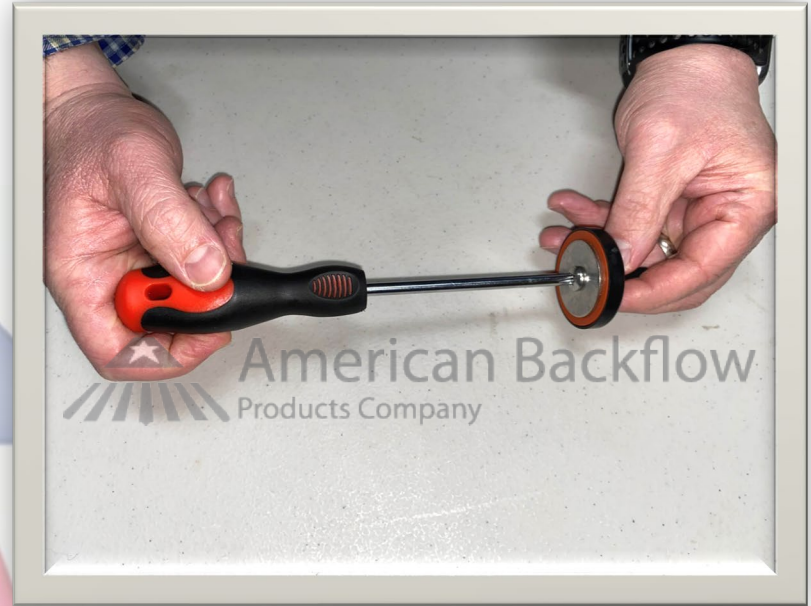
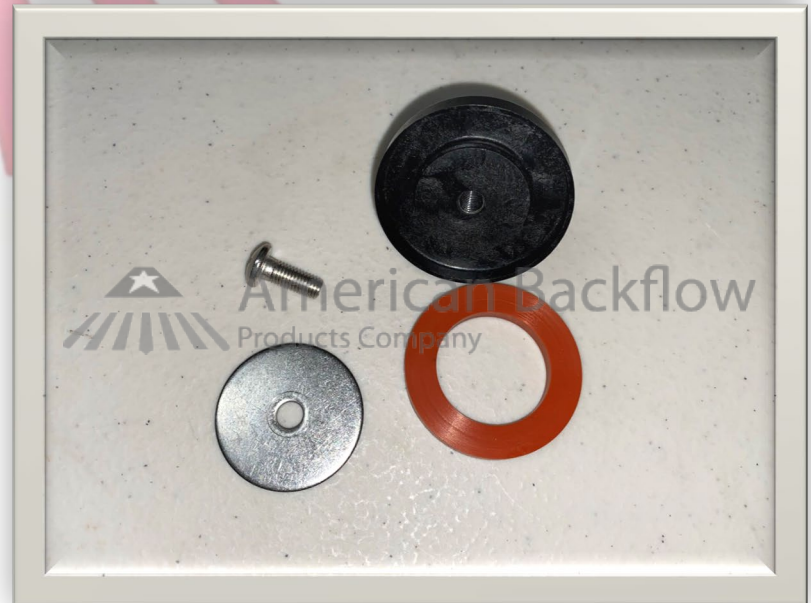
Check Disc Replacement

Remove screw and disc washer from poppet.

Reassemble in reverse order.

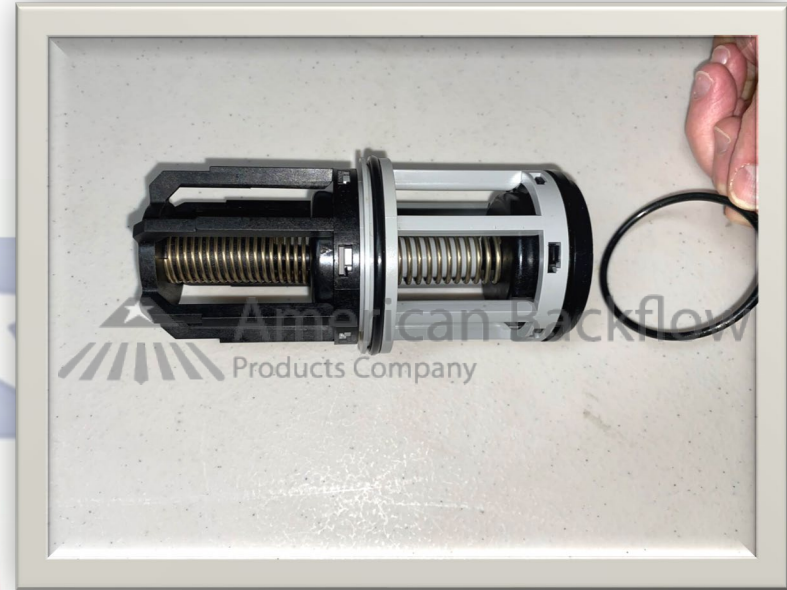
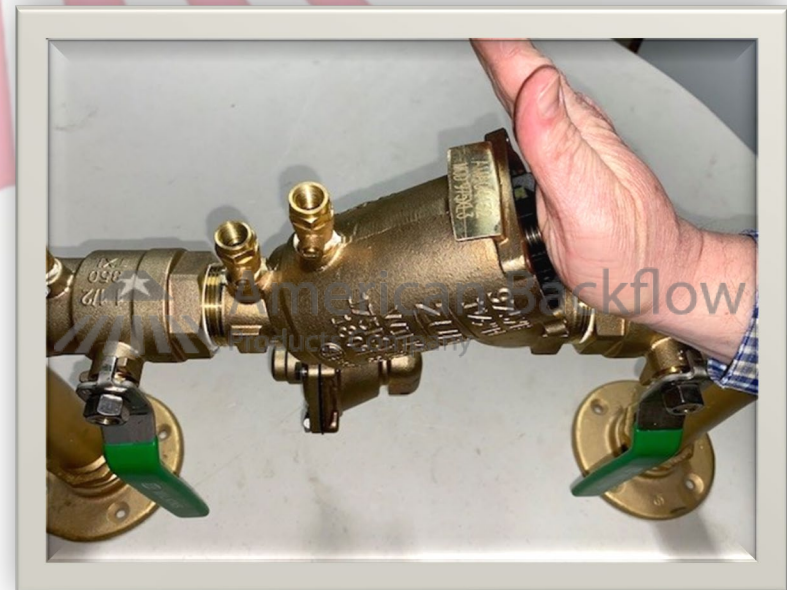
Cartridge Reassembly Notes:

Install cartridge o-ring
on #1 check seat.

Push cartridge into body
until it seats into the
body.

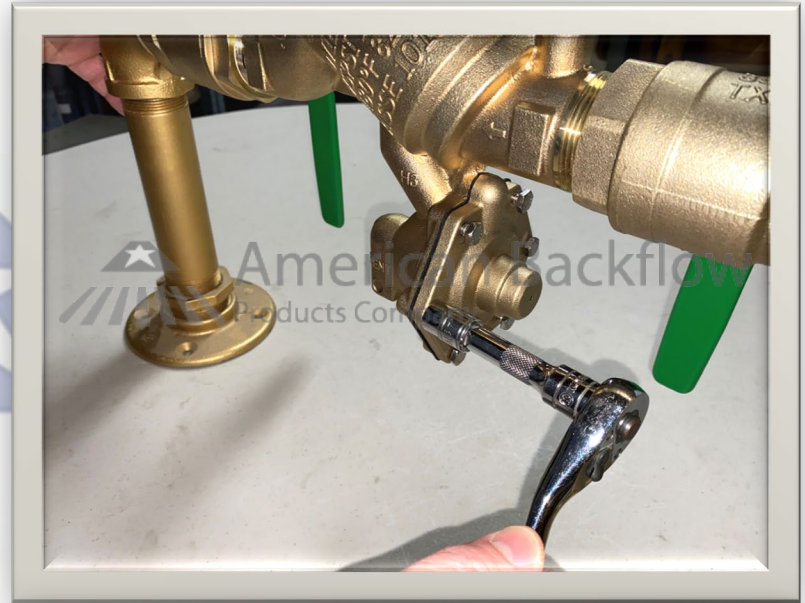
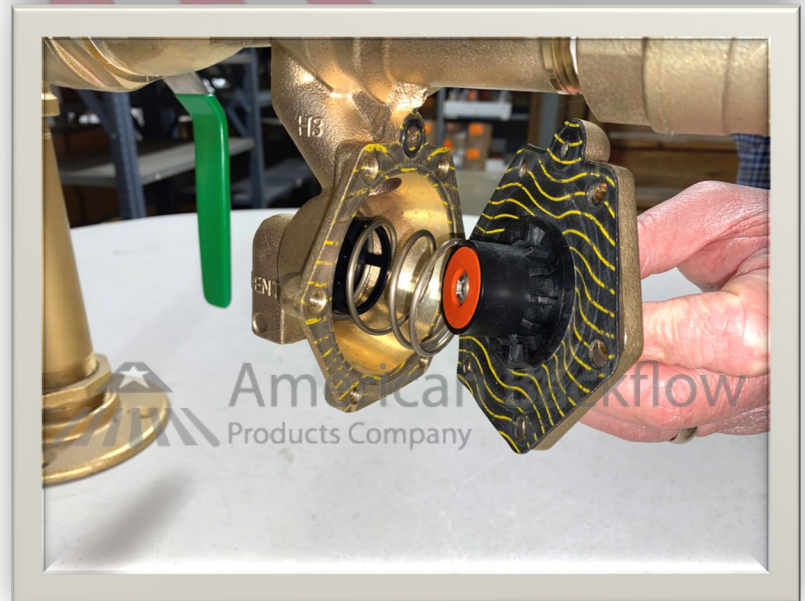
RV Cover Removal

Cover is sealed by the diaphragm and has a slight spring load.

Hold cover firmly as the bolts are removed.

$\frac{3}{4}$ " & 1" cover secured by screws.

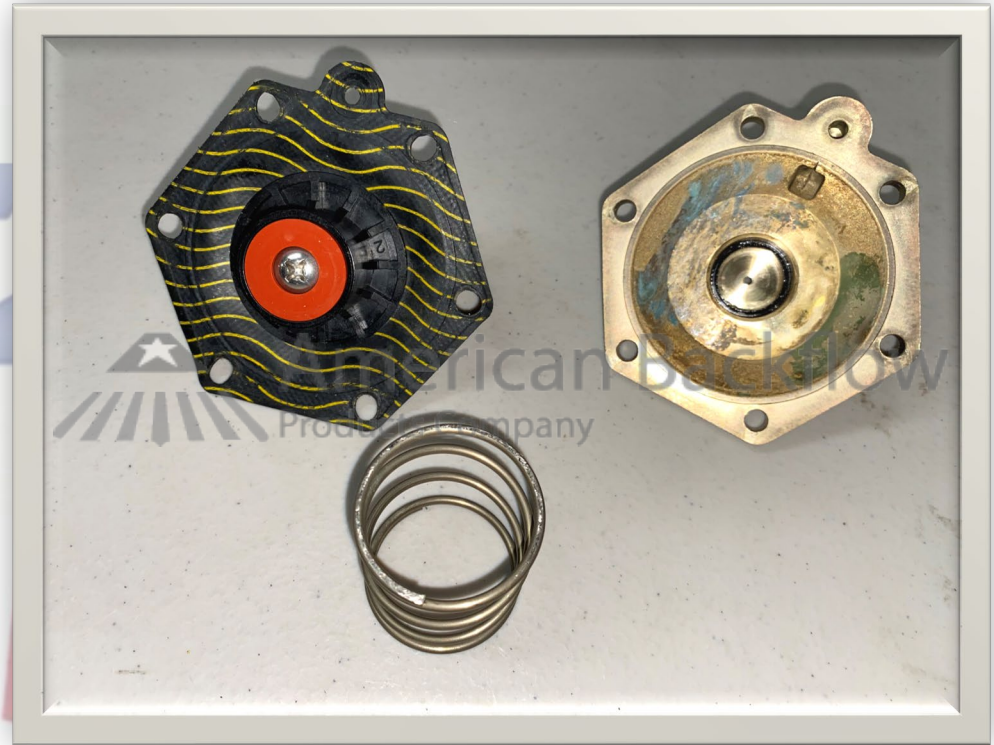
RV Stem Removal

The RV stem assembly and spring are free once cover is removed.

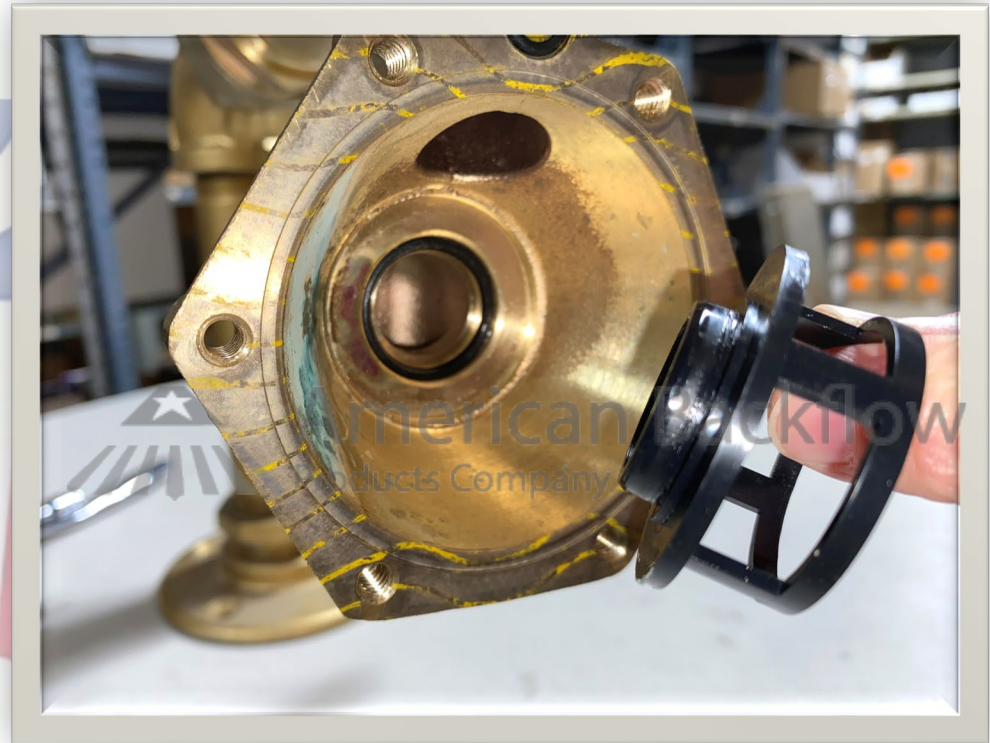
RV Seat Removal

The seat is o-ring sealed and pushed into the body.

No special tools are required.

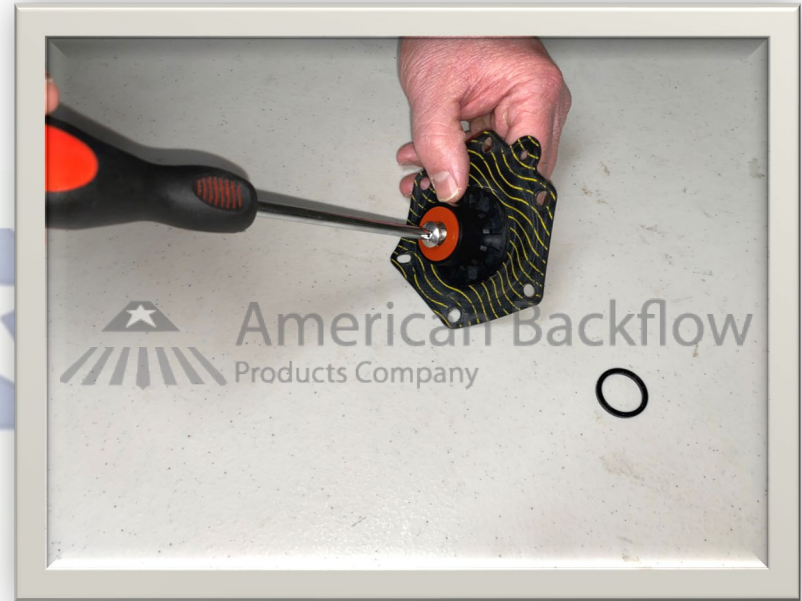
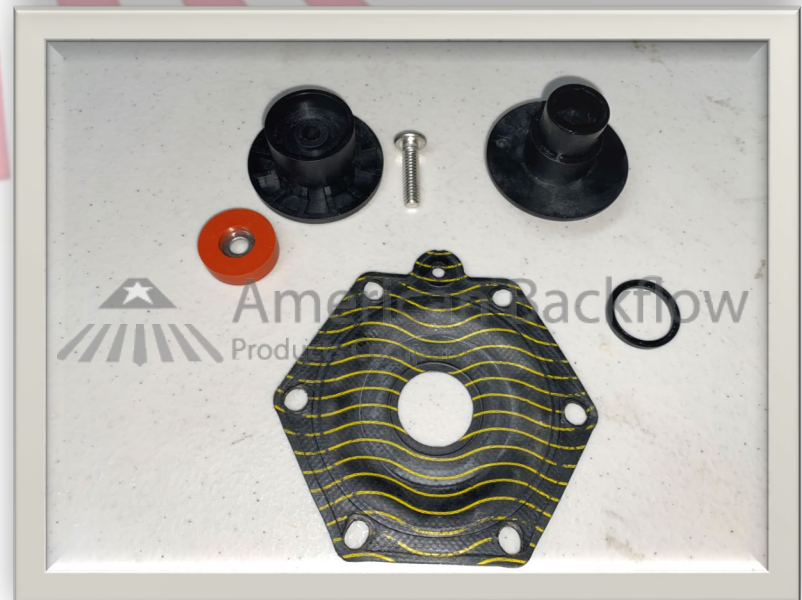
RV Stem Disassembly

Remove the retaining screw.

Pull the disc retainer and stem apart.

Replace diaphragm and seal disc in reverse order.

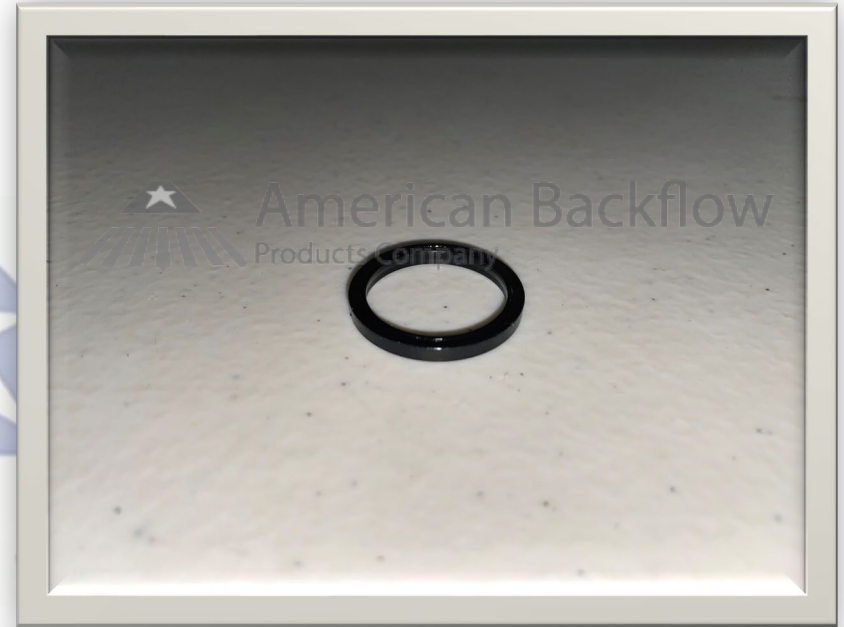
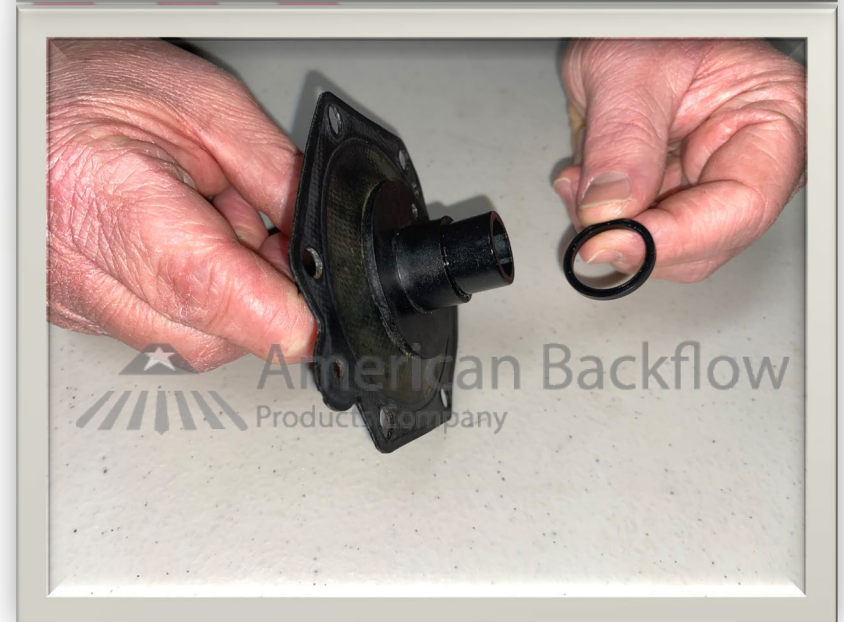
RV Reassembly Notes

The RV stem can use either a “Cup Seal” or an “O-ring” on the upper stem.

** (O-ring is the Update)

If Re-using old Cup Seal, make sure it is installed correctly on the upper stem.

** The groove of the seal must face the stem.

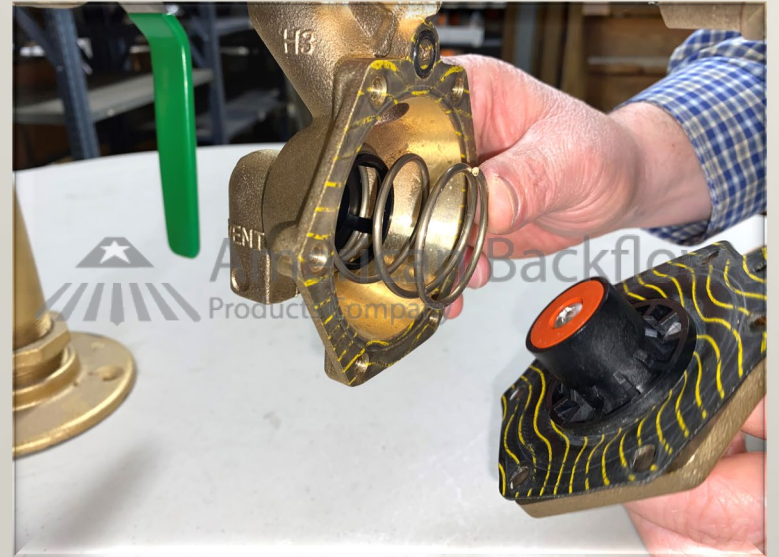
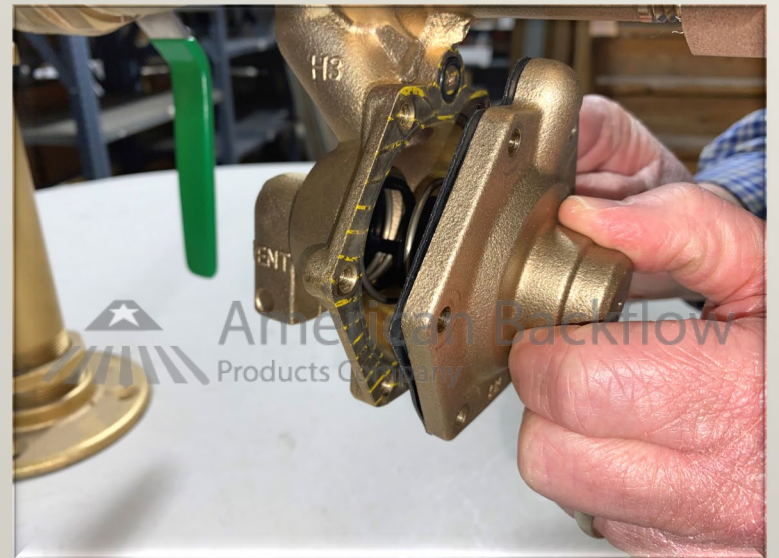
RV Reassembly Notes

Position spring over seat in body.

Make sure the RV sensing passage o-ring is in place.
