850 2½"-10"

Modification Overview

Production of the 850 series began in 1993 and is current.

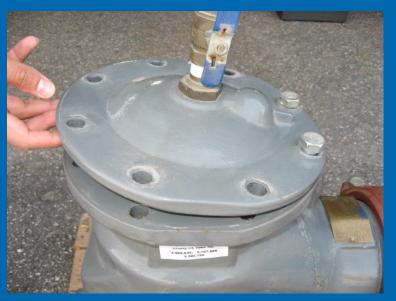
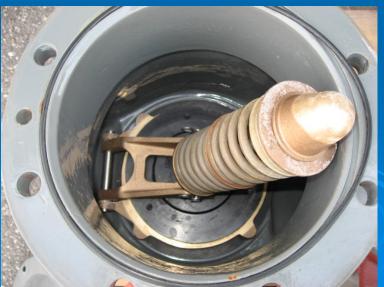
Check Cover Removal

- Cover is bolted and oring sealed.
- There is a slight spring load on cover.

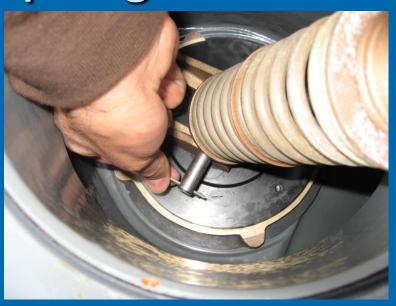
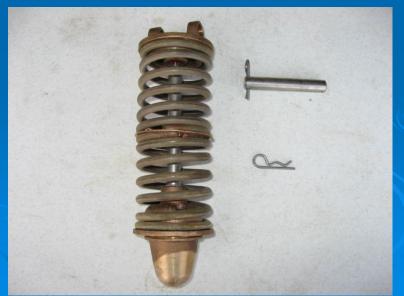
Disassemble Spring Module

- The spring module is held in position by the cover.
- Spring module is captured.
- Remove the retaining clip and hinge pin from the arm assembly.

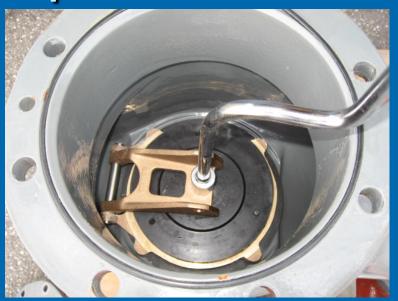
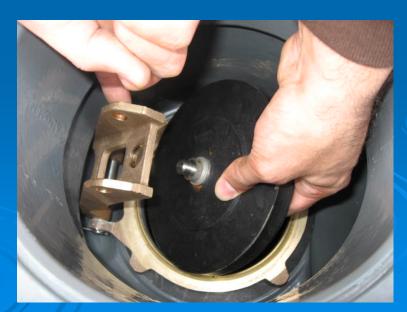
Check Disc Replacement

- The check disc is a vulcanized clapper plate.
- Remove jam nut and washer from the back of the disc plate.
 - ** When jam nut is tight, check disc is designed to "wobble".

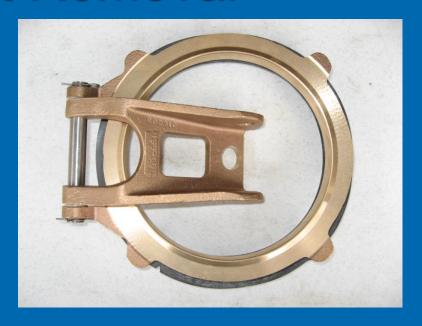
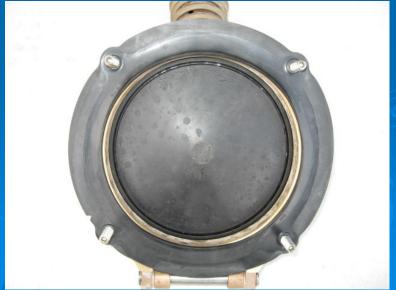
Check Seat Removal

- The seat and arm must be removed as one piece.
- The seat and arm assembly is bolted "through" the body and sealed by a gasket.

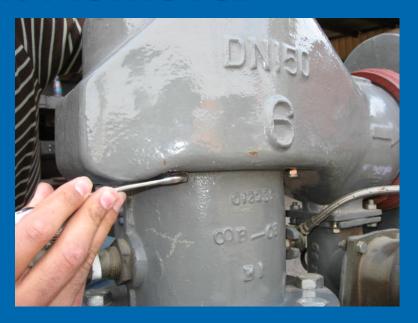
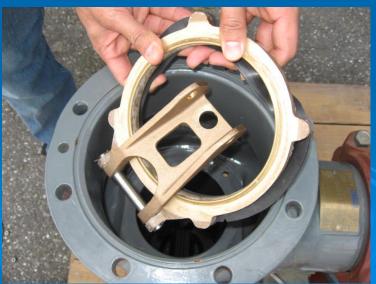
Check Seat Removal

- Locate and remove the four lock nuts on the "outside" of the body.
- Pull the seat and arm assembly straight out of the body.

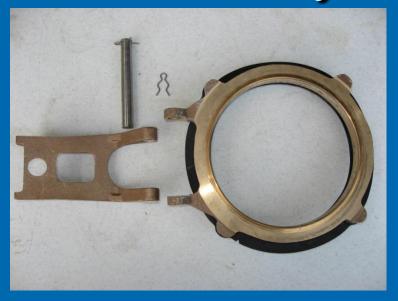
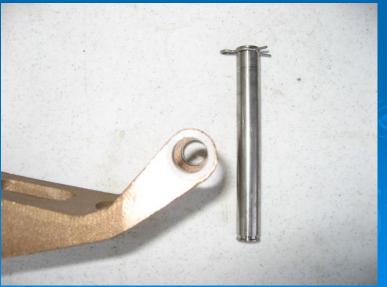
Disassemble Seat Assembly

- Remove retaining clip and hinge pin from arm assembly.
- Inspect bushings and hinge pins for wear.

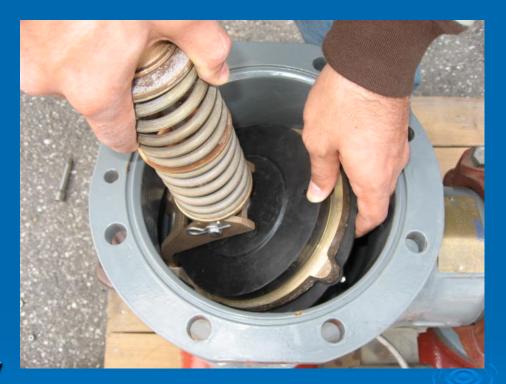
Check Valve Reassembly Notes

- Reassemble in reverse order.
- The seat assembly, disc plate, and spring module can be assembled together and placed into the body as one component.
- The seat ring will only fit into body one way, check the alignment of gasket and studs.

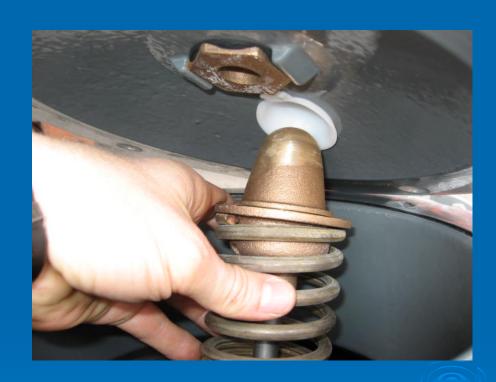
Check Valve Reassembly Notes

- The spring module is positioned by the cover.
- Make sure the pivot bearing is resting in the pivot socket on the cover.
