### **Product Overview**

Model 16 <u>DCDA</u> (1980-1990) Utilized the 3081EX Toggle Lever Checks. Produced in 3"-10" sizes only.

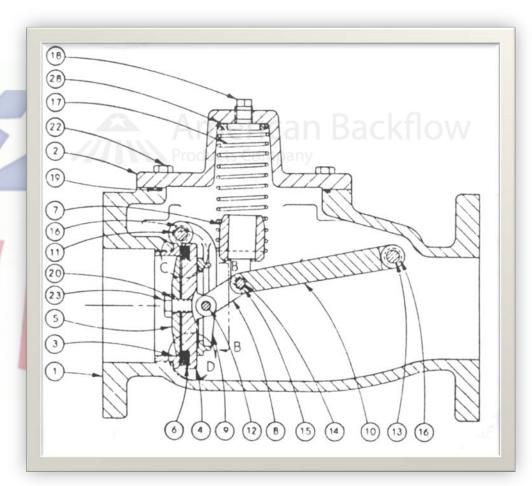
## **Check Reassembly Notes**

When the two pins that hold the toggle-lever (clapper) assembly are installed, be sure to note that the yoke (item 7) and the lever arm pivots upward freely.
