# 420, 420XL

## 1/2" - 1"

# Modification Overview

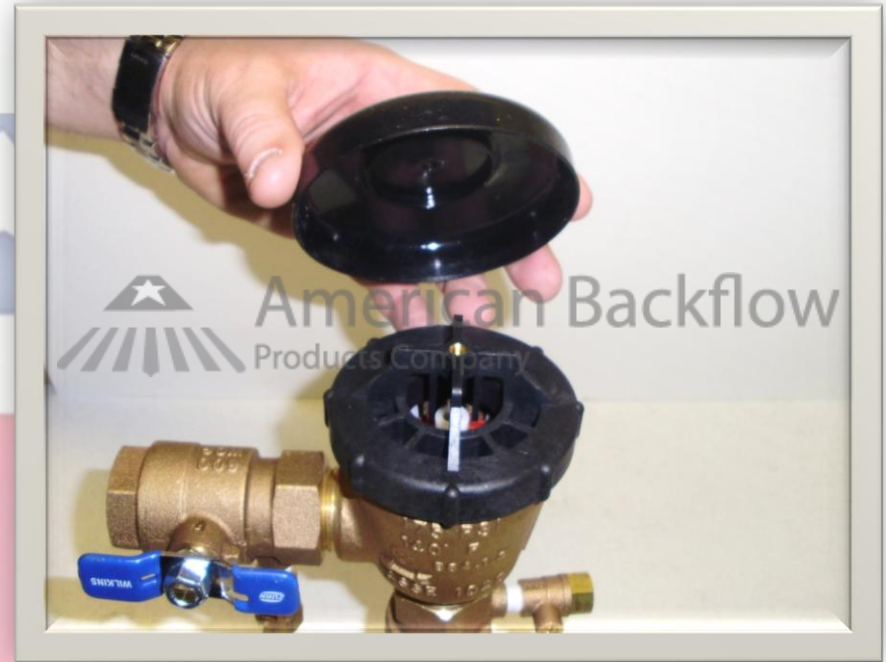
# Canopy Removal

The canopy is secured by one screw.

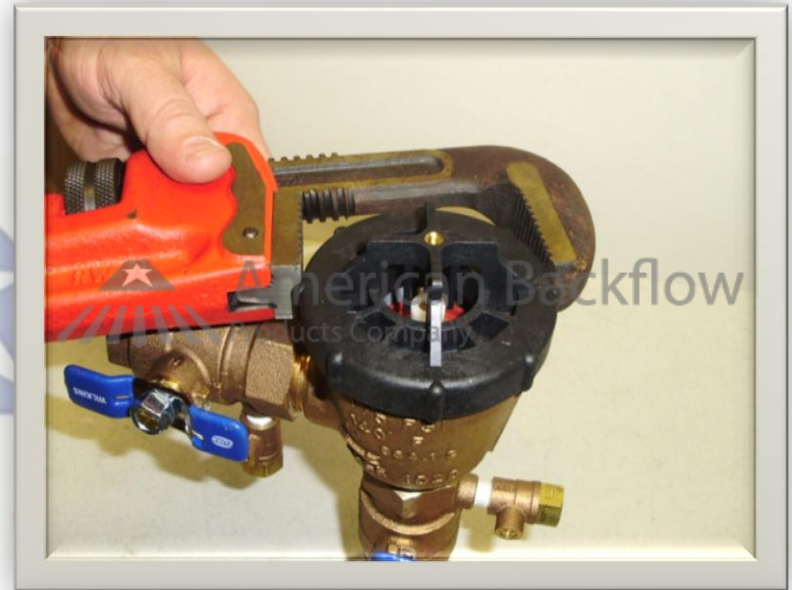
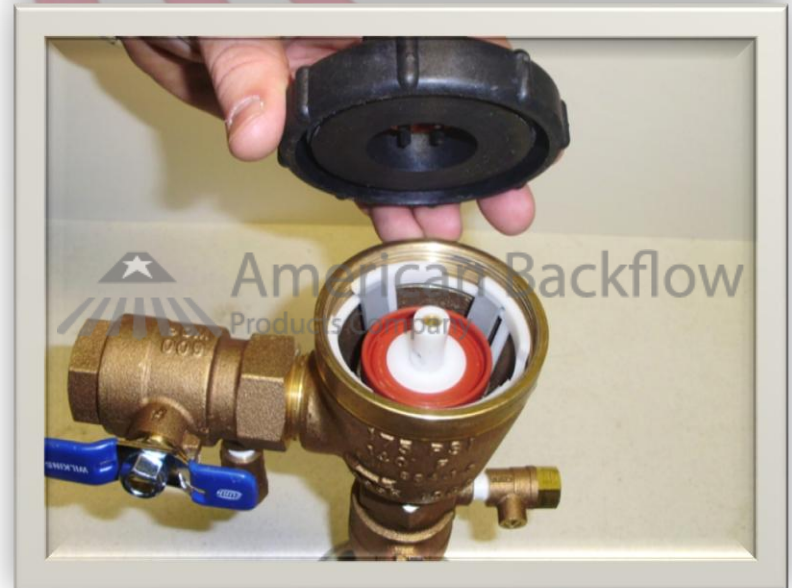
# Bonnet Removal

The bonnet is threaded into the body and sealed by an o-ring.

Unscrew the bonnet counter clockwise.

\* Note: Apply force at the outside edge.

There is no spring load

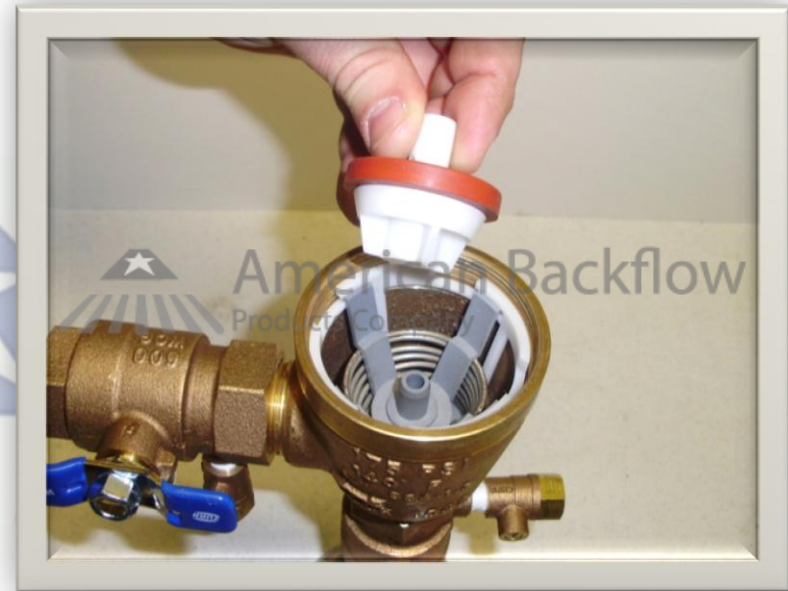
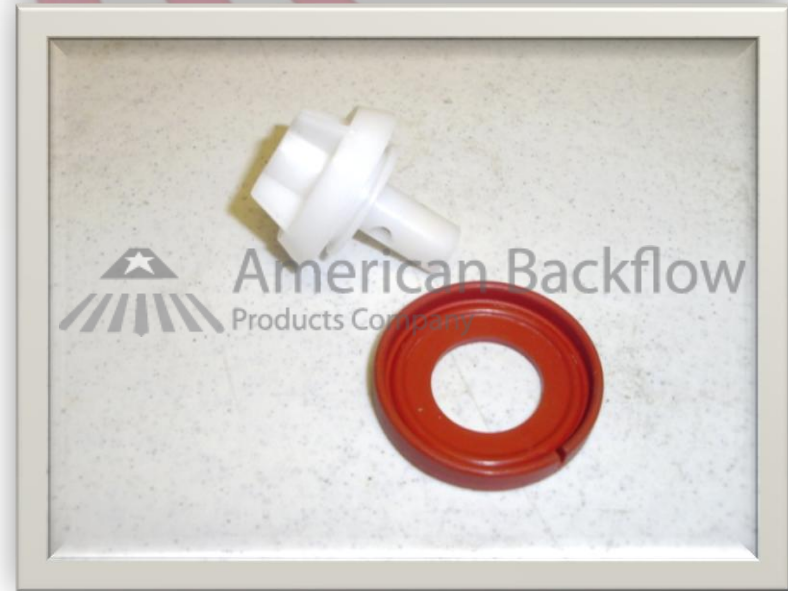
# Float Removal and Service

The float is free once the bonnet has been removed.

\* Note: The float contains a relief valve to protect against freeze damage. If the RV is damaged, the float must be replaced.

Replace the rubber seal by pulling it from the groove on the float.

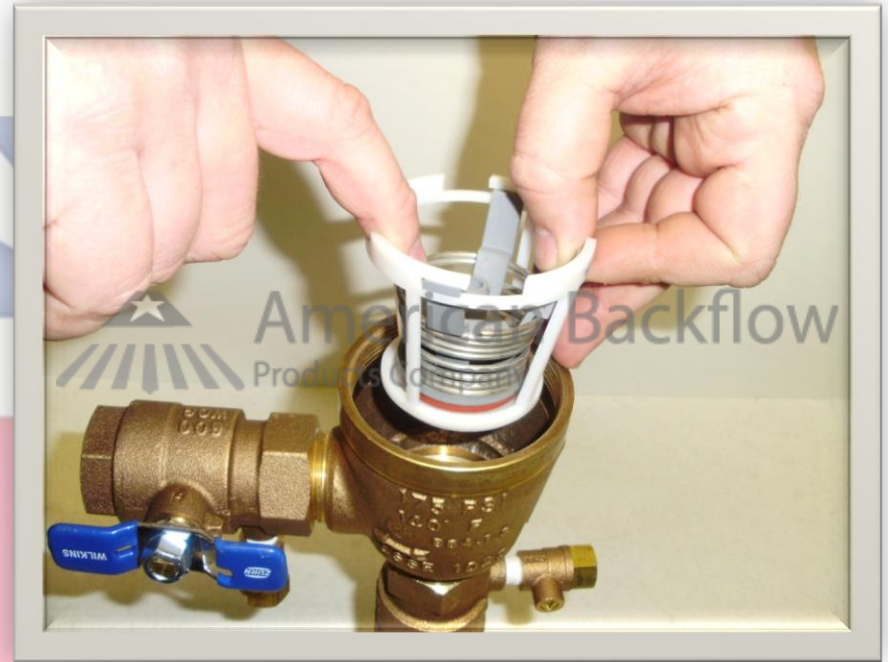
# Check Valve Removal

Check valve module.

The module is sealed by an o-ring.

Slide the module out of the body.

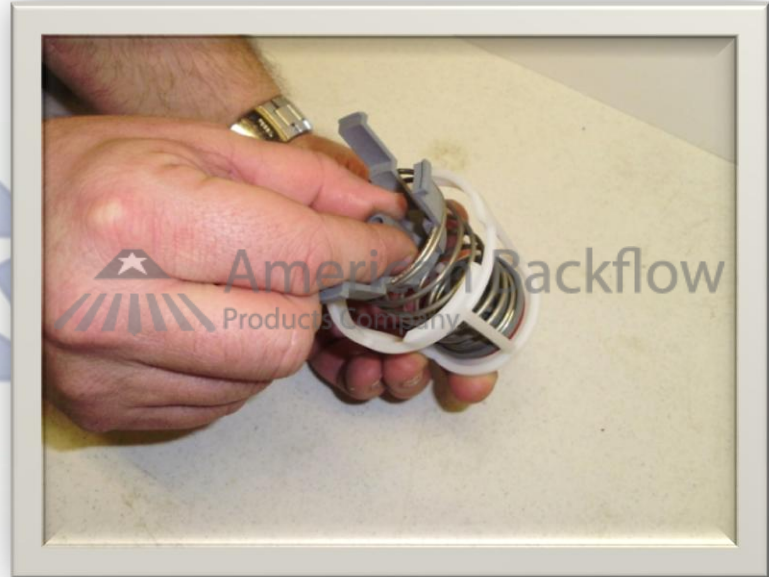
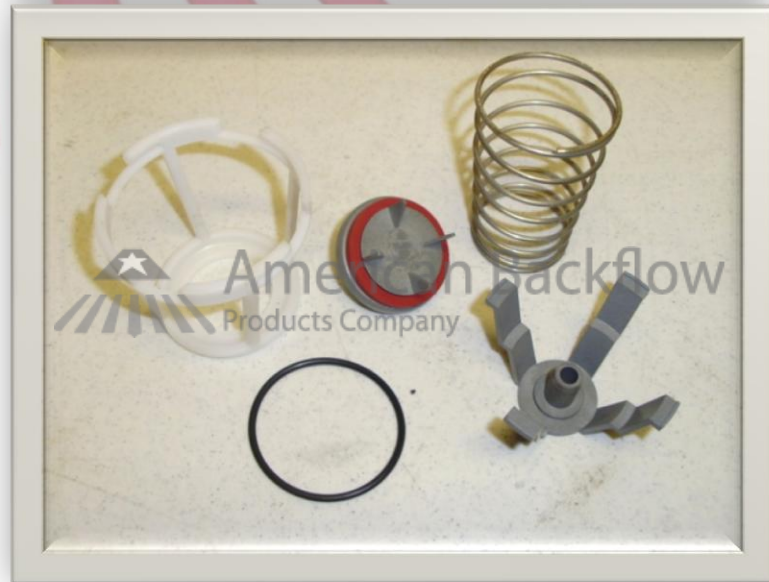
# Check Valve Disassembly

Module is spring loaded.

Remove spring retainer by pressing down and rotating to clear the tabs on seat.

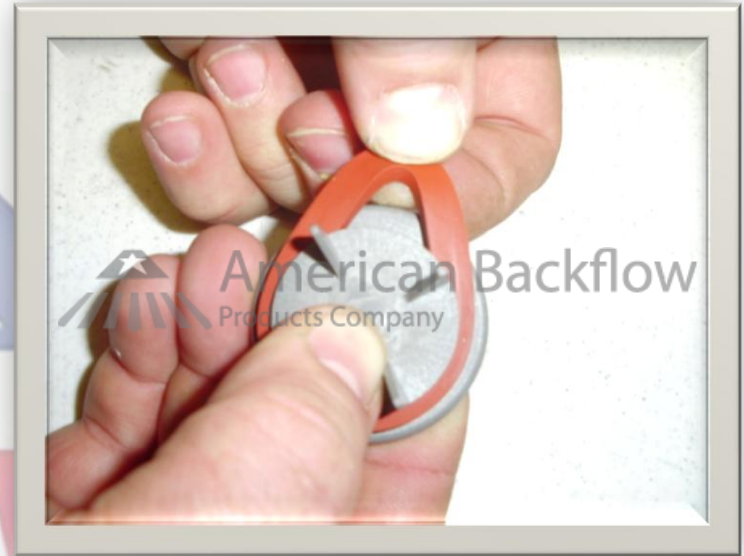
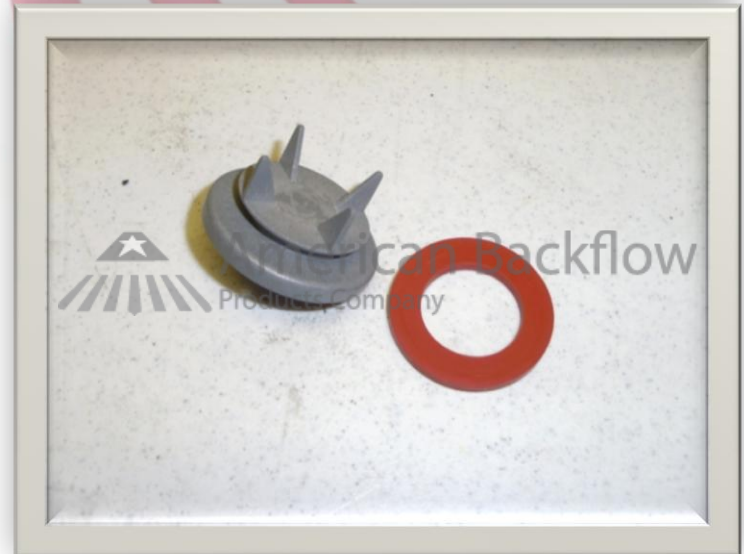
# Check Disc Replacement

Replace the rubber disc by pulling it from the groove on the poppet.

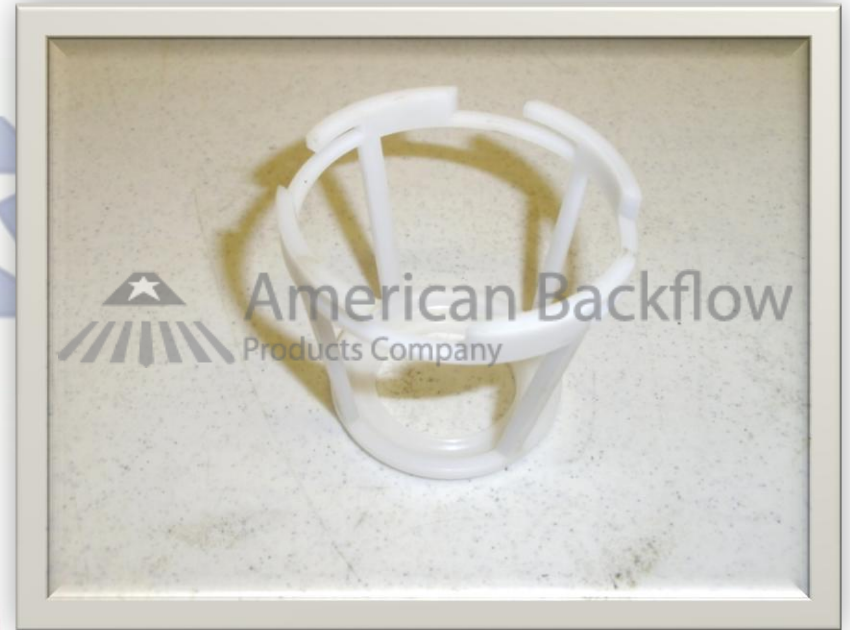
# Check Seat Replacement

The seat is free once the check is disassembled.

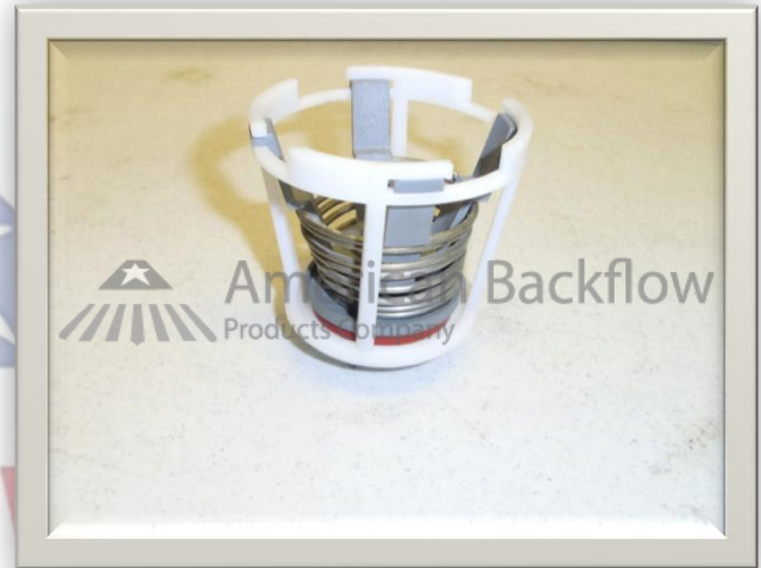
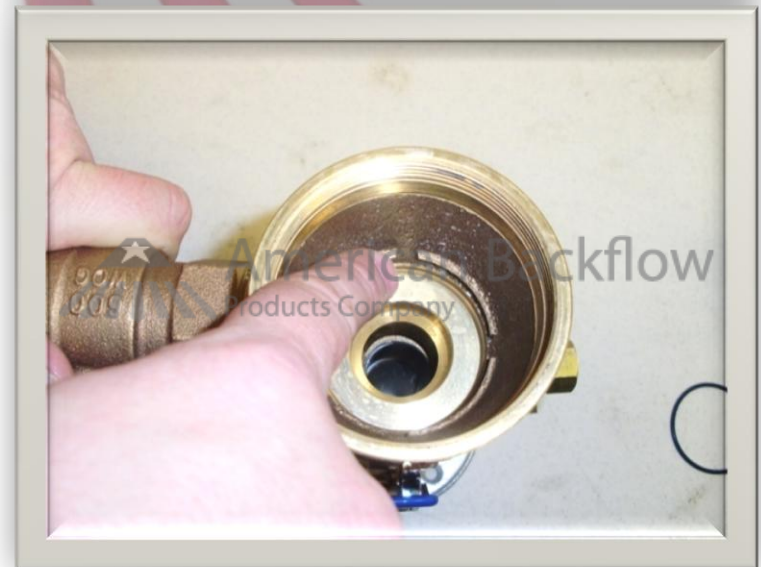
# Reassembly Notes

Reassemble in reverse order.

Make sure the check module slides into the seat guides located in the body.

Lubricate the check and bonnet o-rings.
