800(M2,M3,M4) LF800M4 1/2"-2"

Modification Overview

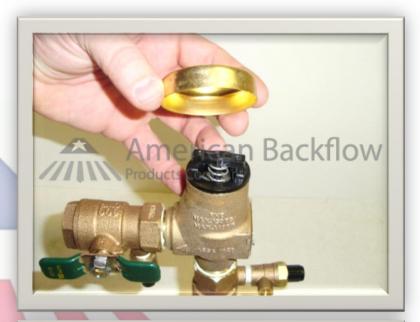
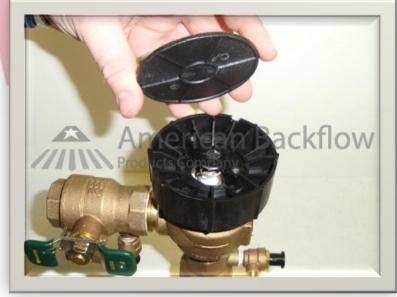
Hood Removal

The ½"- ¾" hood is secured by two screws.

The 1"-2" hood is secured by two screws.

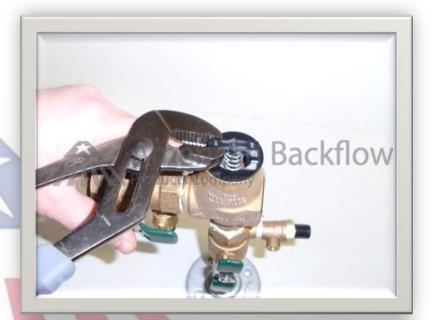
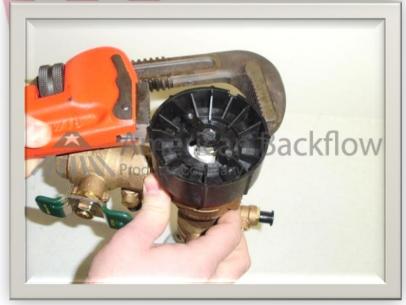
Bonnet Removal

The bonnet is threaded into the body and sealed by an o-ring.

There is no spring load.

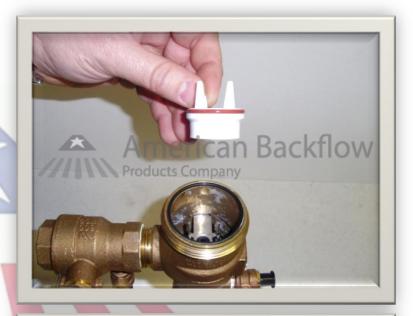
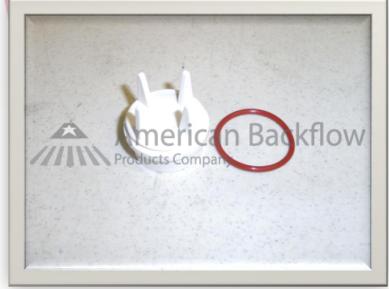
Float Removal and Service

The float is free once the bonnet has been removed.

Replace the rubber seal by pulling it from the groove on the float.

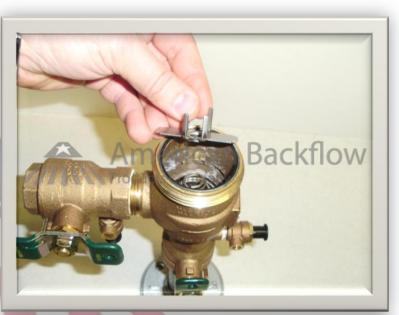
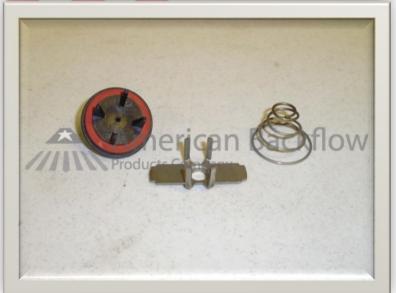
Check Valve Removal

Check valve is spring loaded.

Remove spring retainer by pressing down and rotating to clear tabs on the body.

Remove spring and poppet.

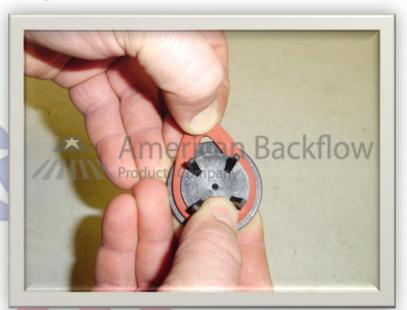
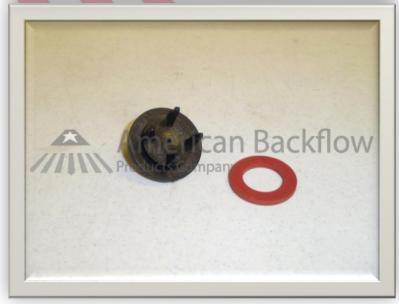
Check Disc Replacement

Replace the rubber disc by pulling it from the groove on the poppet.

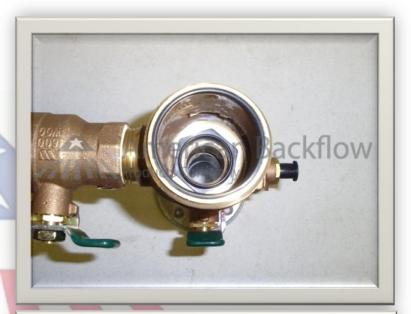
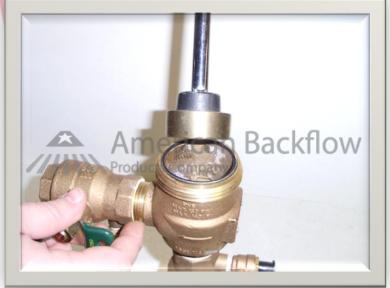
Check Seat Replacement

The check seat is threaded into the body and sealed by an o-ring.

** Note: A special tool is needed to remove the seat.

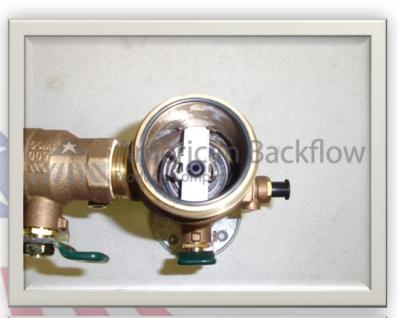
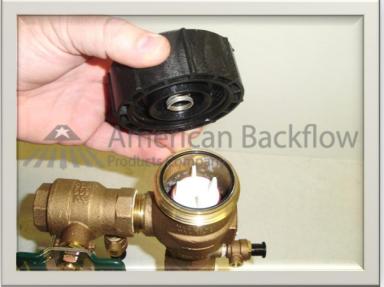
Reassembly Notes

Reassemble in reverse order.

Place large end of spring down in body.

The guides on the retainer face up.

The guides on the float face up.

Make sure the float spring is centered on the float.
