806 & 806YD

2 1/2" - 10"

American Backflow
Products Company

Modification Overview

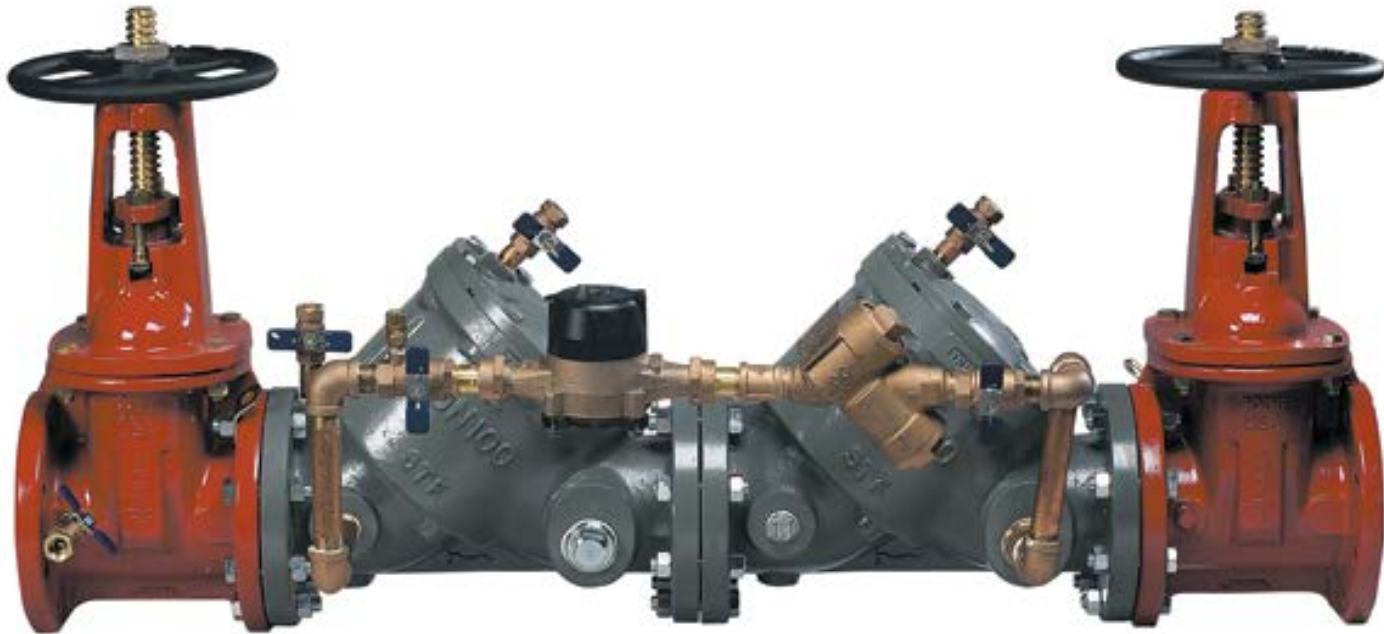
806 (1979-1988): Cast Iron body. Threaded in seats. Internal check parts are epoxy coated iron.

806YD (1988-2013): Ductile iron body. Bolted in seats. Internal check parts are stainless steel.

The 806/806YD utilized the $\frac{3}{4}$ " 805YB as the bypass assembly.

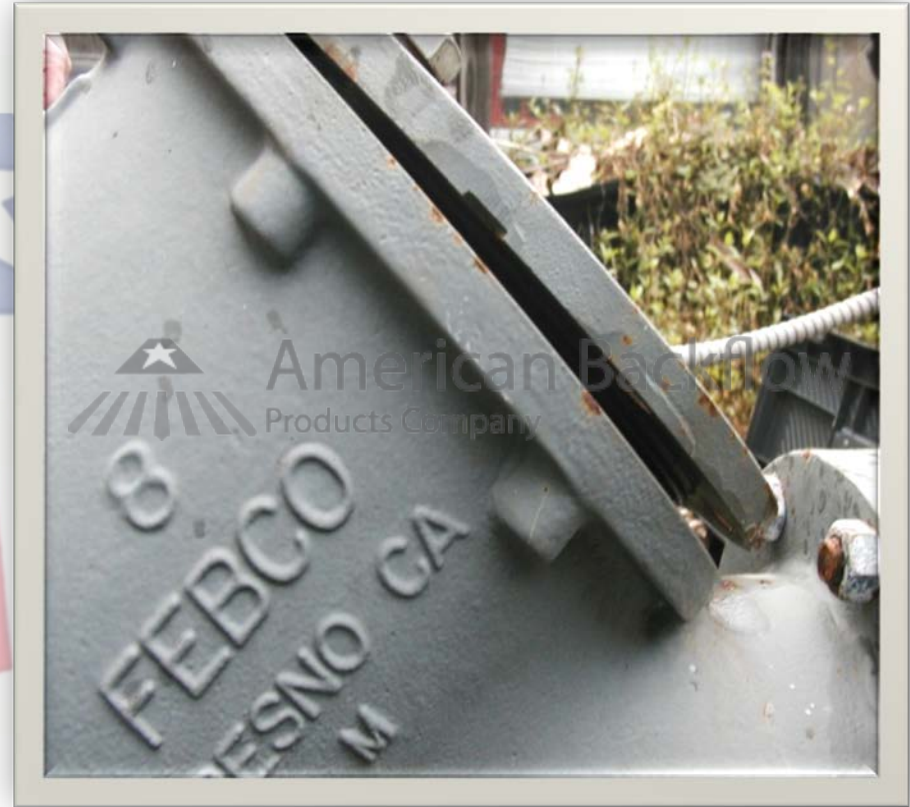
Check Cover Removal

Cover is o-ring sealed.

3" cover is spring loaded.
Hold cover firmly while
removing bolts.

4" - 10" Loosen bolts $\frac{1}{2}$ ".
Spring load is now
released from the cover
and retained by the check
assembly.

Verify spring load before
removing all the bolts.

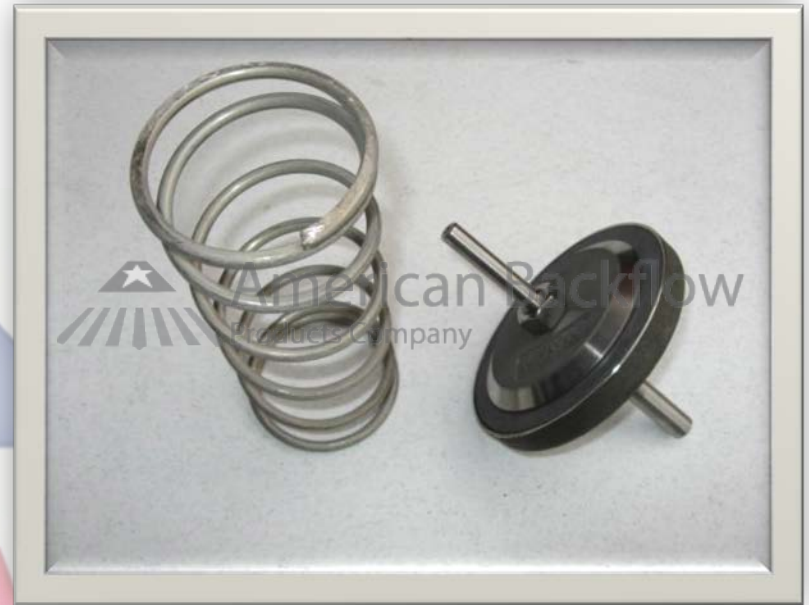
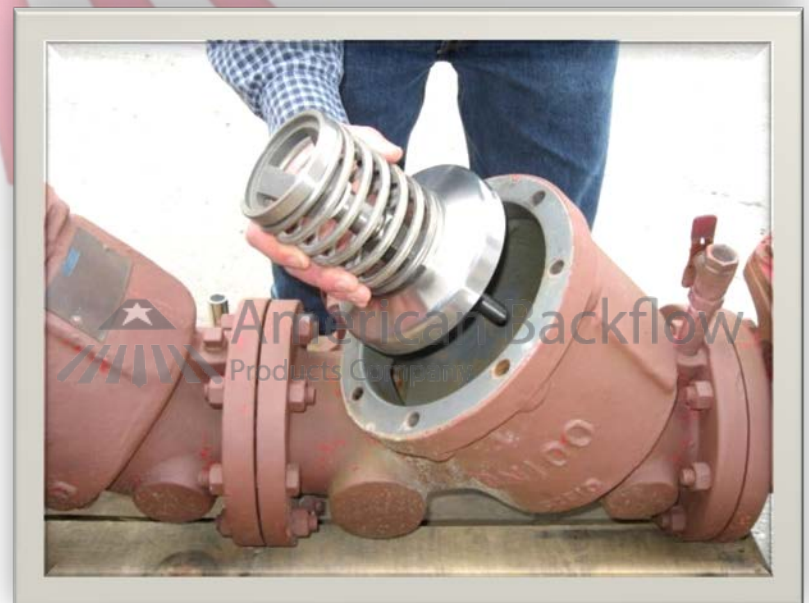
Check Valve Removal

Center stem guided check assembly.

3" spring, stem, and disc holder are free once cover is removed.

4" - 10" disc & spring subassembly.

Slide subassembly straight out of seat and body.

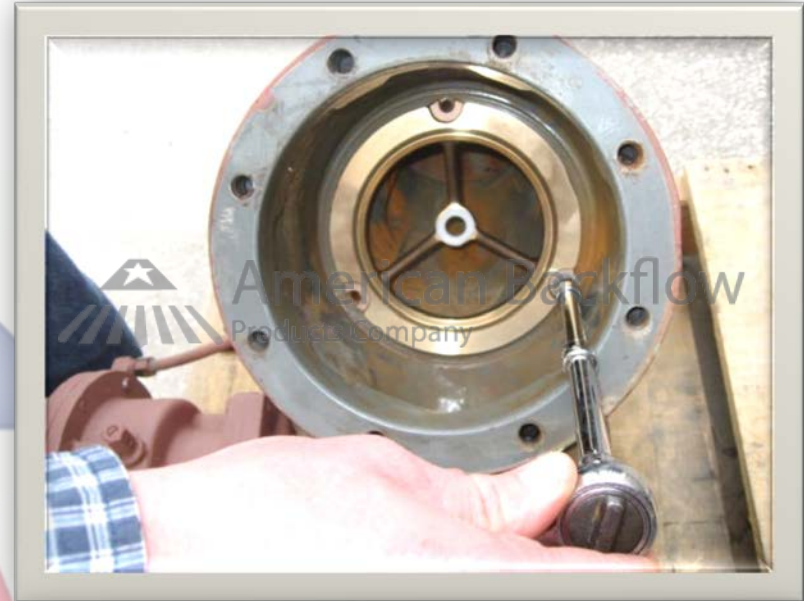
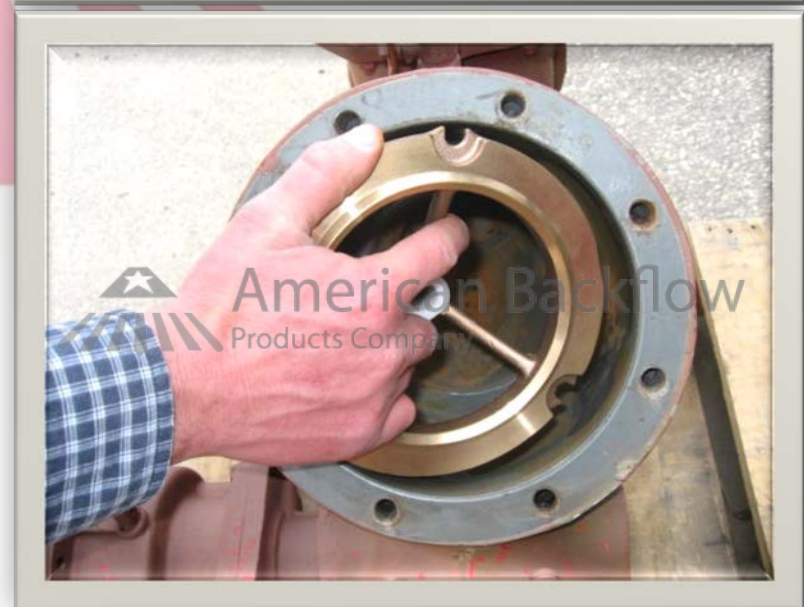
Check Seat Removal

806YD series seats are o-ring sealed and bolted into the body.

Remove bolts and pull seat straight out of body.

Inspect the plastic guide bushing in center of seat.

(806) series seats are threaded into the body.

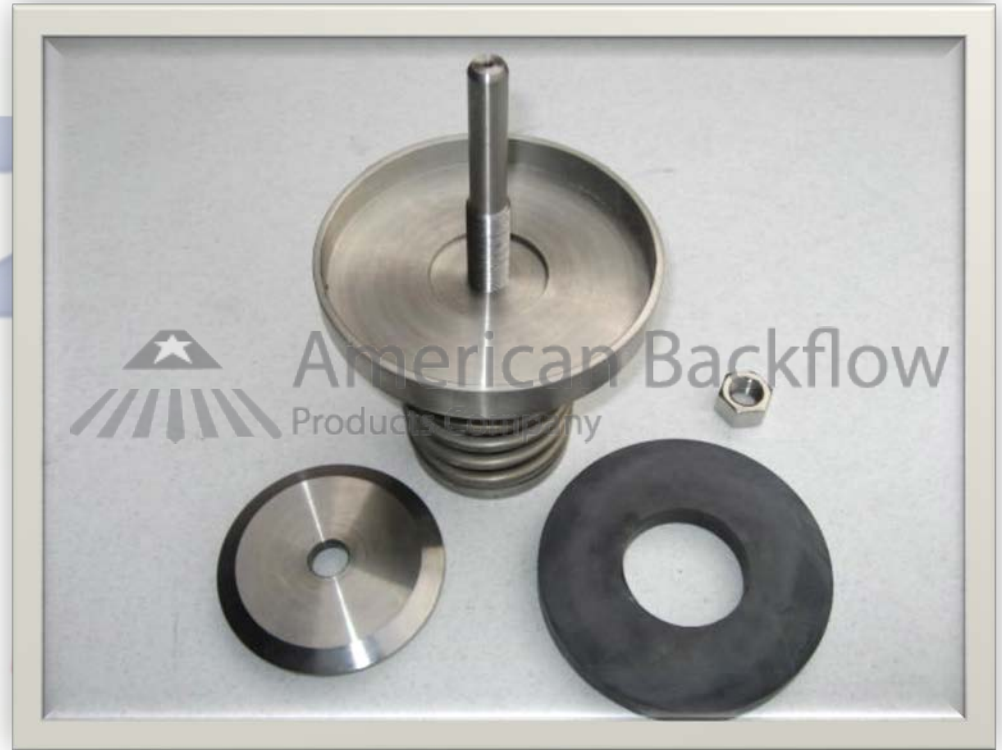
Check Disc Replacement

Unthread the nut from the stem and remove disc retainer.

For model (806) spring tension may have to be released to replace disc. Consult service center.

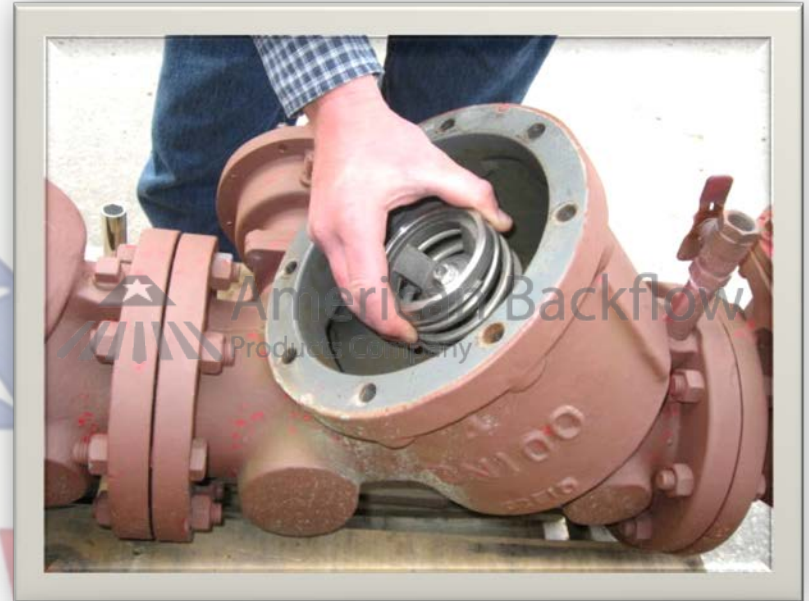
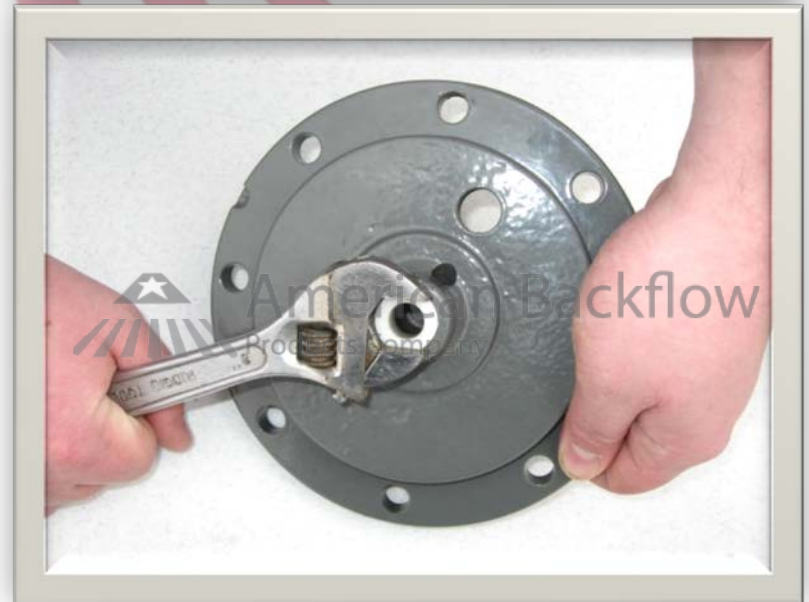
Check Valve Reassembly Notes

Reassemble in reverse order.

Apply lubricant to o-rings.

3" Models: Inspect and clean the plastic guide in the check cover.
