850 2 ½" - 10"

Modification Overview

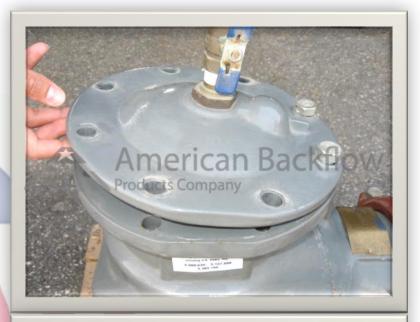
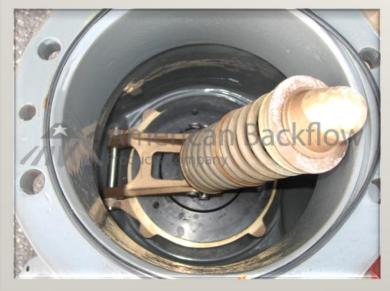
Check Cover Removal

Cover is bolted and o-ring sealed.

There is a slight spring load on cover.

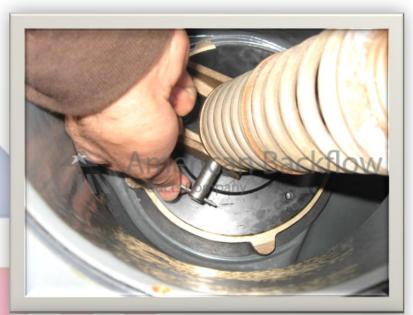
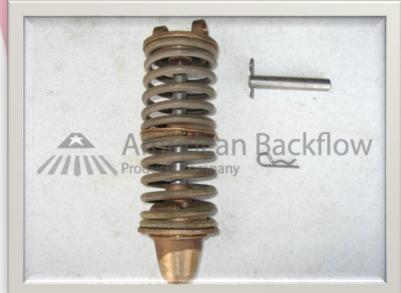
Disassemble Spring Module

The spring module is held in position by the cover.

Spring module is captured.

Remove the retaining clip and hinge pin from the arm assembly.

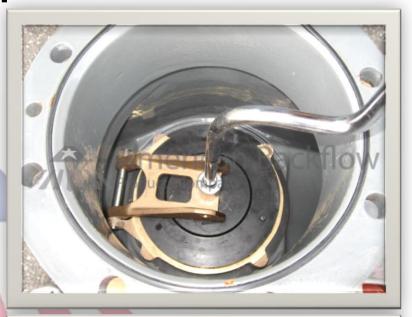
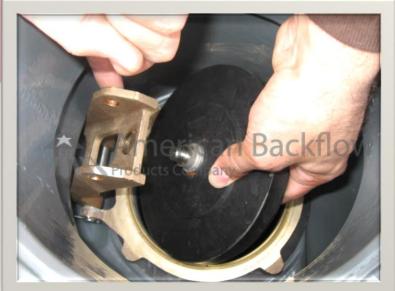
Check Disc Replacement

The check disc is a vulcanized clapper plate.

Remove jam nut and washer from the back of the disc plate.

When jam nut is tight, check disc is designed to "wobble".

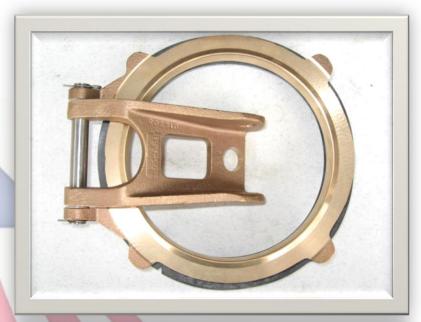
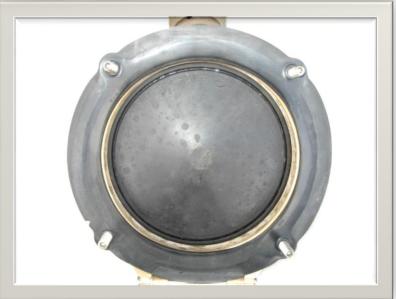
Check Seat Removal

The seat and arm must be removed as one piece.

The seat and arm assembly is bolted "through" the body and sealed by a gasket.

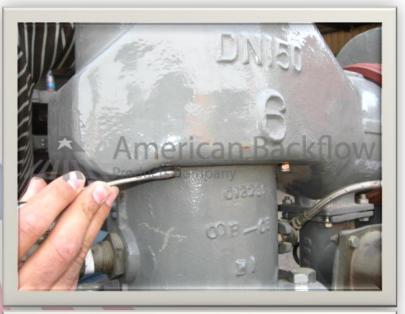
Check Seat Removal

Locate and remove the four lock nuts on the "outside" of the body.

Pull the seat and arm assembly straight out of the body.

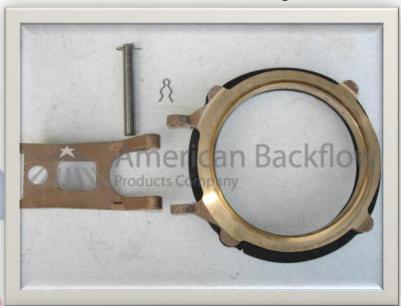
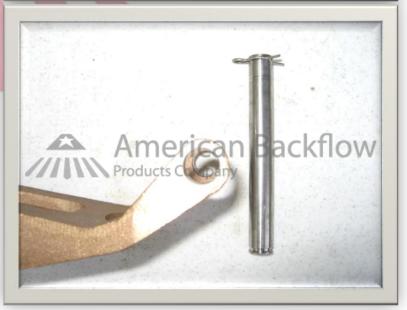
Disassemble Seat Assembly

Remove retaining clip and hinge pin from arm assembly.

Inspect bushings and hinge pins for wear.

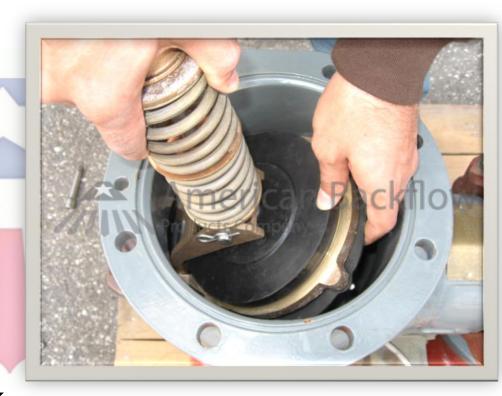
Check Valve Reassembly Notes

Reassemble in reverse order.

The seat assembly, disc plate, and spring module can be assembled together and placed into the body as one component.

The seat ring will only fit into body one way, check the alignment of gasket and studs.

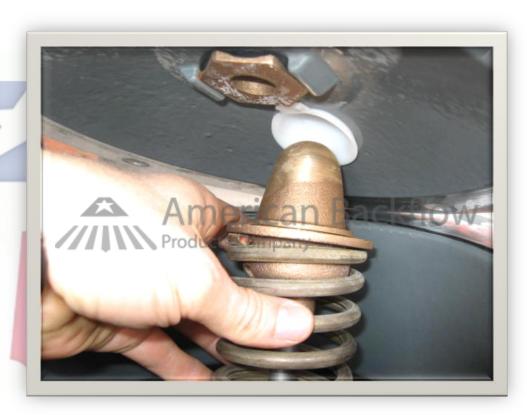
Check Valve Reassembly Notes

The spring module is positioned by the cover.

Make sure the pivot bearing is resting in the pivot socket on the cover.
