867
2 1/2" - 3"

American Backflow
Products Company

Modification Overview

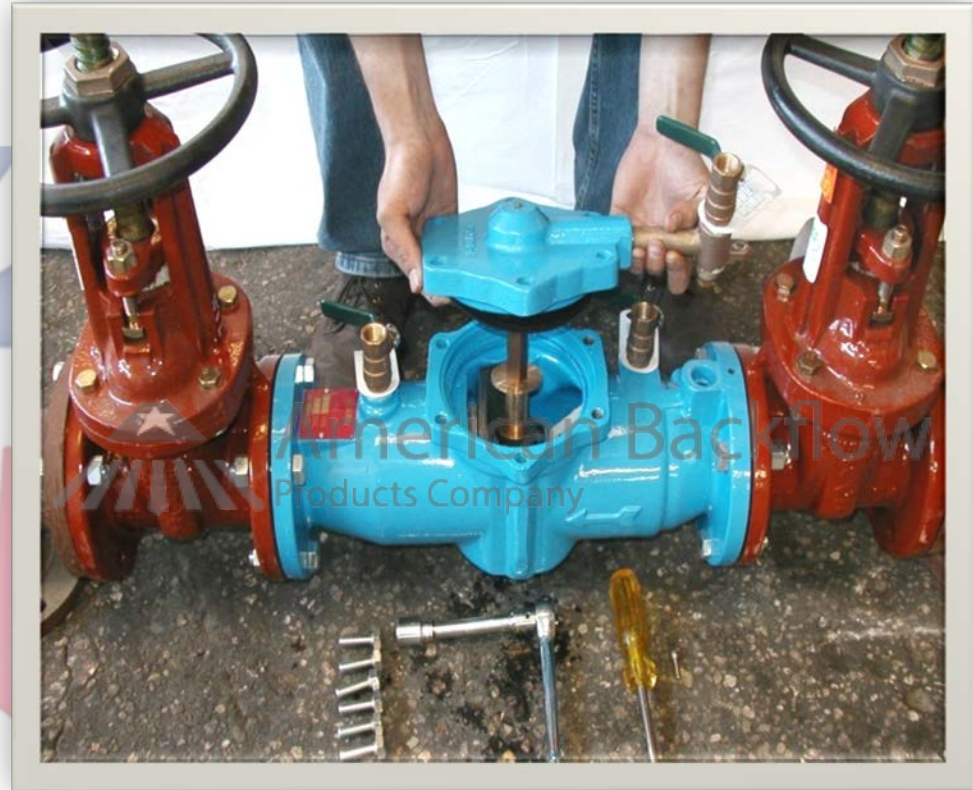
Single Access Cover Removal

Cover is o-ring sealed.

Cover has spring load from the RV spring.

Remove bolts while holding cover down.

RV Stem may come out with cover.

Lift cover straight off.

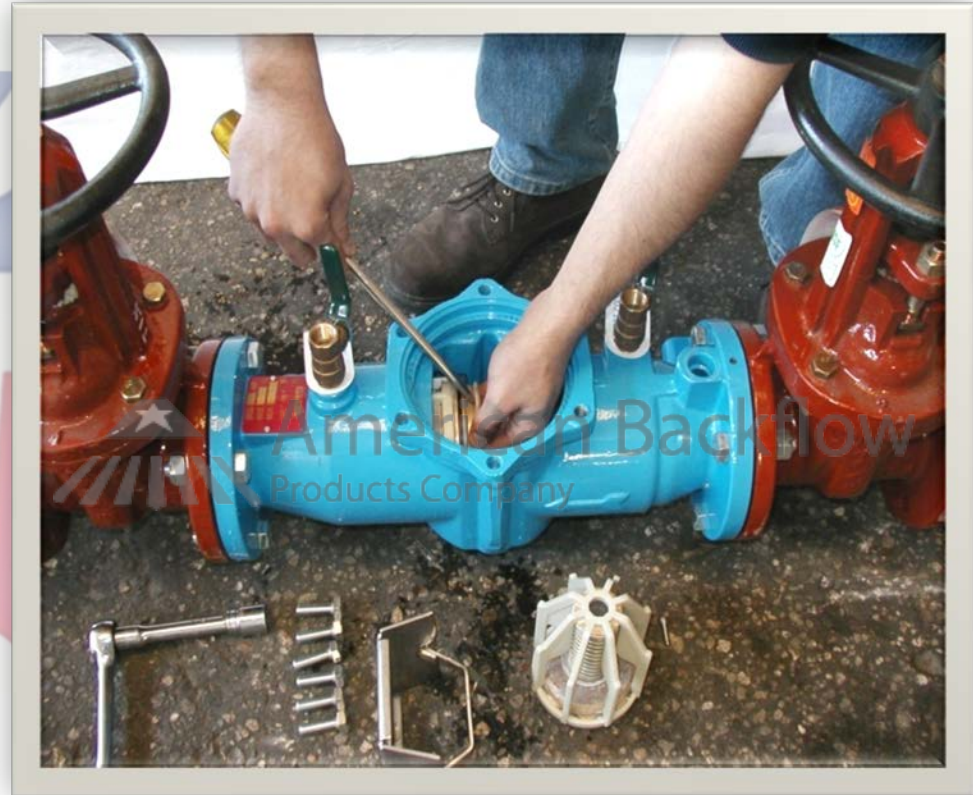
Check Valve Removal

Check valve modules.

Modules sealed by o-ring and secured by a retainer.

Slide retainer straight out of body.

Modules can now be removed by hand or with a flat head screwdriver.

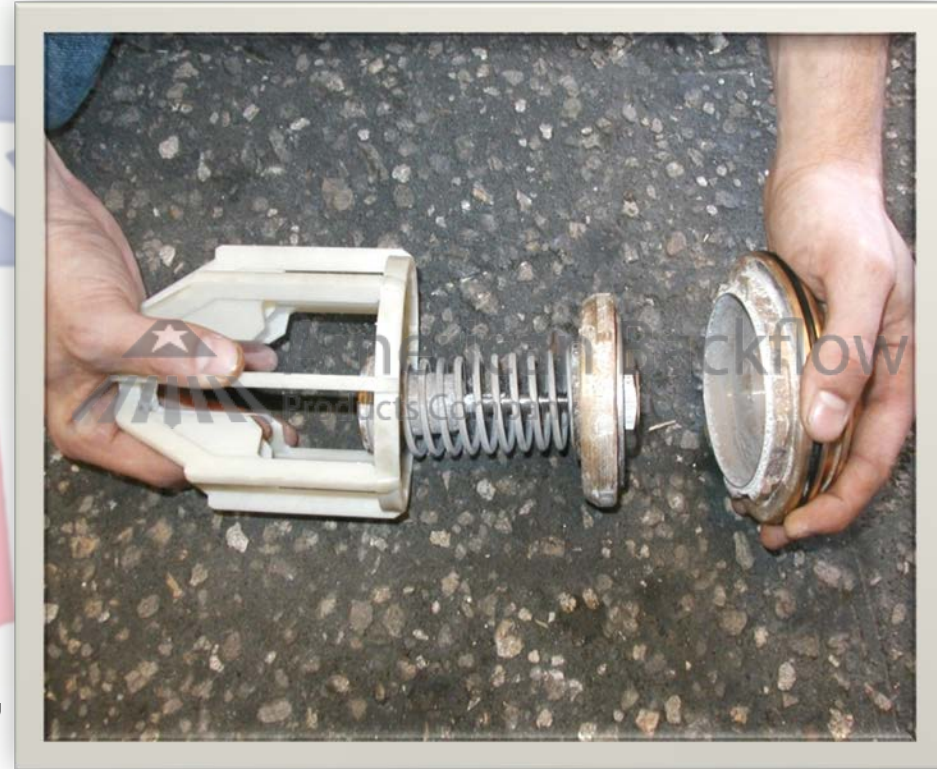
Check Seat Removal

Check seats are part of each module.

Check seats are attached to the cage with a bayonet type locking system.

Check spring is contained.

Hold the cage in one hand, push the seat inward and rotate counter-clockwise.

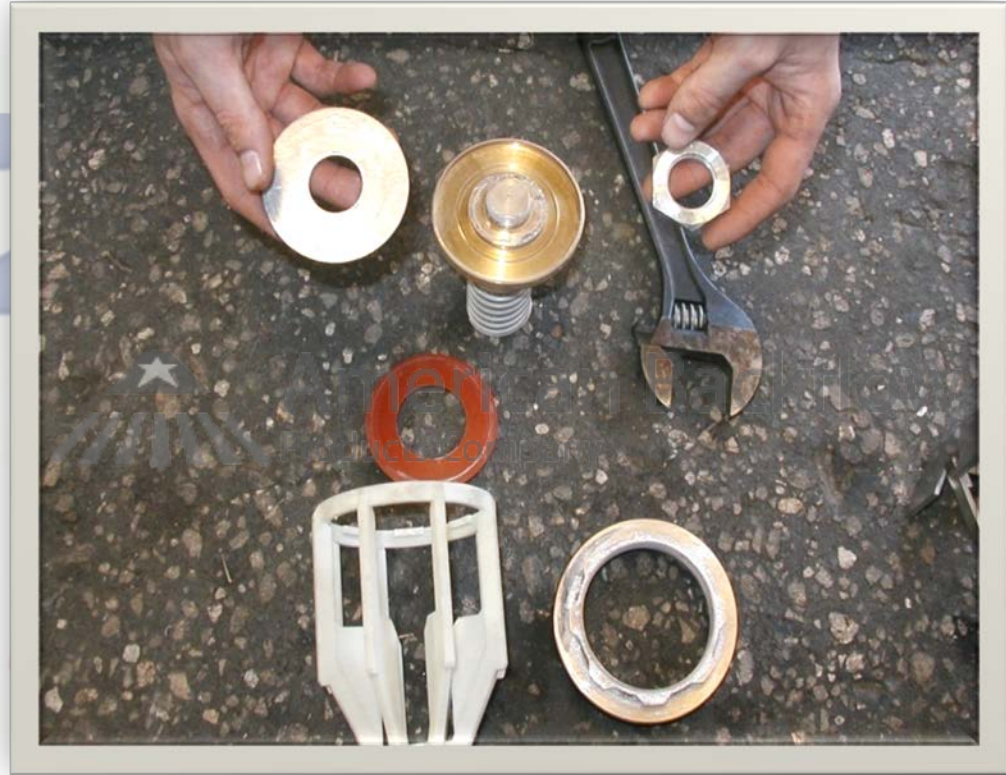
Check Disc Replacement

Remove retaining nut from disc holder and replace rubber.

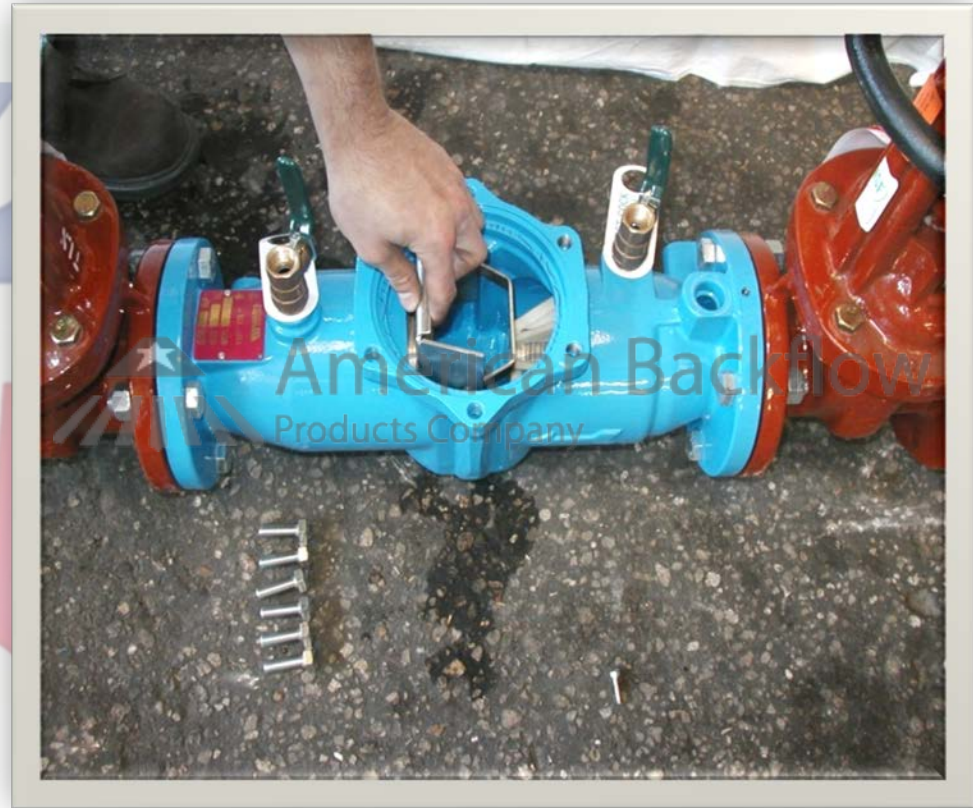
Check Valve Reassembly Notes

Reassemble in reverse order.

Apply lubricant to o-rings.

If check retainer does not slide into place easily, make sure check valves are seated properly.

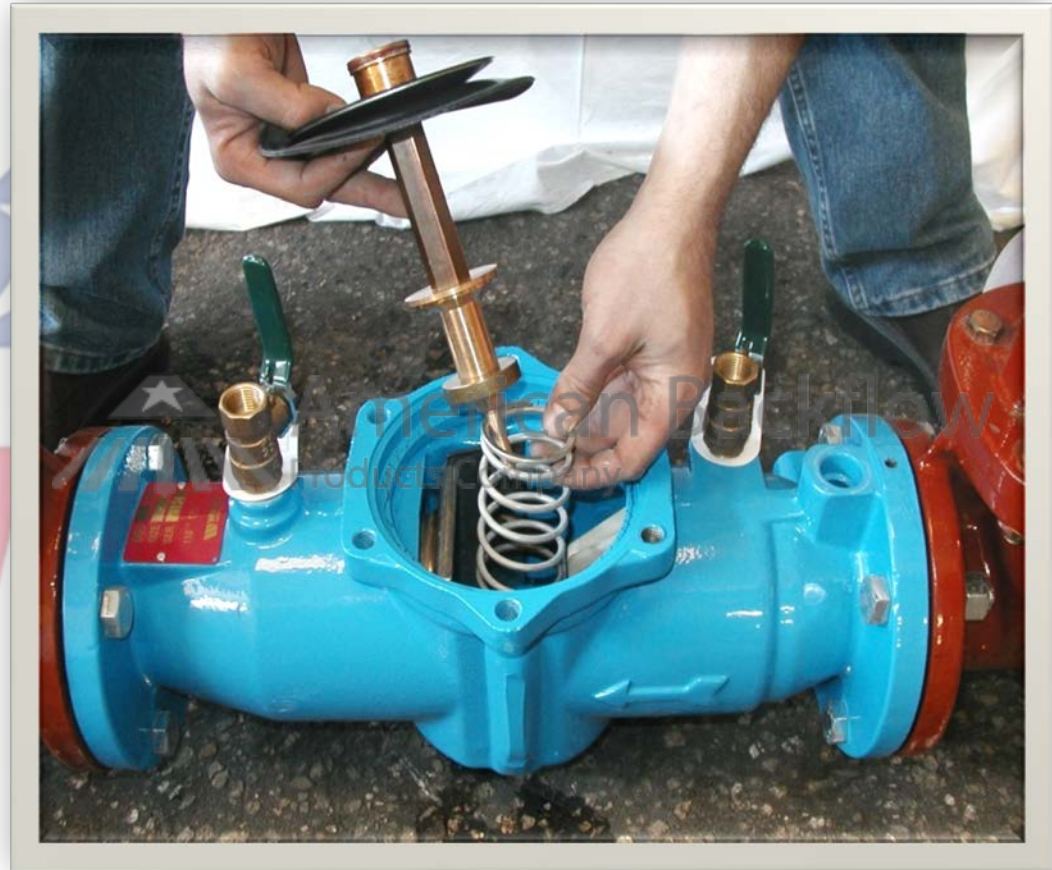
RV Stem Removal

The RV Stem and spring are situated between the check valves and are free once the single access cover is removed.

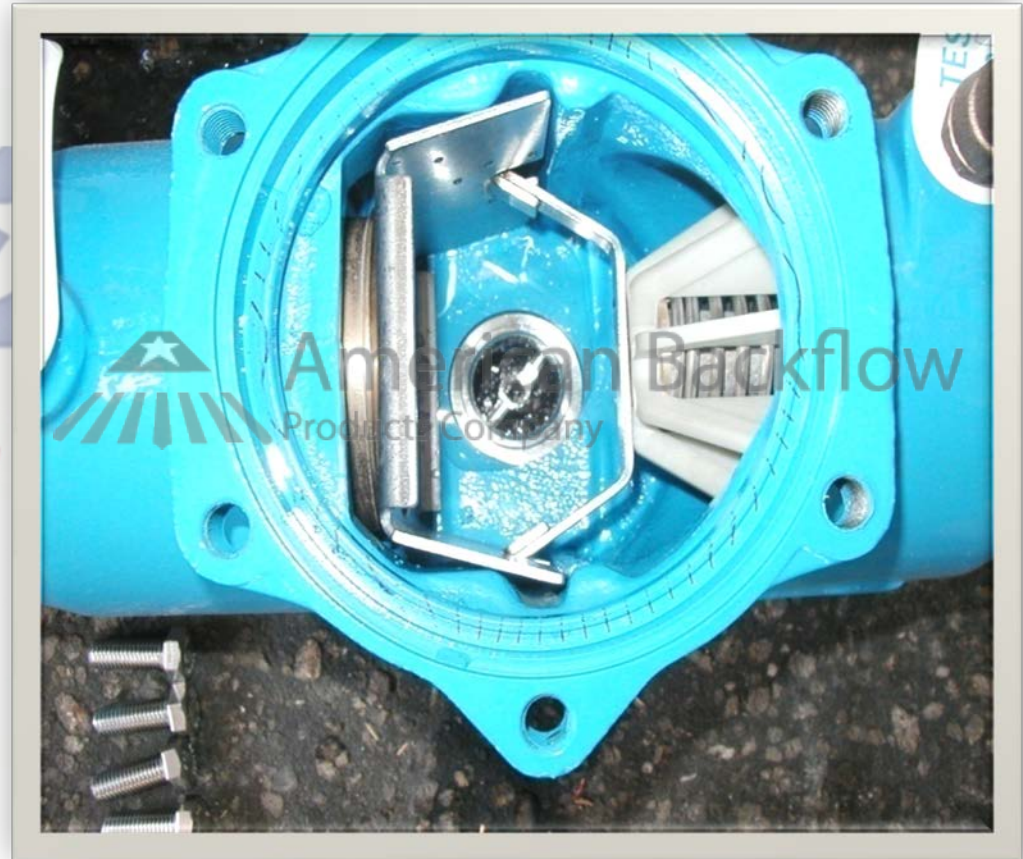
RV Seat Removal

Unless damaged, there is no need to remove RV seat.

The seat is pushed firmly into the body and is o-ring sealed.

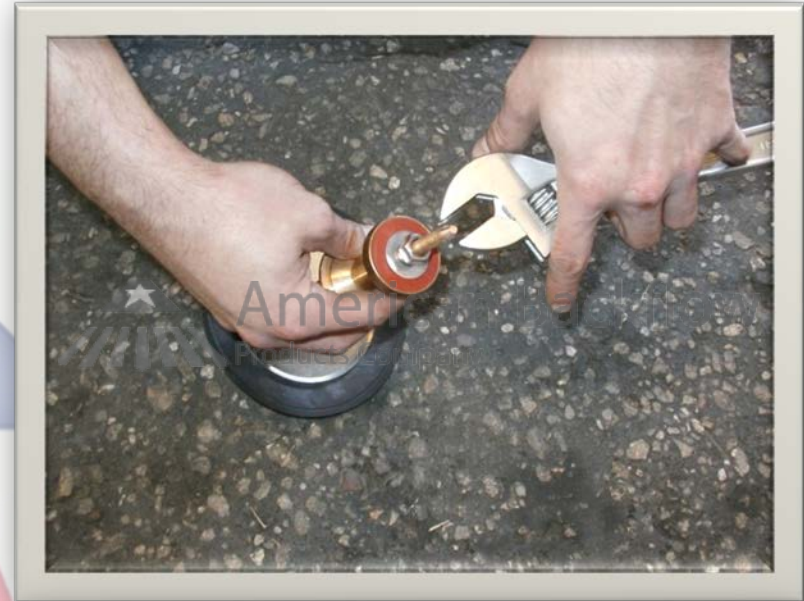
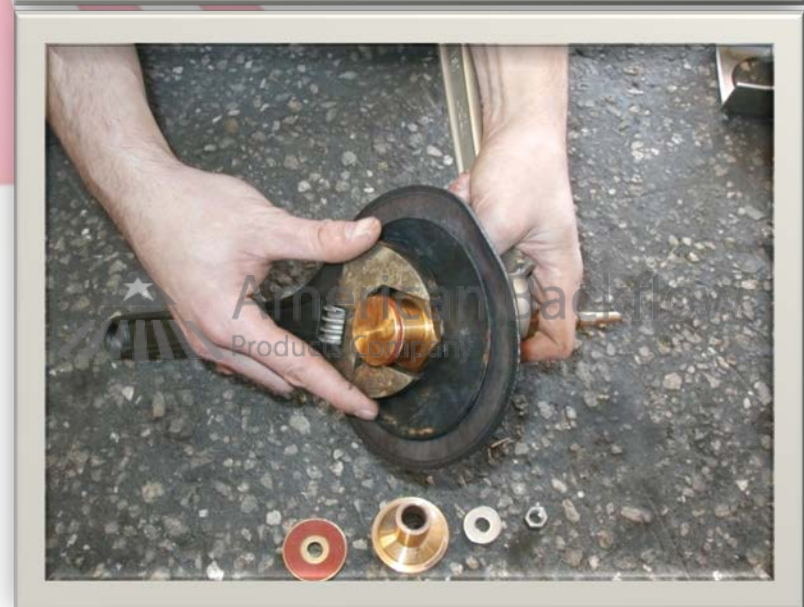
RV Rubber Replacement

The RV molded disc is on the lower stem. Simply unscrew the nut from the guide.

Replace the o-ring behind the disc.

The diaphragm is on the upper stem. Simply unscrew the stem cap from the stem.

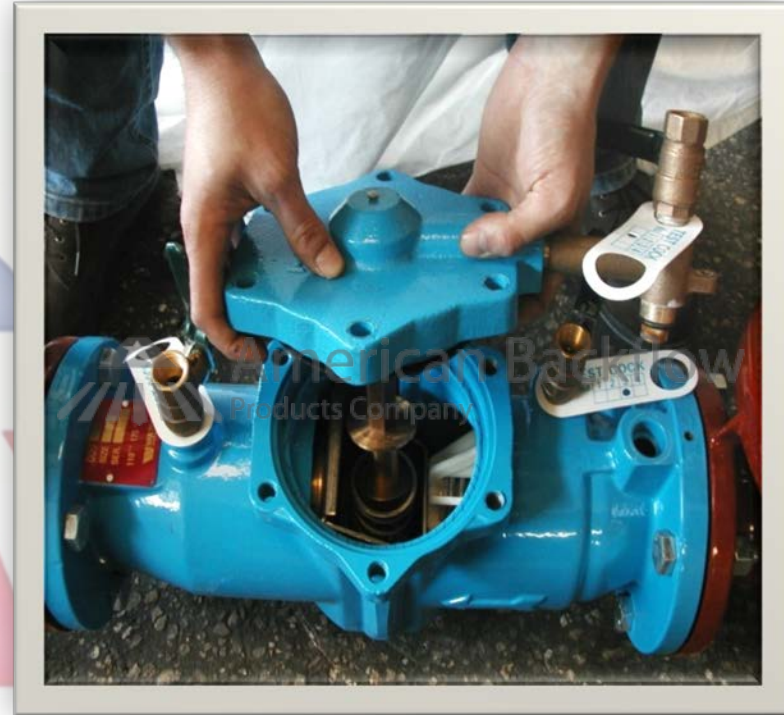
RV Reassembly Notes

Center the spring on the seat and insert the cover and stem assembly as a unit straight into the body.

Make sure that the lower guide on the RV stem goes through the guide hole in the seat.

If the cover will not press flat against body, the stem is crooked and must be realigned.
