975, 975XL

3/4" - 2"

WILKINS

Modification Overview

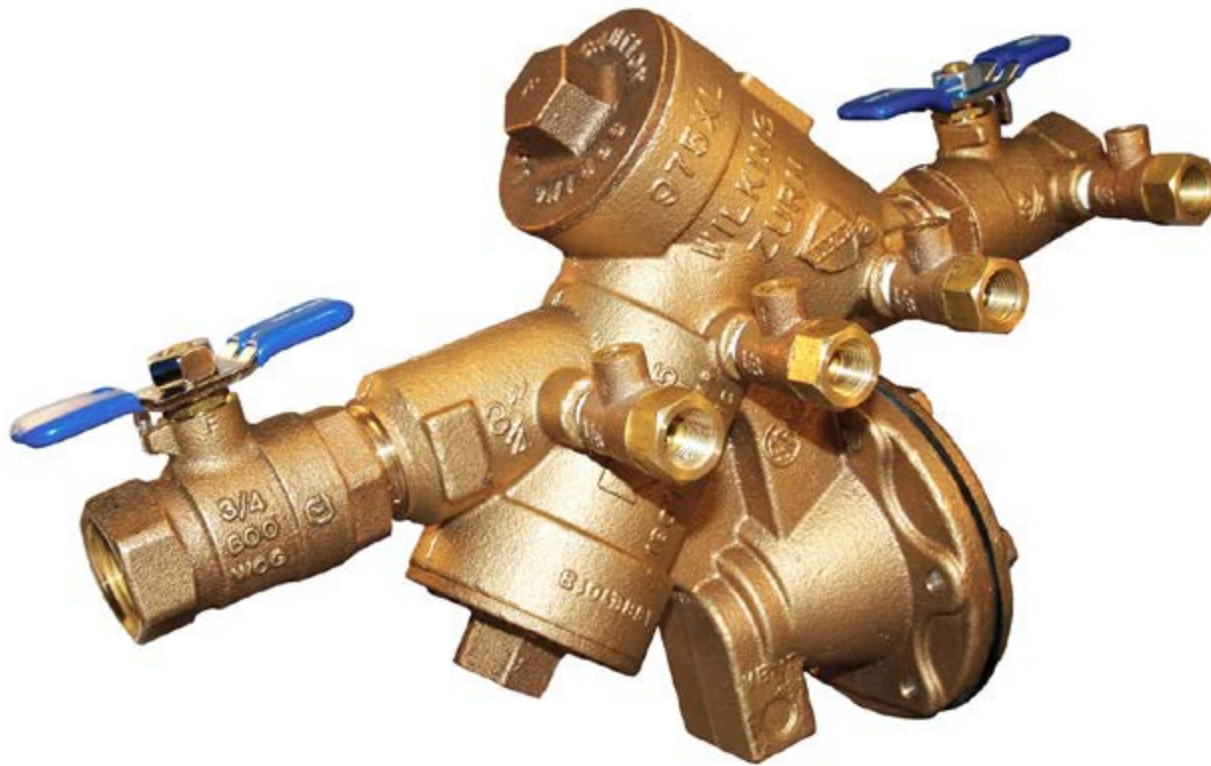
Production of the original 975 began in 1990. This version had buna-n check discs and did not have replaceable check seats. Discontinued in 1992.

The 975A had bronze replaceable seats.

The 975XL (1993-Current) has plastic replaceable seats and silicone check discs.

A lead free version 975XL2 was introduced in 2010.

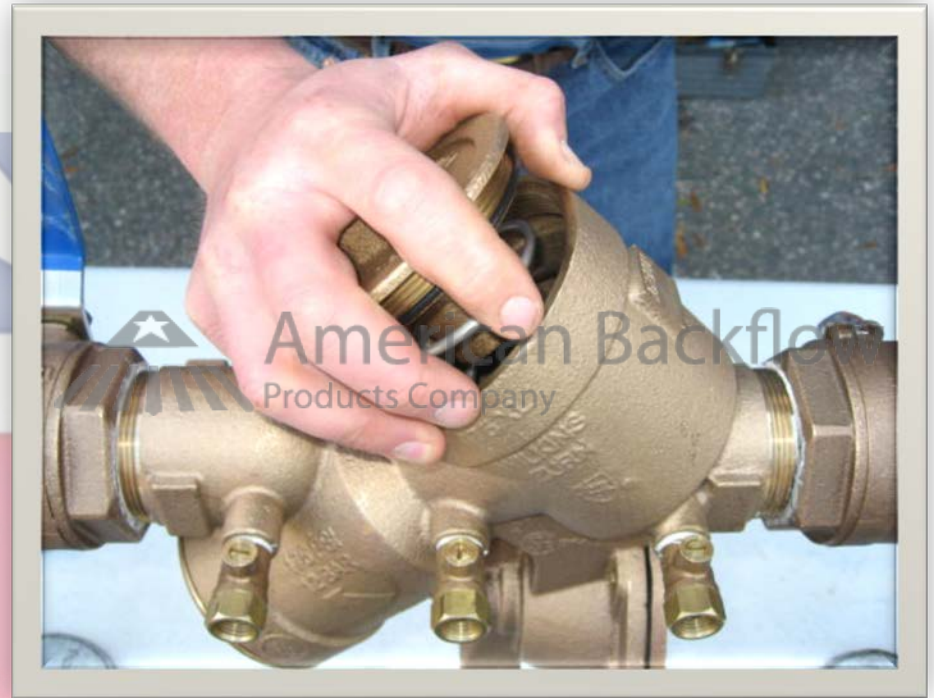
Check Cover Removal

Cover is threaded into body and o-ring sealed.

Cover is spring loaded.

Loosen cover with wrench, then remove by hand while holding tightly against spring pressure.

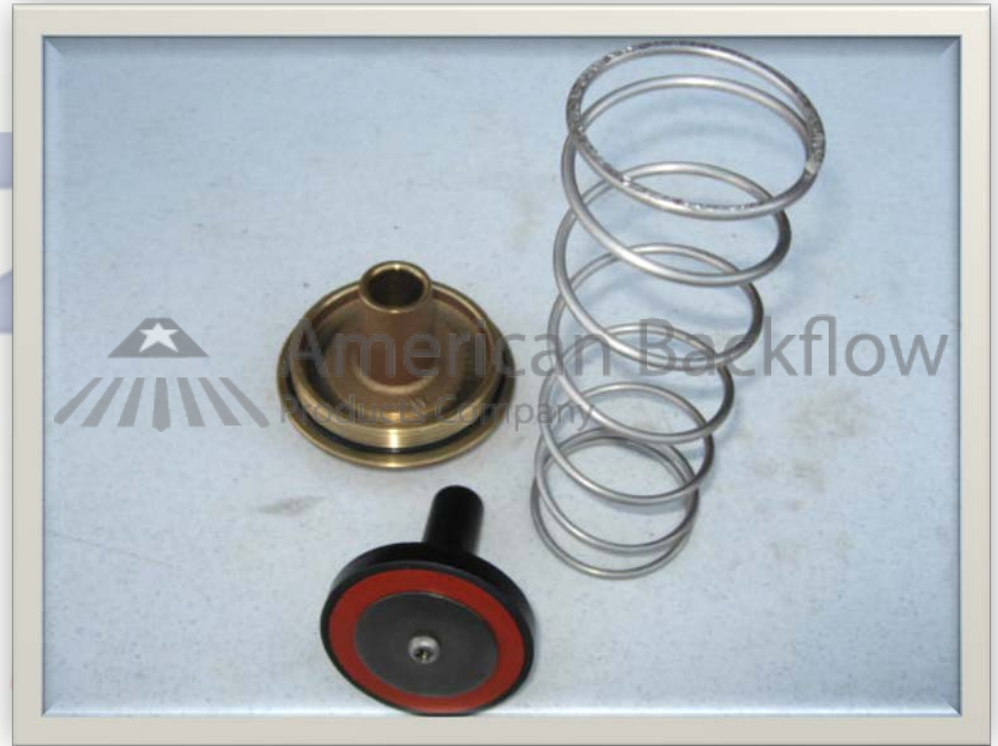
Check Valve Removal

Poppet style check valve.

The poppet and spring are free once the cover is removed.

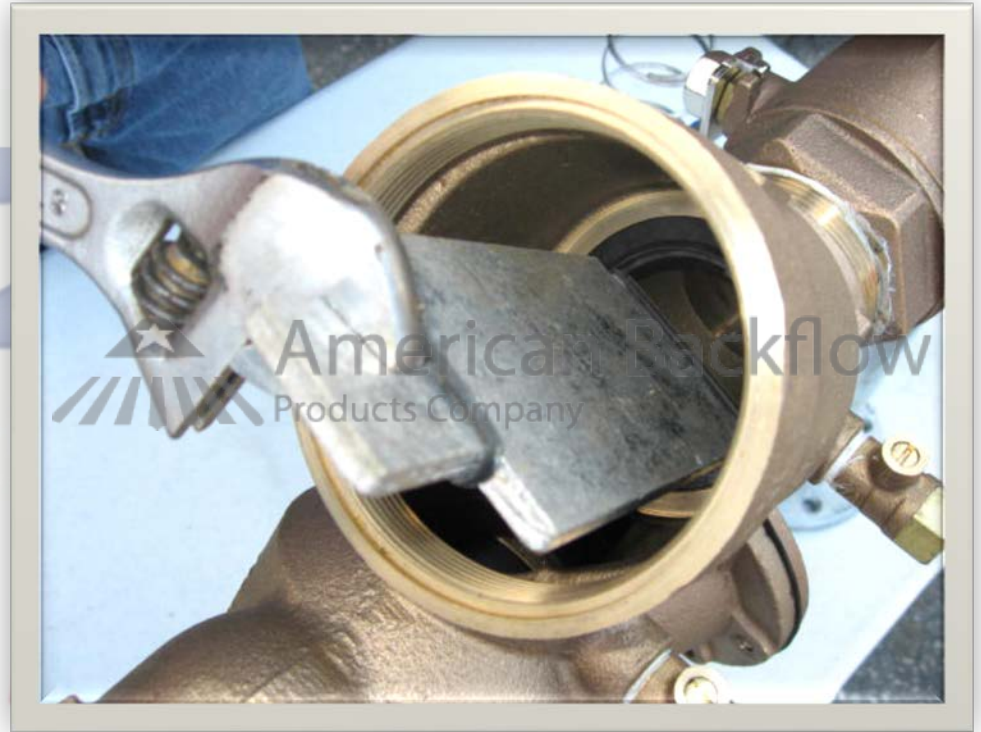
Check Seat Removal

Check seats are threaded into body and o-ring sealed.

A “special tool” is needed for removal.

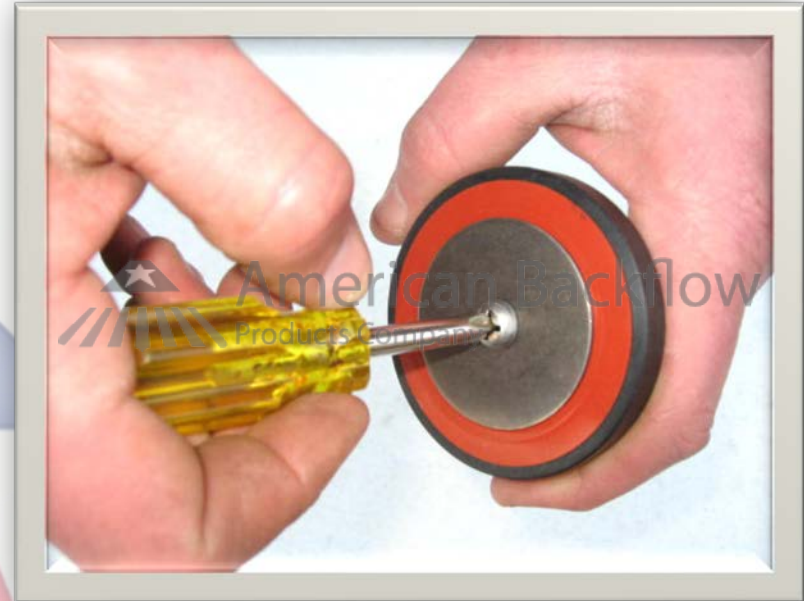
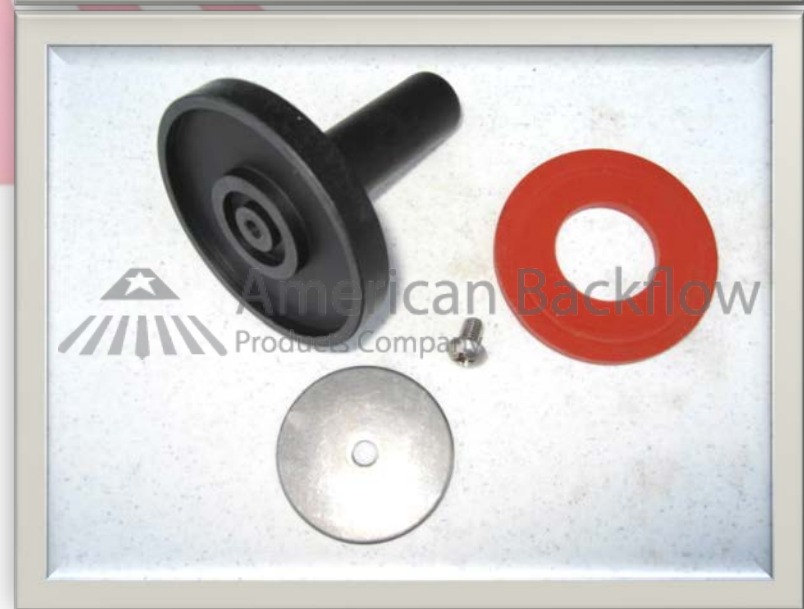
Check Disc Replacement

Remove screw and disc washer from poppet.

Reassemble in reverse order.

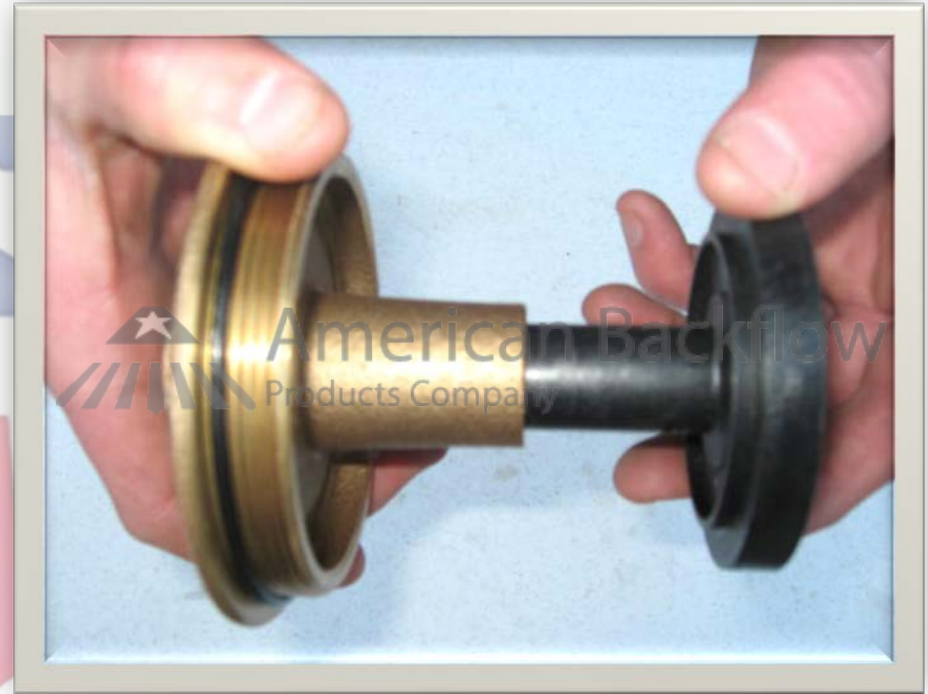
Check Valve Reassembly Notes

Inspect and clean the guide bore on the cover.

The stem must move freely in the guide bore.

Reassemble in reverse order.

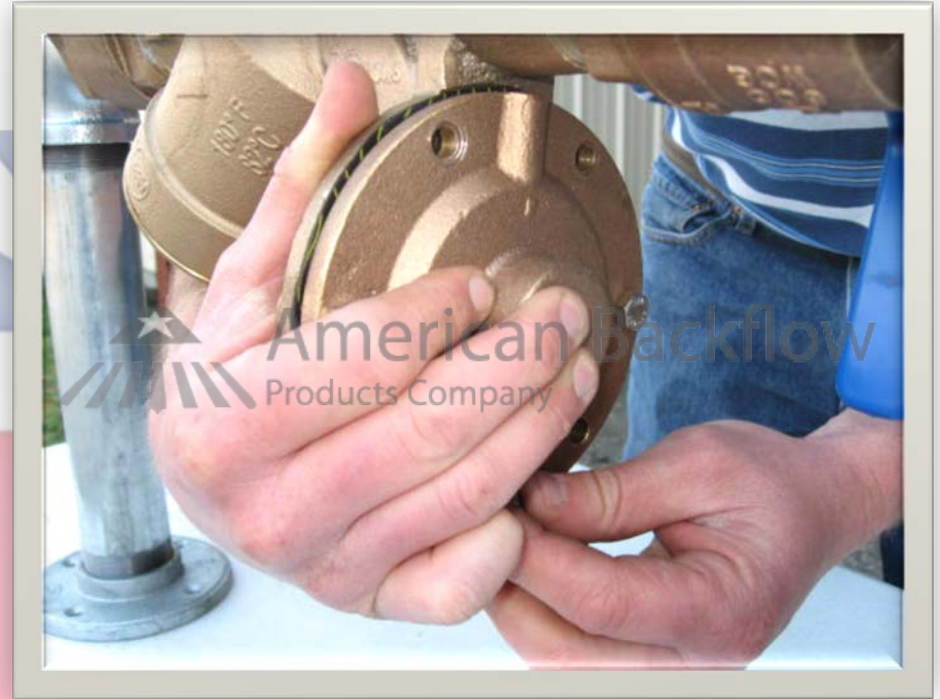
RV Cover Removal

Cover is sealed by the diaphragm.

Cover has a slight spring load.

Hold cover firmly as the bolts are removed.

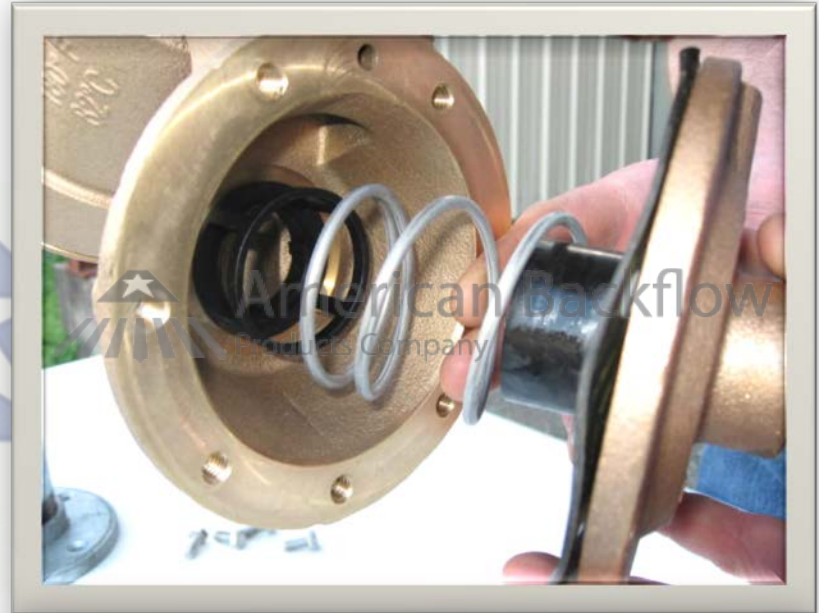
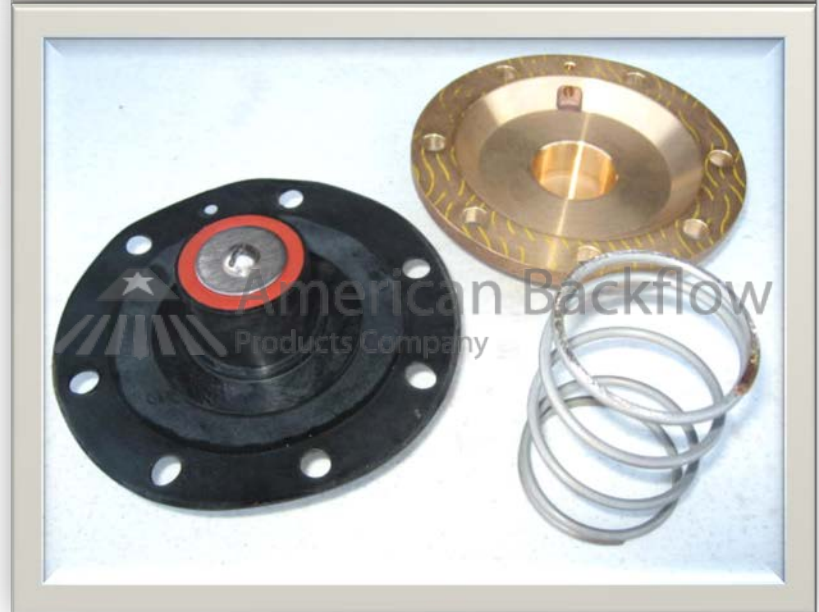
RV Stem Removal

Gently pull on the diaphragm to remove the RV stem.

The spring should fall out when the stem is removed.

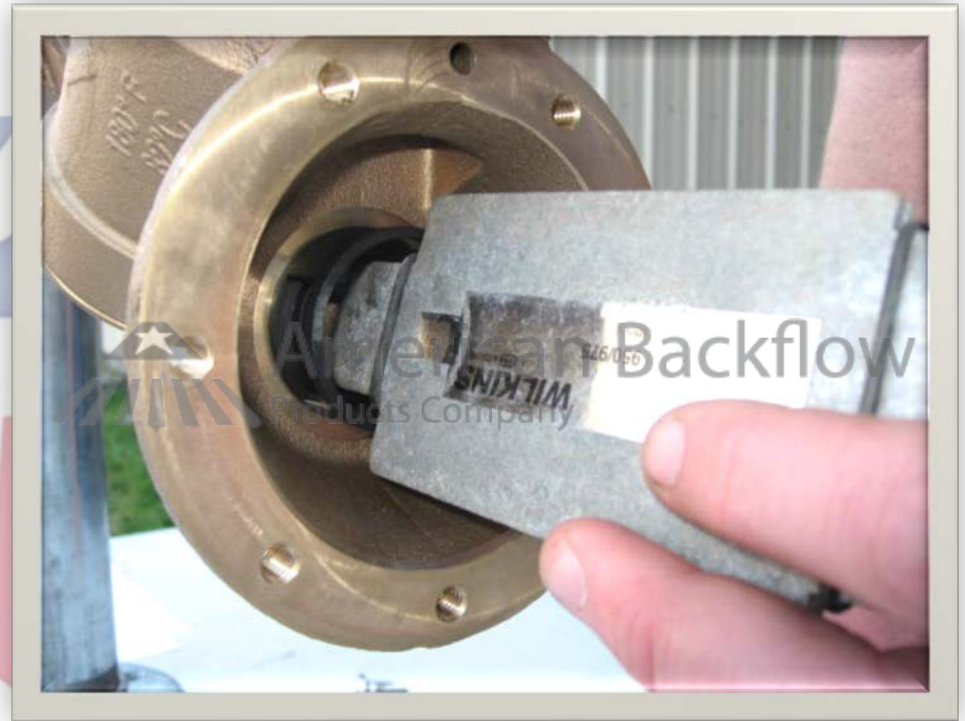
RV Seat Removal

The seat is threaded into body and o-ring sealed.

A “special tool” is needed to remove the RV seat.

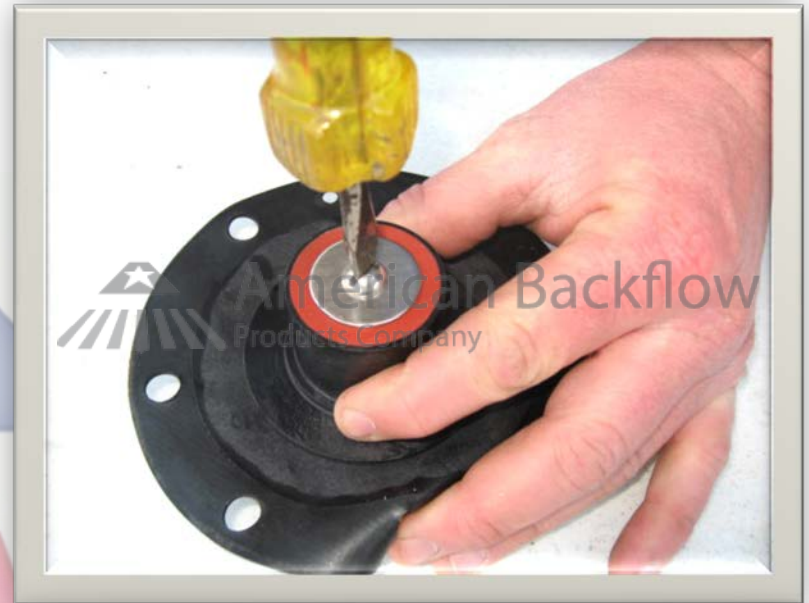
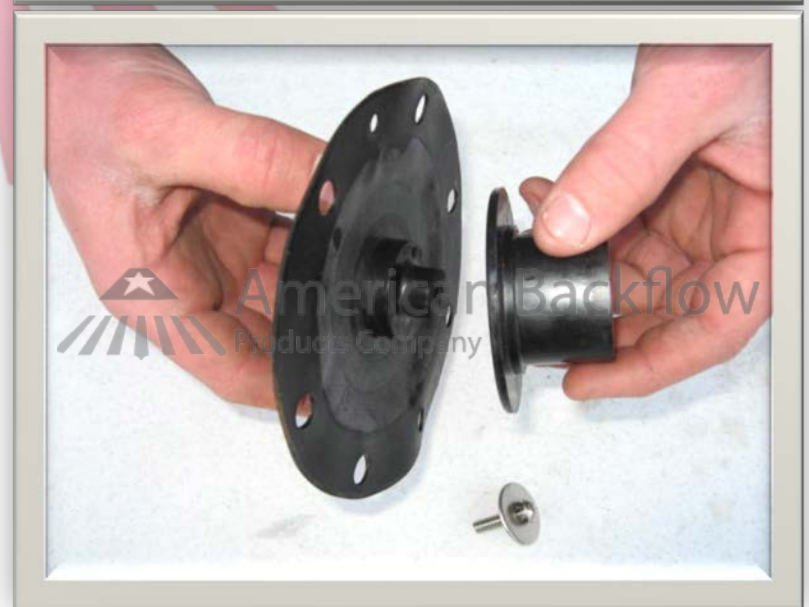
RV Stem Disassembly

Remove the retaining screw.

Pull the disc retainer and stem apart.

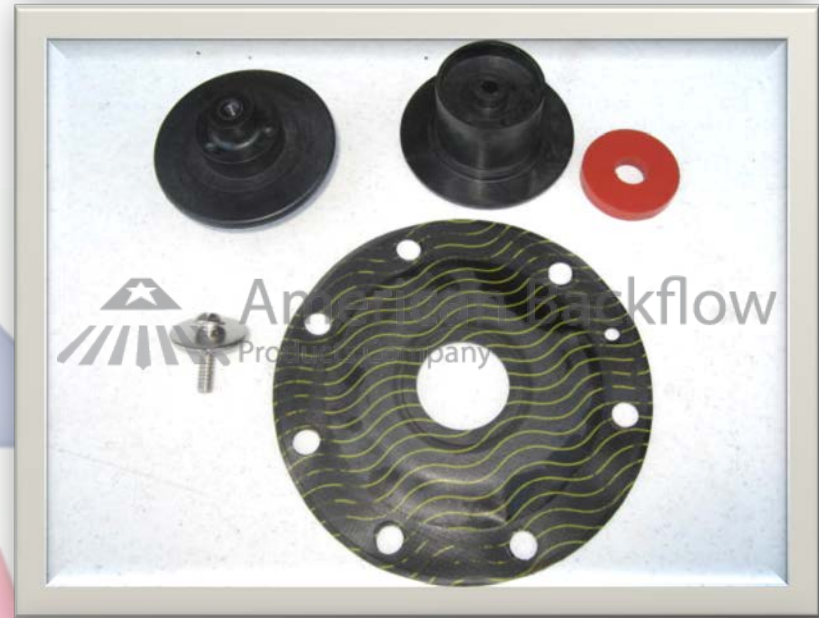
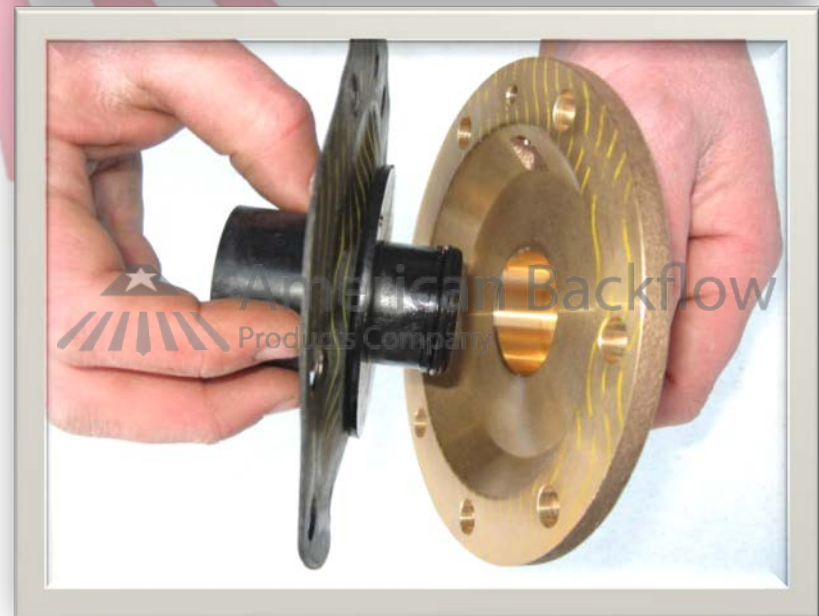
RV Rubber Replacement

The diaphragm and seat disc are free once the stem is disassembled.

Replace rubber in reverse order.

Lubricate plunger o-ring on stem.

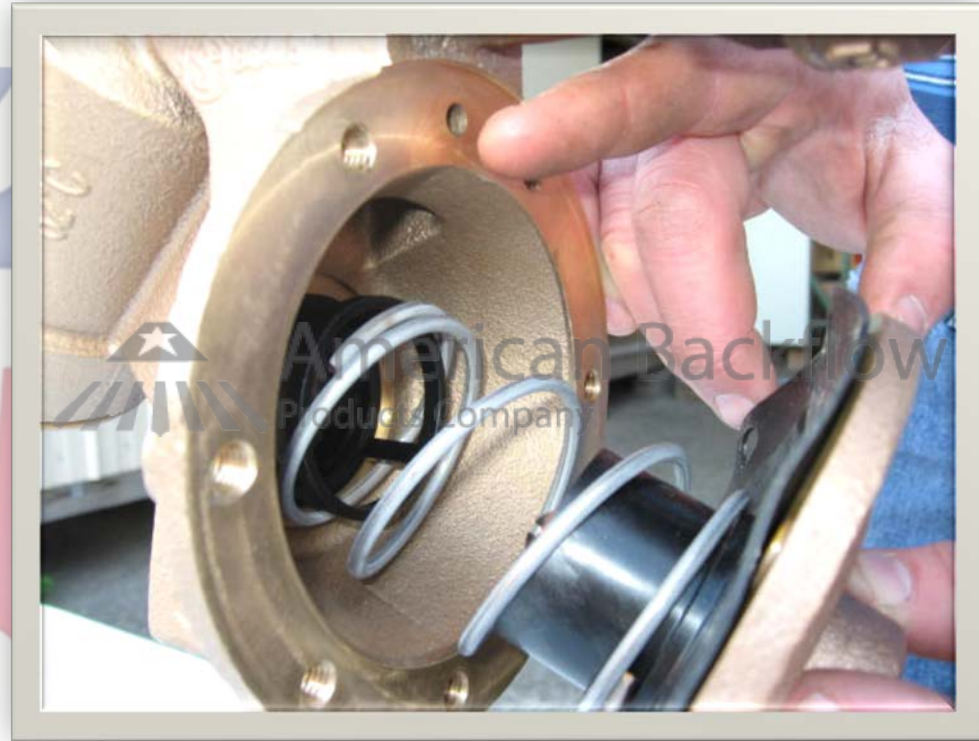
RV Reassembly Notes

Reassemble the stem in reverse order.

Position spring in body.

Make sure diaphragm does not cover hole for sensing line.
