A200 1/2" - 2"

Modification Overview

Production of the A200 (Watts 800M4) began in 1997 and is the current model.

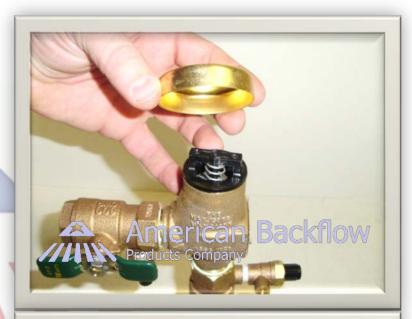
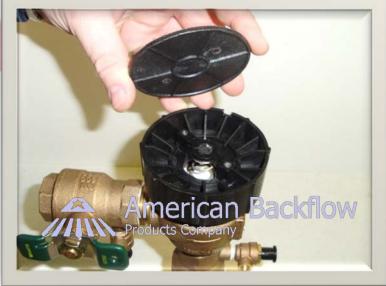
Hood Removal

The ½" - ¾" hood is secured by two screws.

The 1"-2" hood is secured by two screws.

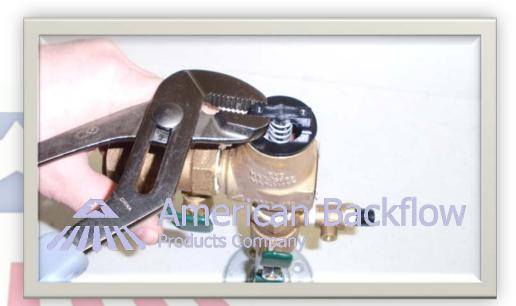
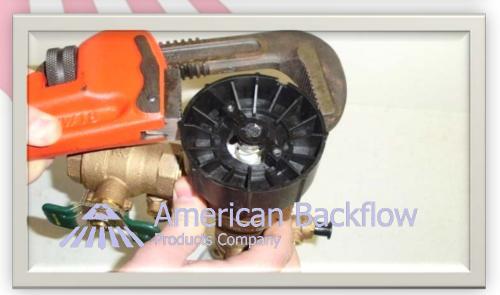
Bonnet Removal

The bonnet is threaded into the body and sealed by an o-ring.

There is no spring load.

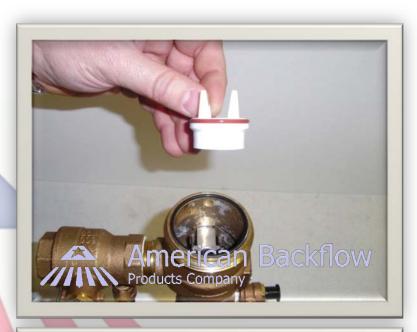
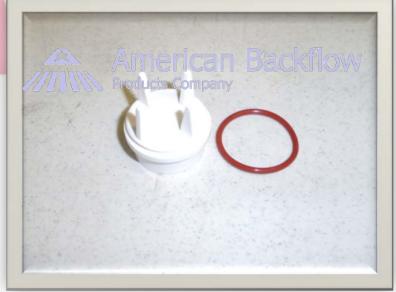
Float Removal and Service

The float is free once the bonnet has been removed.

Replace the rubber seal by pulling it from the groove on the float.

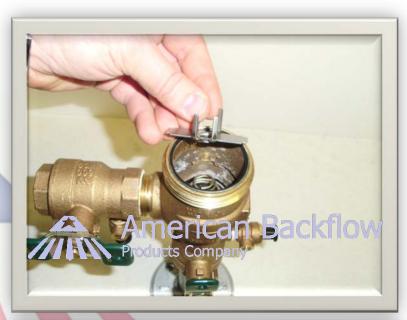
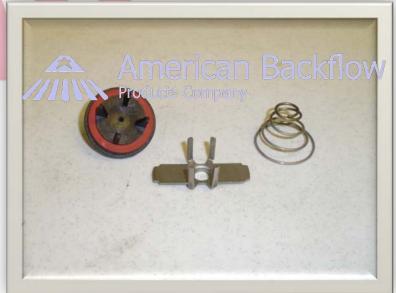
Check Valve Removal

Check valve is spring loaded.

Remove spring retainer by pressing down and rotating to clear tabs on the body.

Remove spring and poppet.

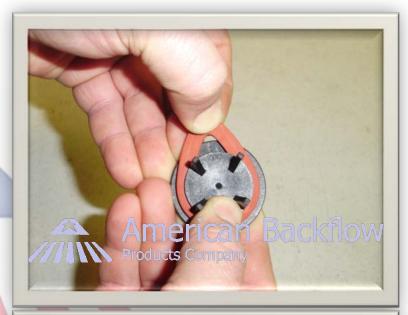
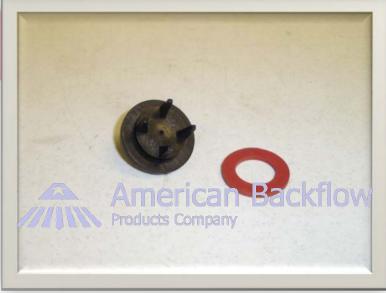
Check Disc Replacement

Replace the rubber disc by pulling it from the groove on the poppet.

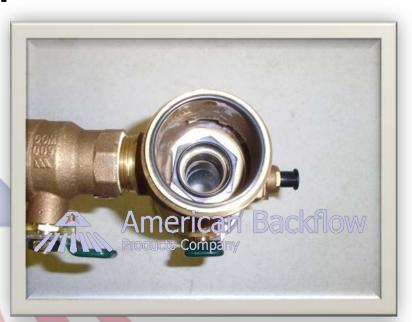
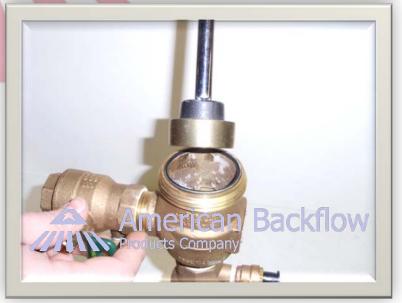
Check Seat Replacement

The check seat is threaded into the body and sealed by an o-ring.

Note: A special tool is needed to remove the seat.

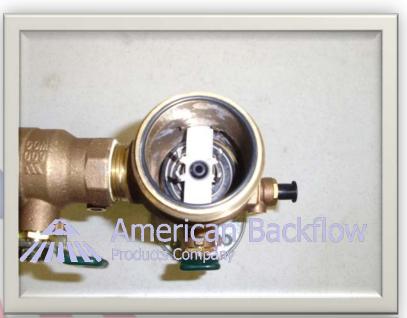
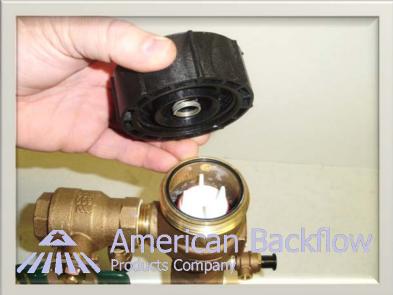
Reassembly Notes

Reassemble in reverse order.

Place large end of spring down in body.

The guides on the retainer face up.

The guides on the float face up.

Make sure the float spring is centered on the float.
