C200, C200N (2 ½ " – 10") C200A (2 ½ " - 6")

Modification Overview

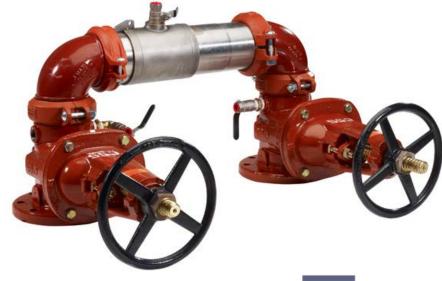
Production began in 2000 under the Hunter name. In 2002 it was produced as the Ames Colt (C) Series.

(a) suffix after the model number indicates the original version that contains a bi-link check valve. Discontinued in 2008.

The current version contains a tri-link check valve.

Repair steps are the same for both check models.

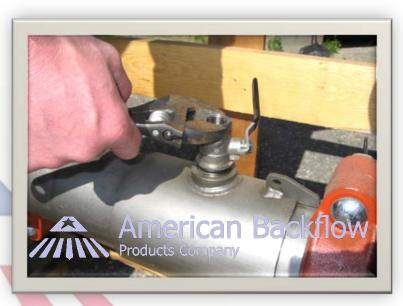
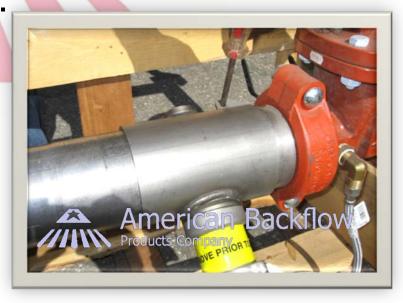
Check Cover Removal 2 1/2" - 6"

Cover slides back and is o-ring sealed.

Remove test cock # 3 from the body.

Insert a screwdriver into the hole on top of the cover sleeve.

Using both hands, rotate the cover ¼ turn clockwise and counter-clockwise to break oring seal.

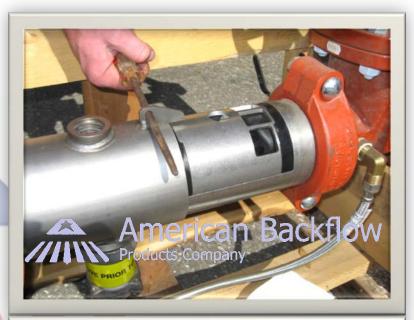
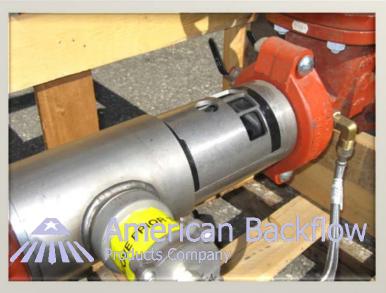
Check Cover Removal 2 1/2" - 6"

Slowly slide the cover sleeve to the downstream side of the housing.

Once fully pulled back, turn the sleeve 90 degrees.

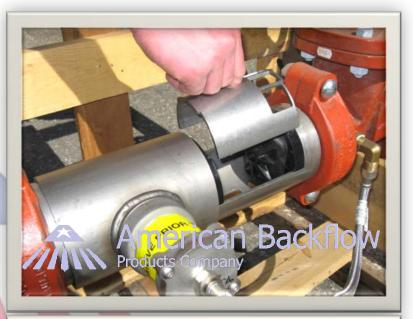
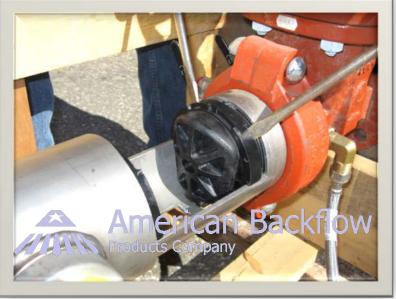
Check Valve Removal 2 1/2" - 6"

Check valve modules.

Modules are o-ring sealed.

Remove the check retainer.

Remove check 1 first, then check 2.

Using a flat blade screwdriver, gently pry the module out of the body.

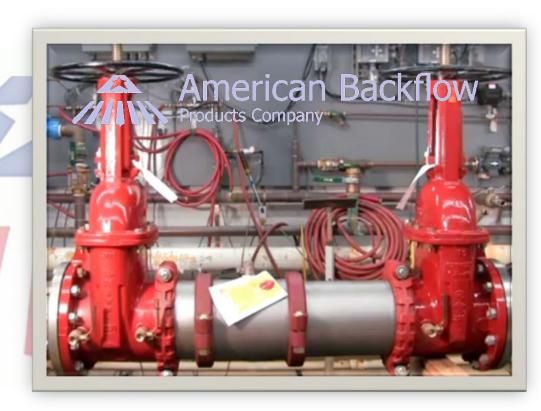
Check Cover Removal 8" - 10"

For the 8-10" sizes, remove both Victaulic couplers.

Remove test cock # 3 from the body.

Slide the cover downstream.

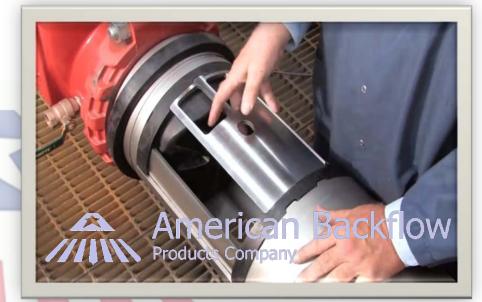
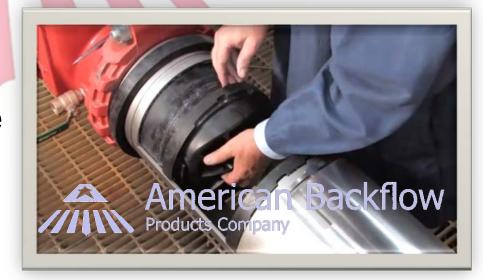
Check Valve Removal 8" - 10"

Modules are o-ring sealed.

Remove the 3 check retainers.

Remove check 1 first, then check 2.

Using a flat blade screwdriver, gently pry the module out of the body.

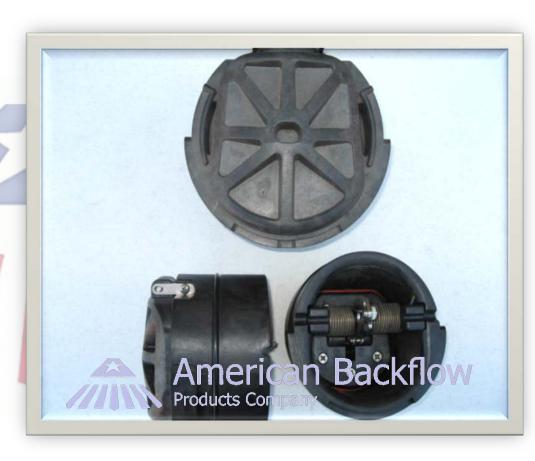
Check Seat Removal

The check seat is part of the module.

If seat is damaged, the entire module will have to be replaced.

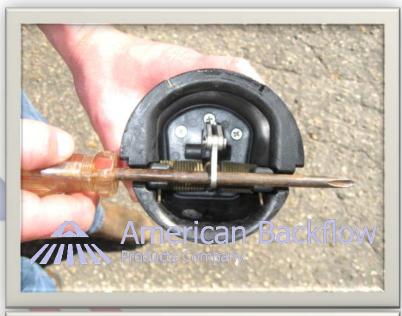
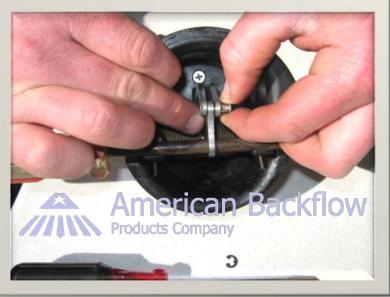
Check Disc Replacement 2 1/2" - 4"

The check modules are spring loaded.

Insert a screwdriver through the hole in the linkage and let it rest in the arbors on the module.

Remove the "E"-clip and pin connecting the linkage.

The clapper will open with no tension.

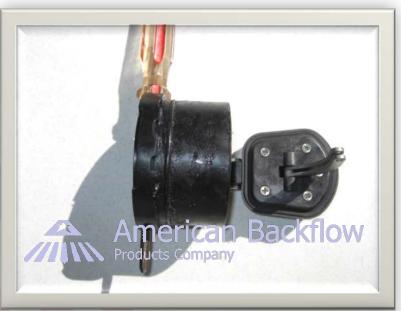
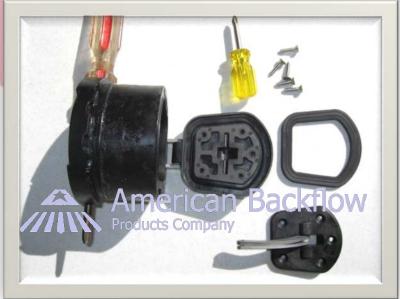
Check Disc Replacement 2 1/2" - 4"

Remove the screws on the disc retainer.

Once disc is replaced, reassemble in reverse order.

Do not remove the spring assembly.

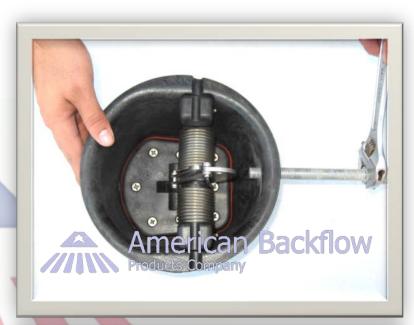
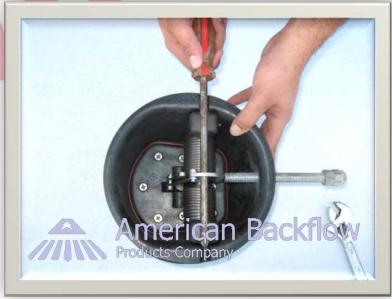
Check Disc Replacement 6" - 10"

Locate the service hole on the side of the check module.

Use a ½"-13 x 5 fully threaded bolt.

Thread the bolt until the hole in the linkage is aligned with the notches in the spring arbors.

Insert a long phillips screwdriver through the hole and arbors.

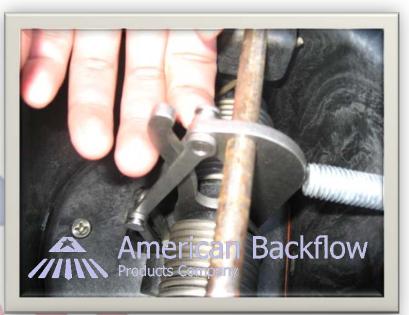
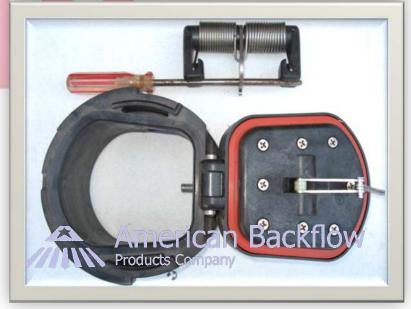
Check Disc Replacement 6" - 10"

Back the bolt out until the spring tension is transferred to the screwdriver.

Remove retaining clip and pin from linkage.

Spring assembly can be removed from the module.

Remove screws from disc retainer.
